265 Parkway Blvd Roof Conditions & Solutions Report

Case # 0265-01

October 30, 2020

Title: Roof Core Analysis Photographic Report

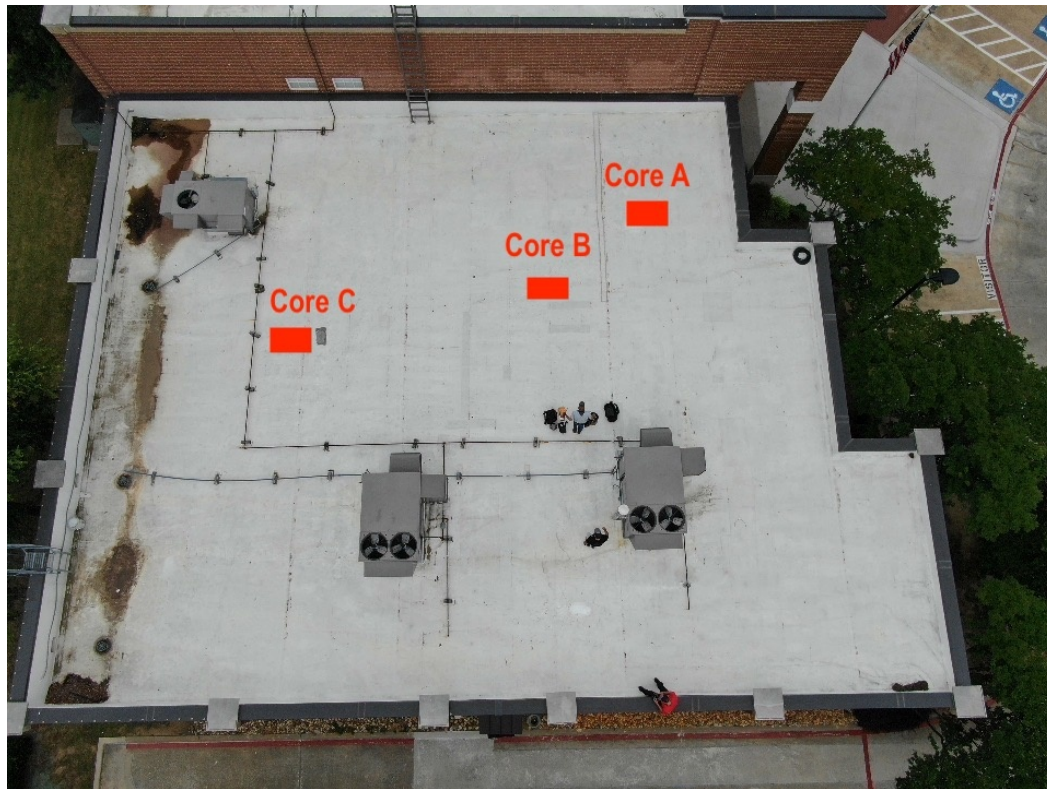
Photo 1

Photograph shows all core sections on lower roof section.

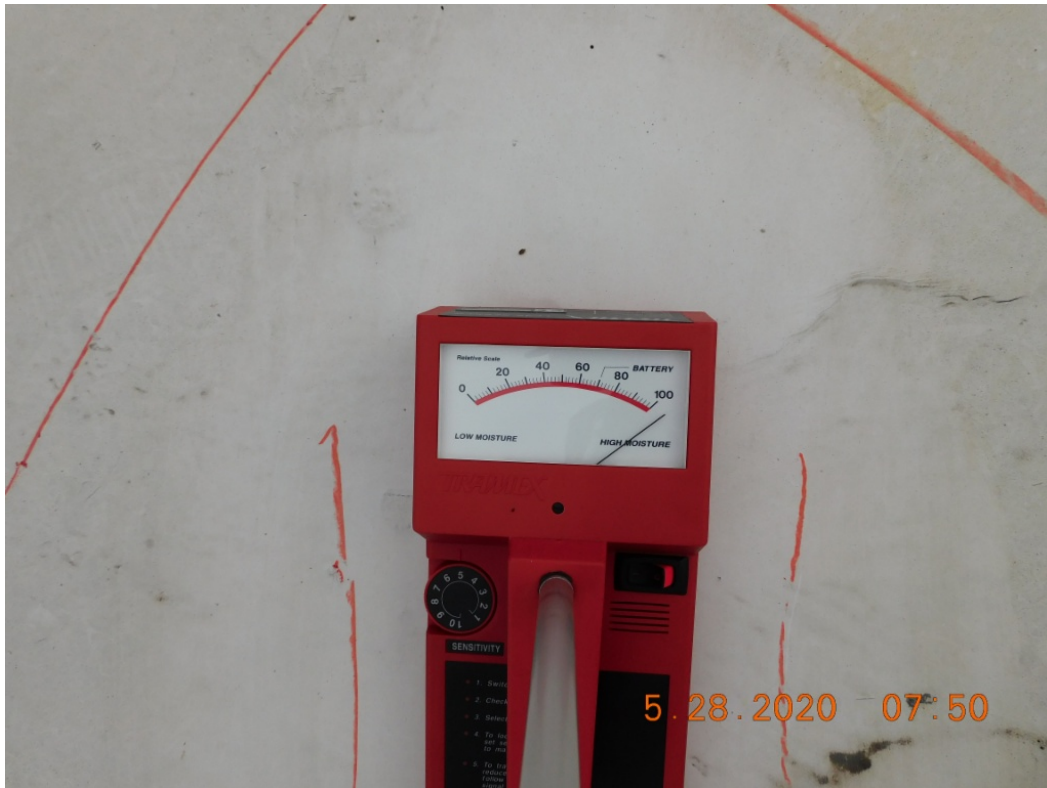
Photo 2

Photograph shows 100% reading on Tramex Model RWS (moisture detection) in roof assembly at Core A location.

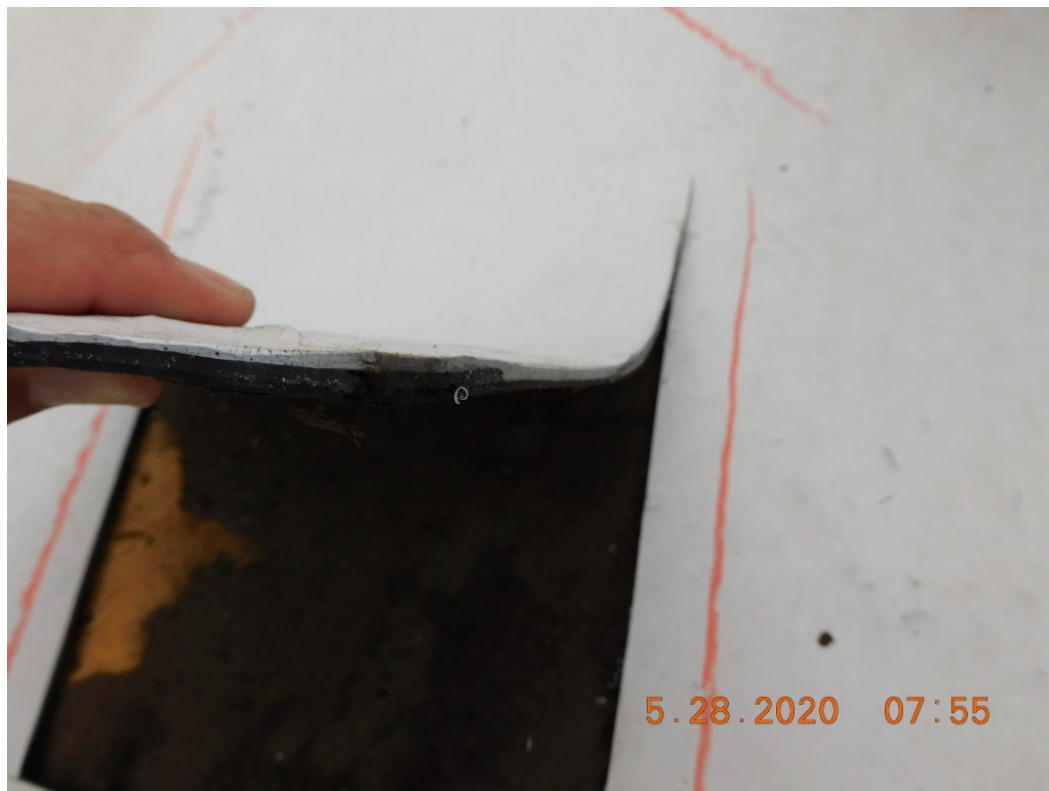
Photo 4

Observed liquid applied roofing system applied over original EPDM single ply roof membrane.

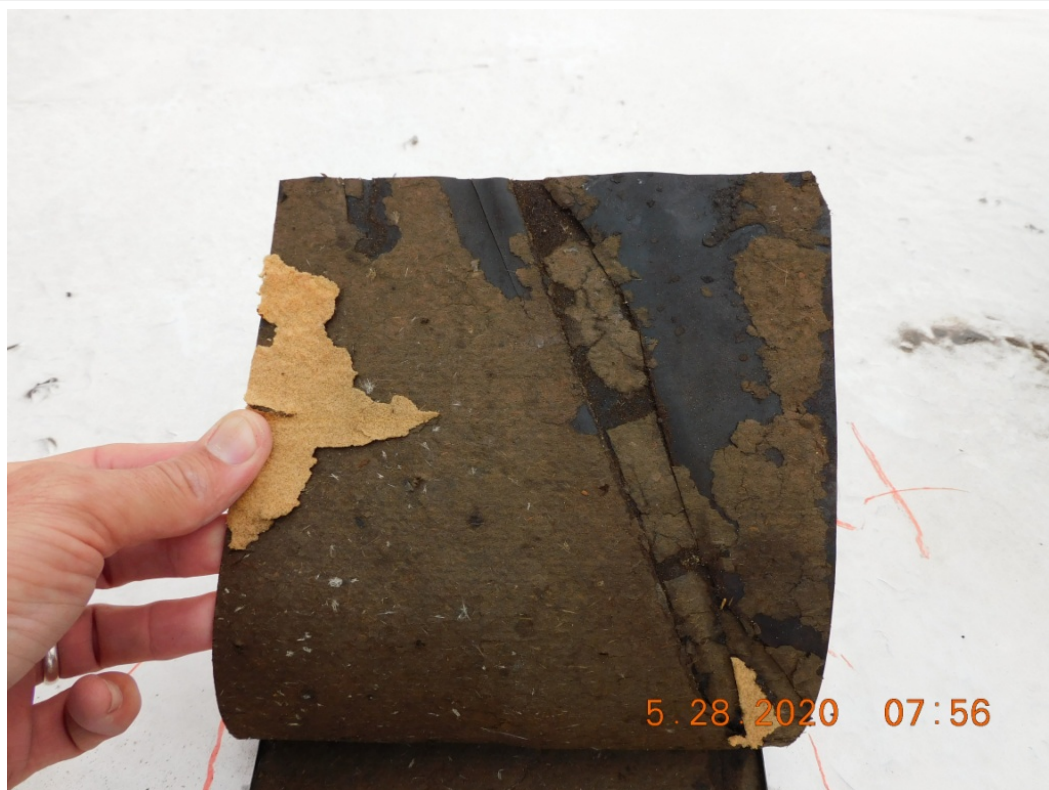
Photo 5

Observed moisture on insulation facer sheet.

Observed moisture present on underside of single ply roof membrane.

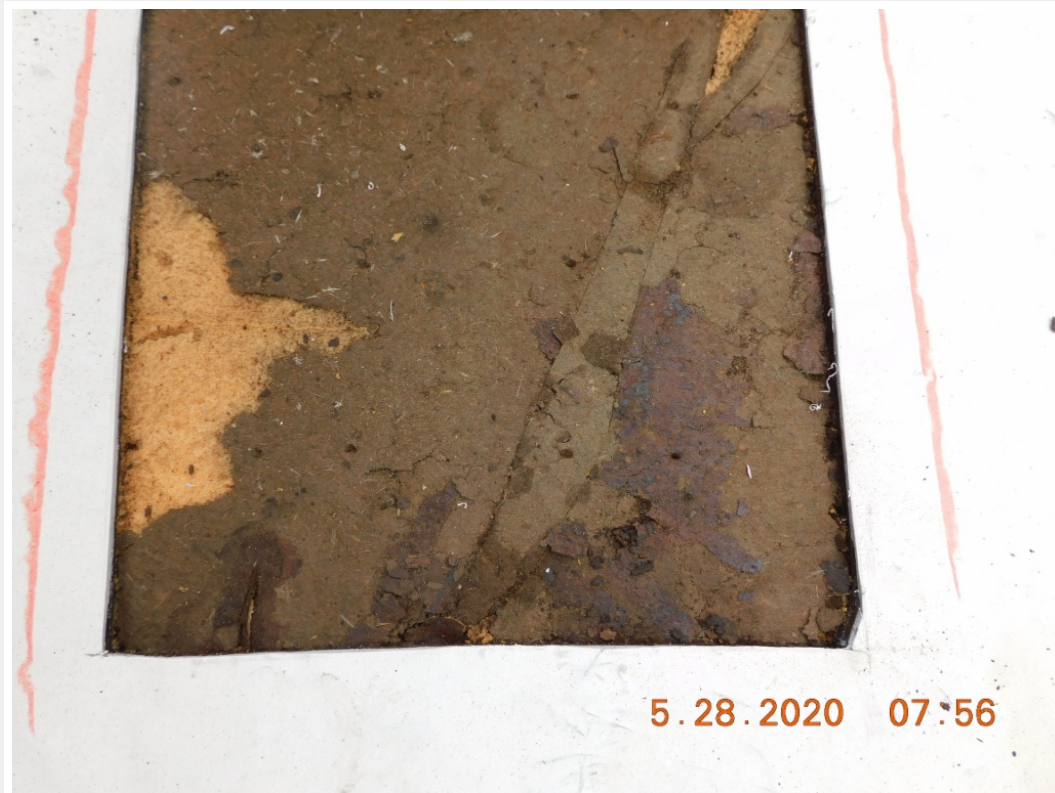
Photo 6

Observed moisture on insulation facer sheet.

Observed moisture present on insulation board surface.

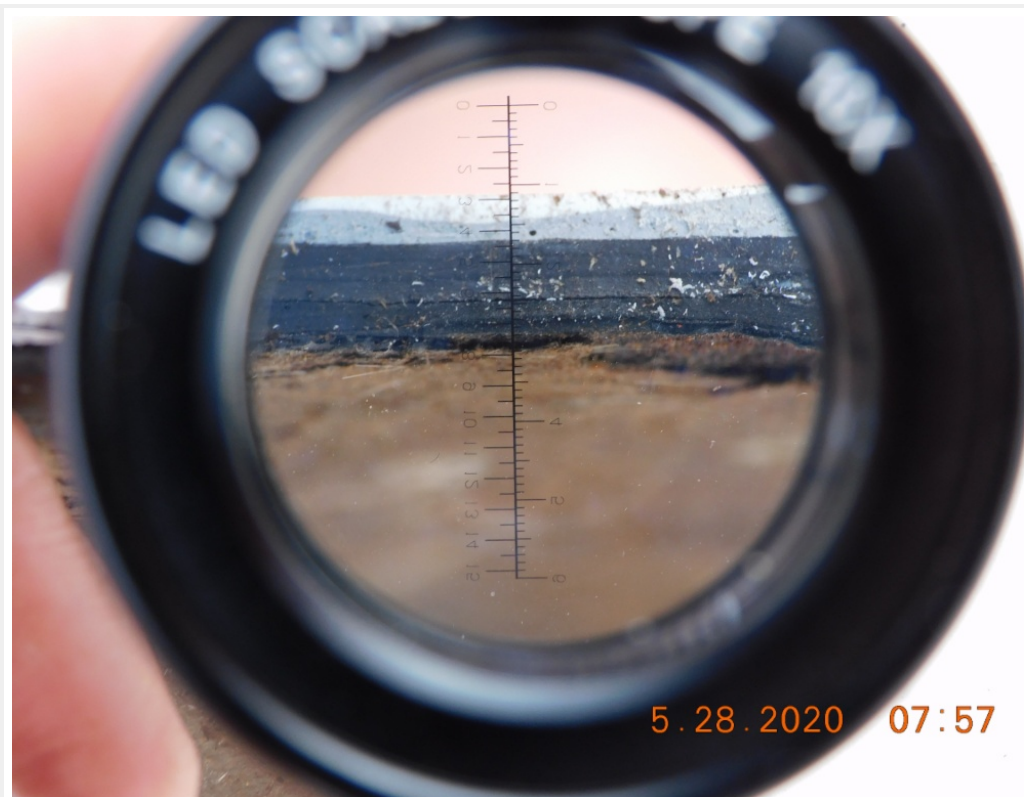
Photo 7

Observed EPDM single ply membrane with liquid applied base layer and white reflective liquid applied roof system.

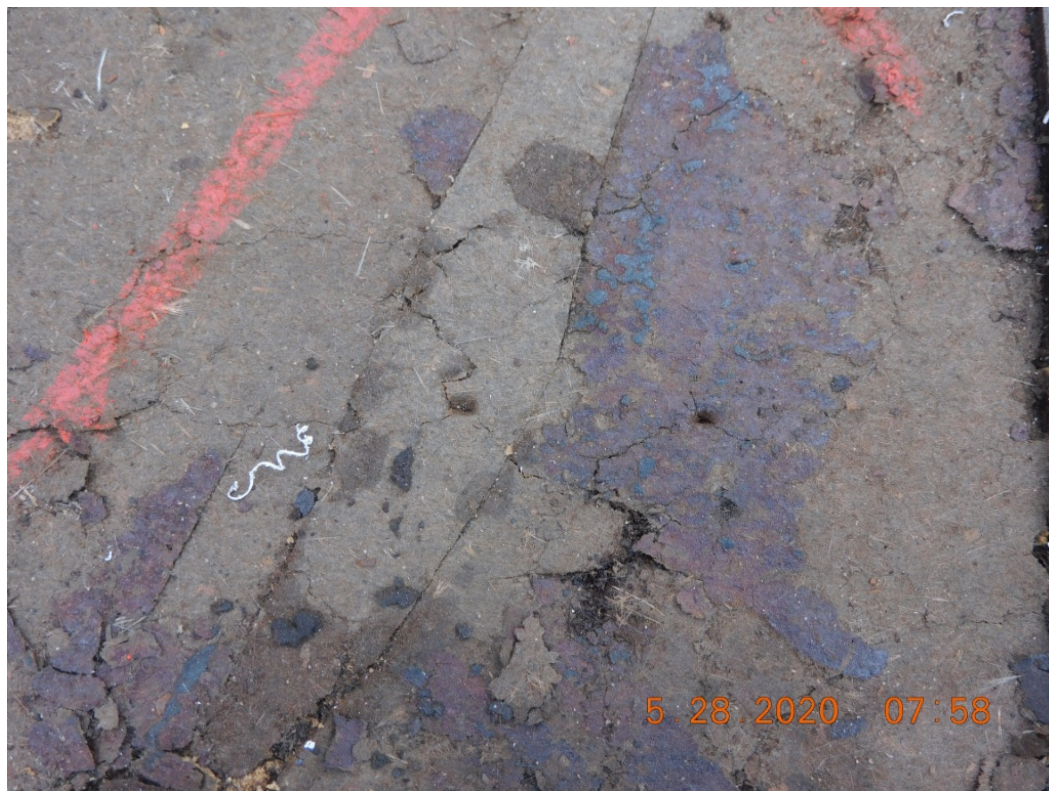
Photo 8

Observed moisture on insulation facer sheet.

Observed weather related impacts on insulation facer sheet from recent storm events.

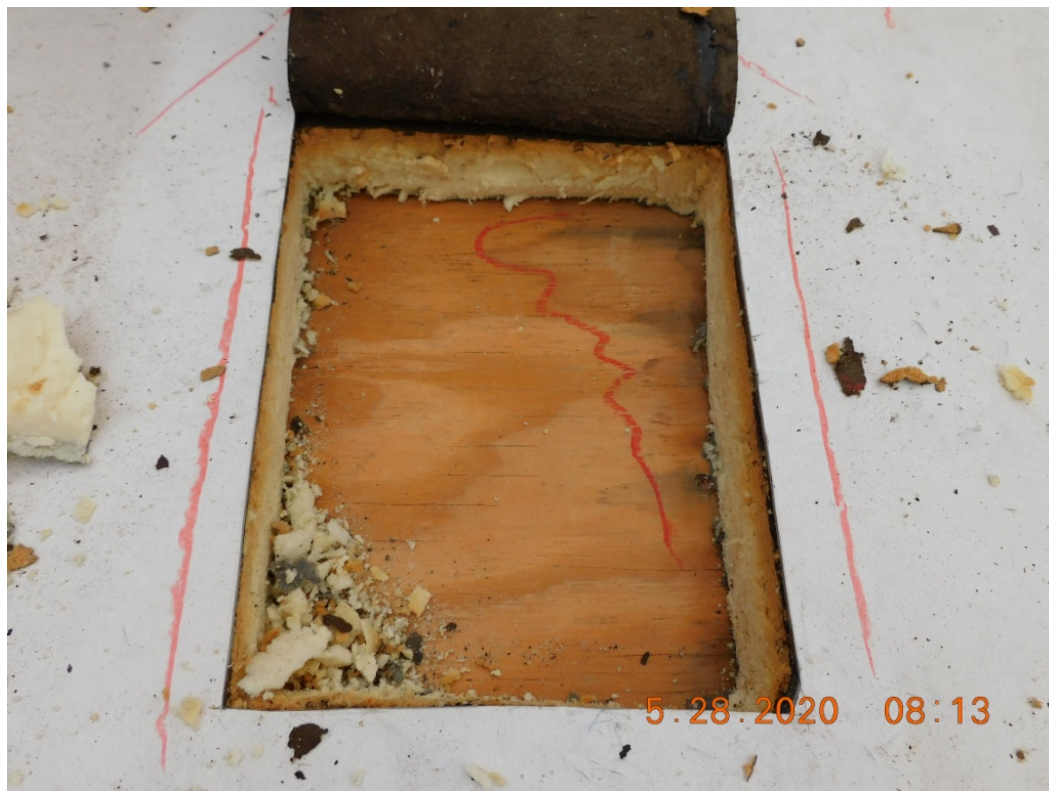
Photo 10

Observed moisture degradation of wood deck (circled in red).

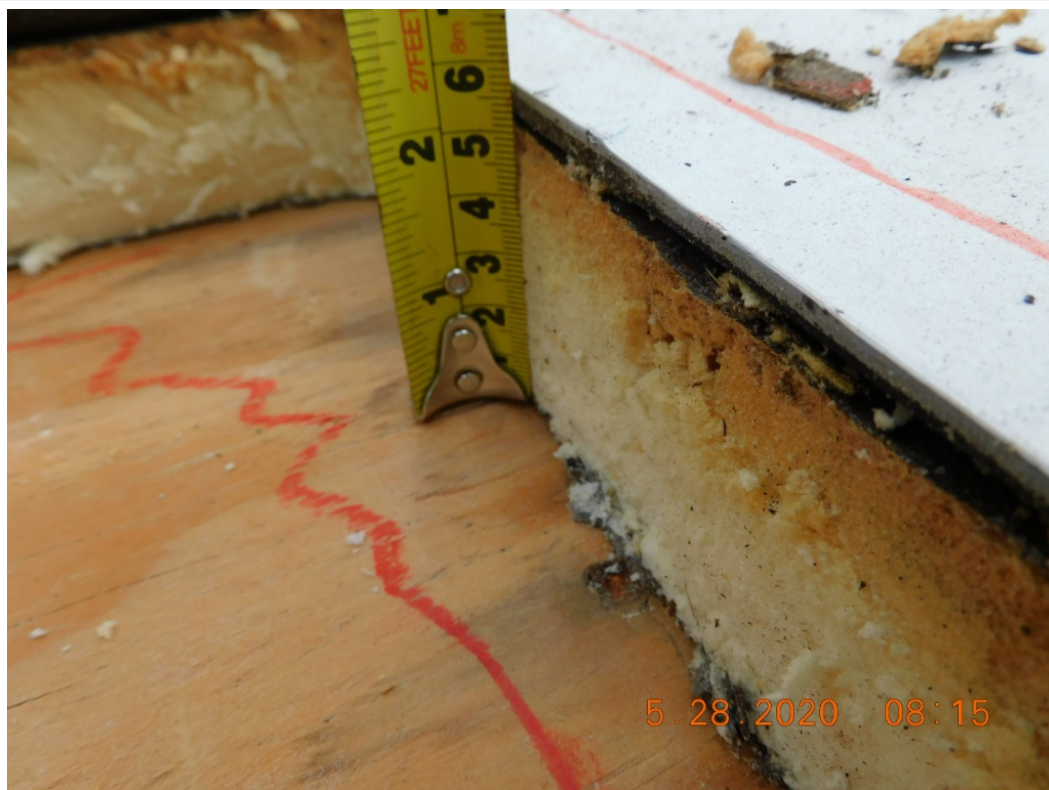
Photo 11

Photograph shows moisture trapped in insulation board directly above moisture degraded wood deck.

*** Existing roof assembly does NOT Have hygric buffer or vapor barrier installed.

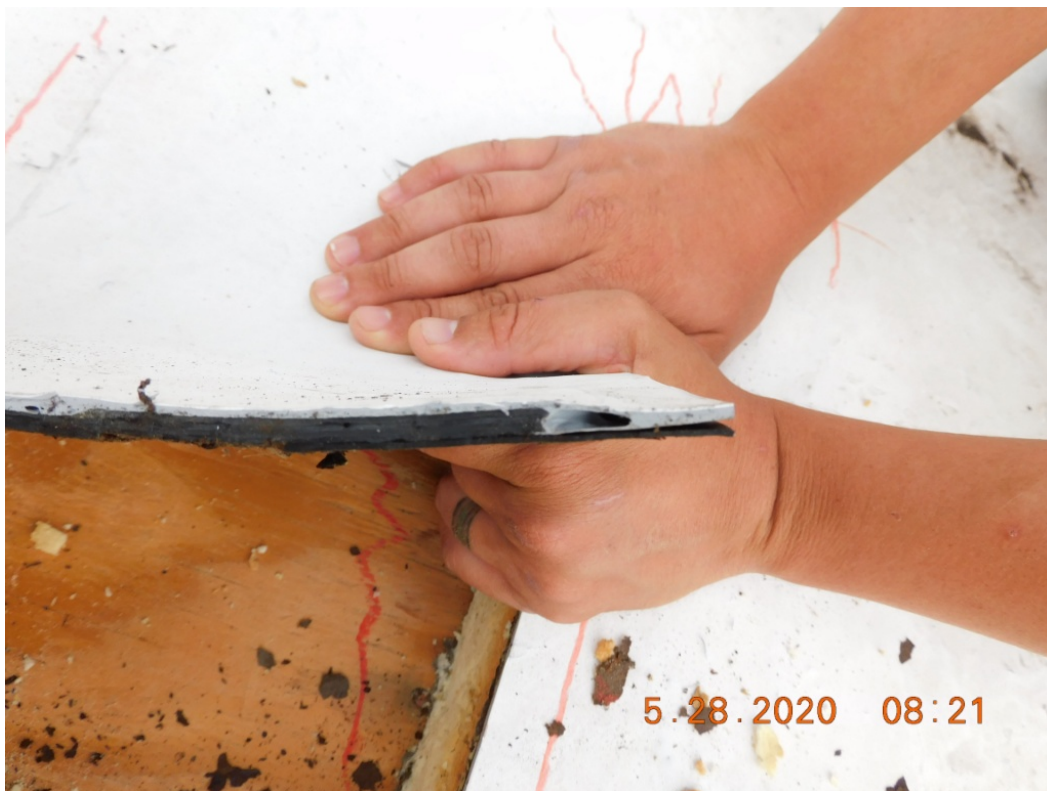
Photo 17

Observed presence of moisture trapped in coating installed over original roof assembly.

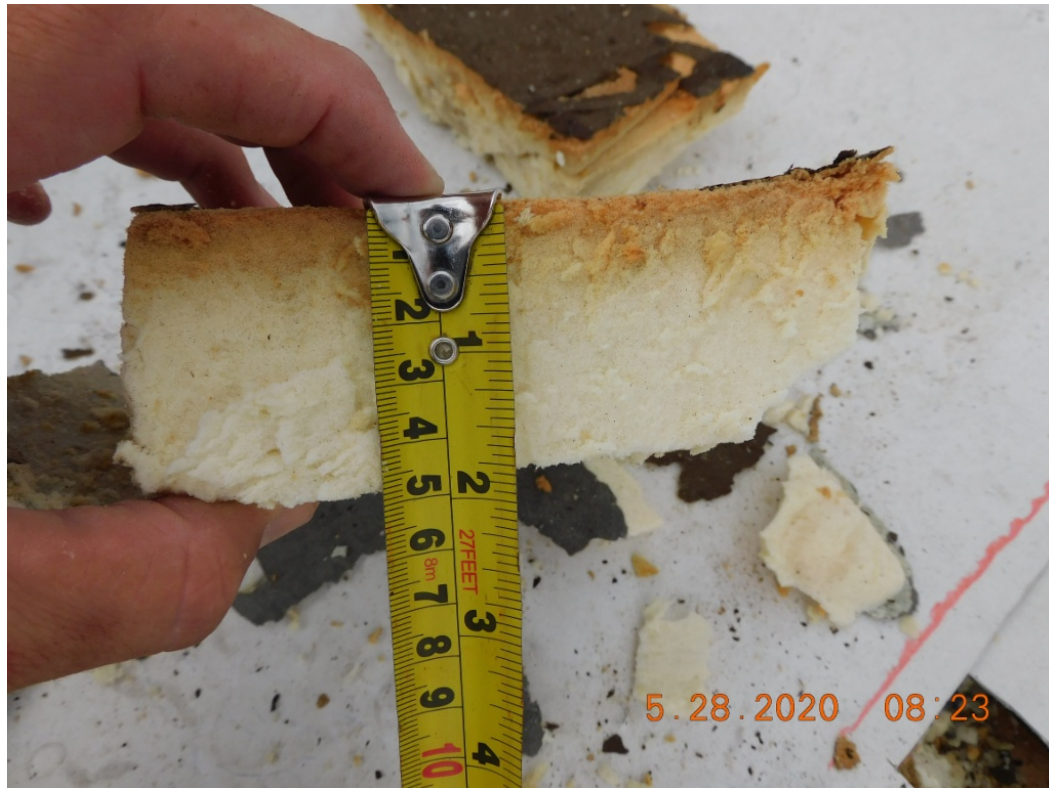
Photo 18

Photograph shows single layer of 2" of insulation board.

** City of Coppell code requires R-25 to be installed on new construction and reroofs.

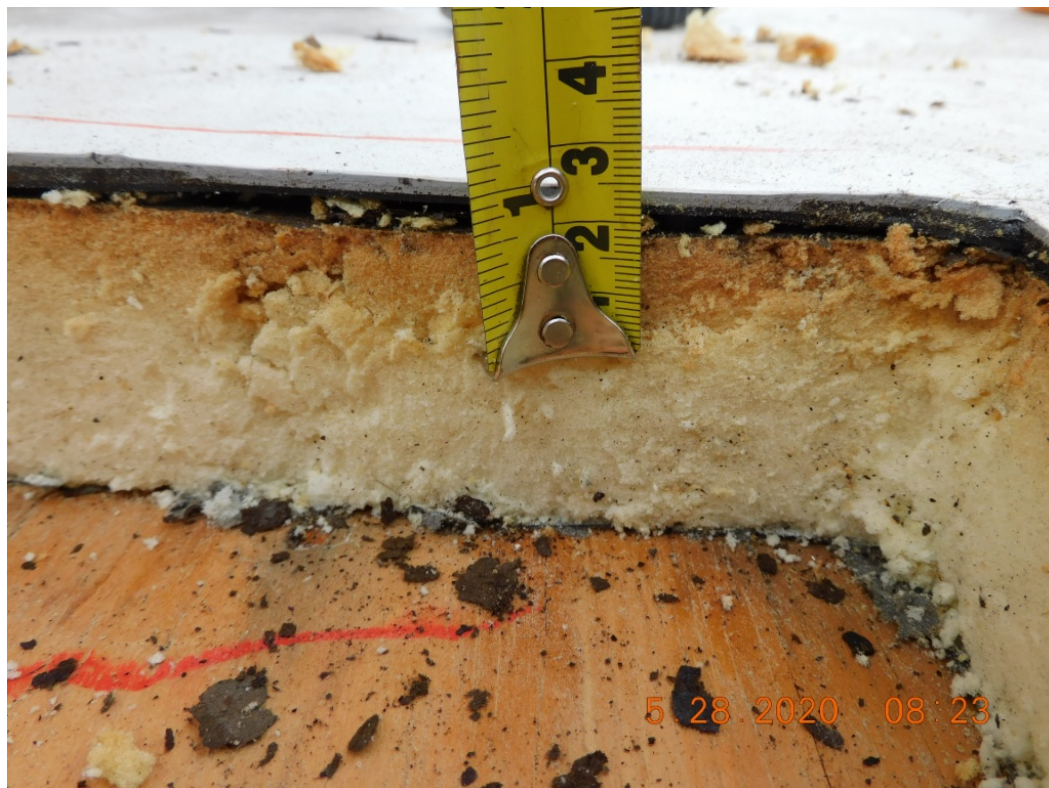
Photo 19

Observed 1" of moisture trapped in top surface of insulation board.

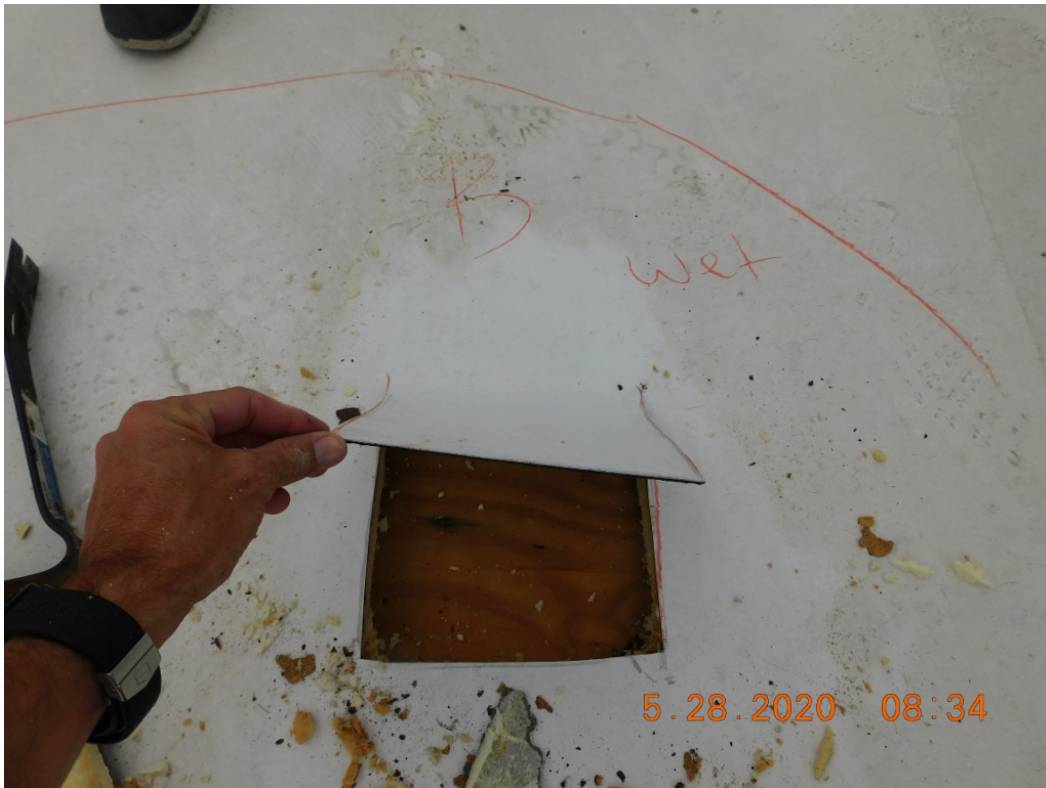
Photo 23

Observed moisture
present on top surface
of insulation board.

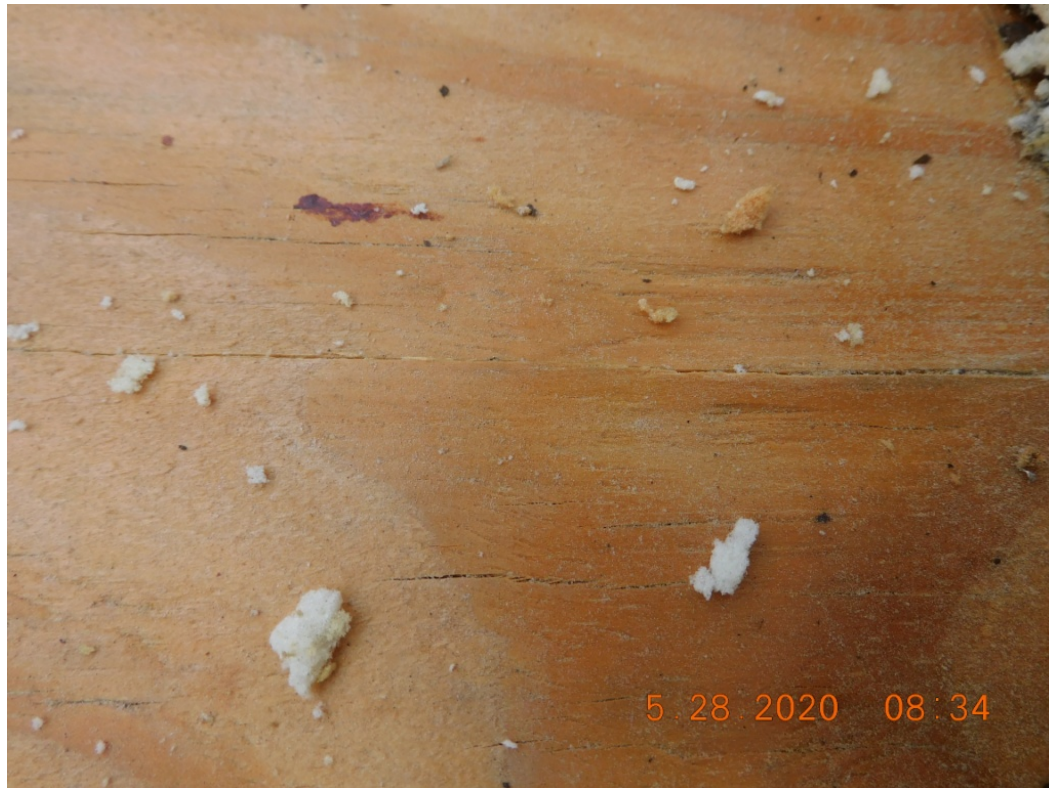
Photo 24

Observed moisture damaged on wood deck surface from contraction and expansion of roof deck. (See cracks and old moisture marks)

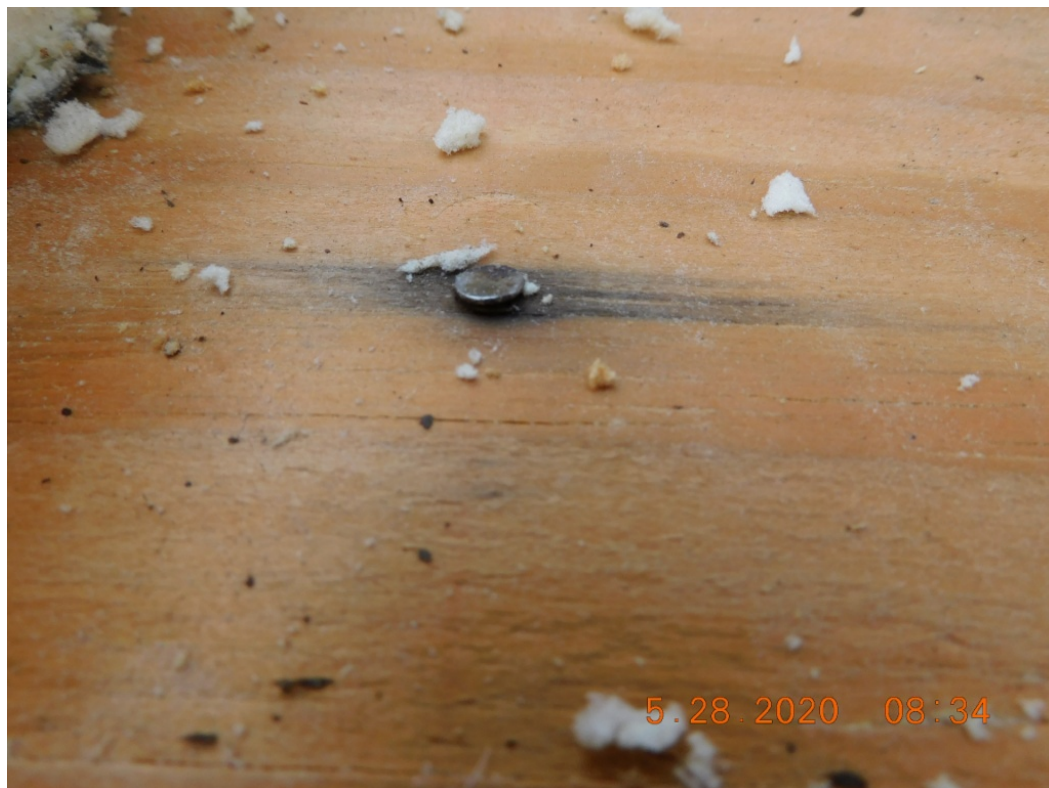
Photo 25

Observed corroded fastener attaching wood deck to framing members "Rafters" below roof deck.

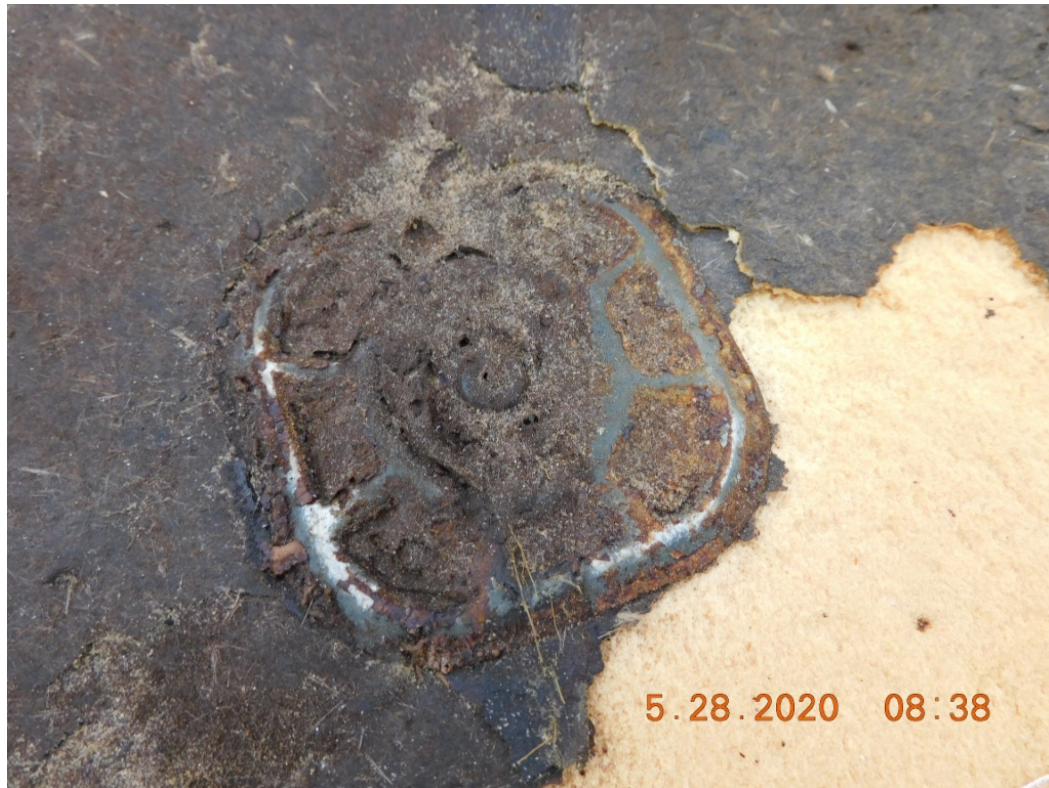
Photo 32

Photograph shows close up view of rapid galvanic corrosion from moisture trapped in roof assembly.

** Fasteners and Plates are crucial for withstanding wind uplift and maintaining ASTM design requirements during gale force winds and high wind events including tornados, wind bursts, etc.

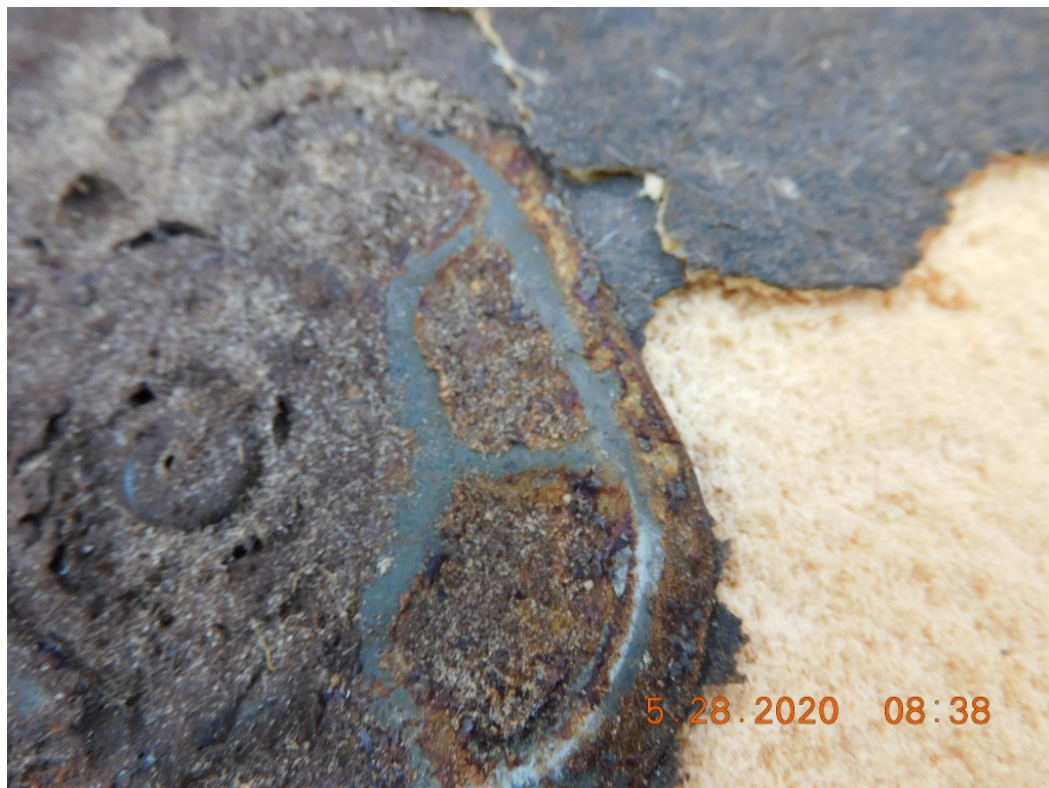
Photo 33

Photograph shows close up view of corrosion on fastener and plate at Lower Roof Section Core C.

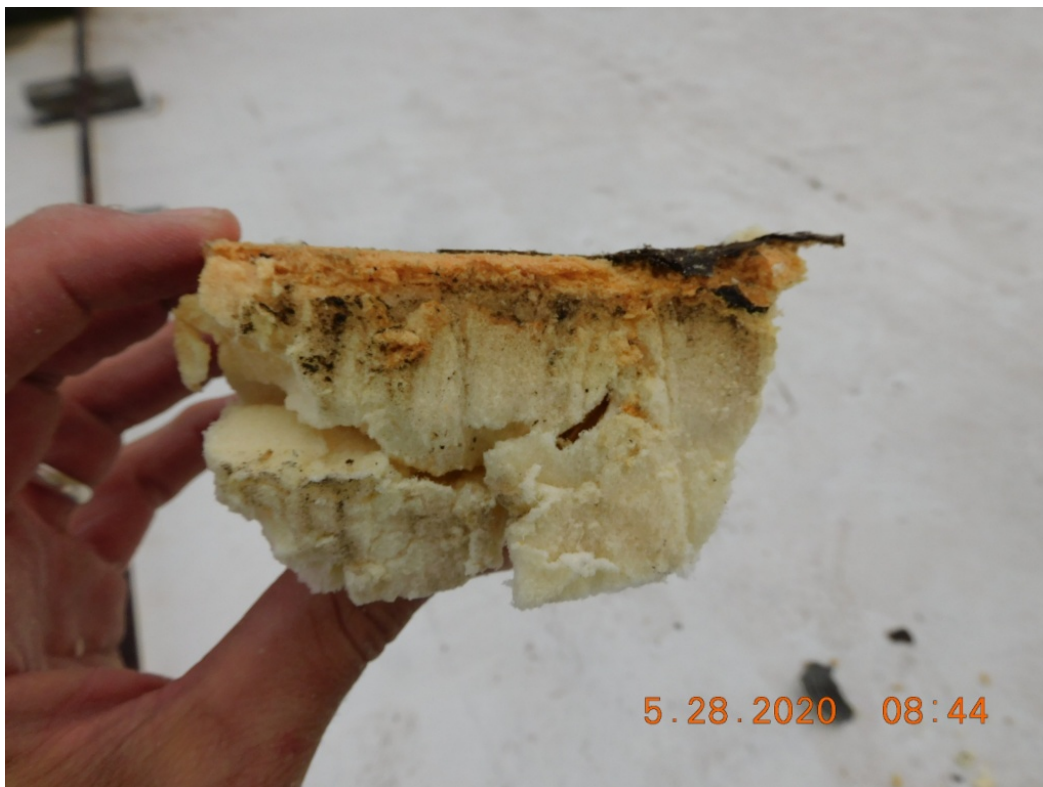
Photo 35

Observed presence of moisture and past moisture damage on insulation board.

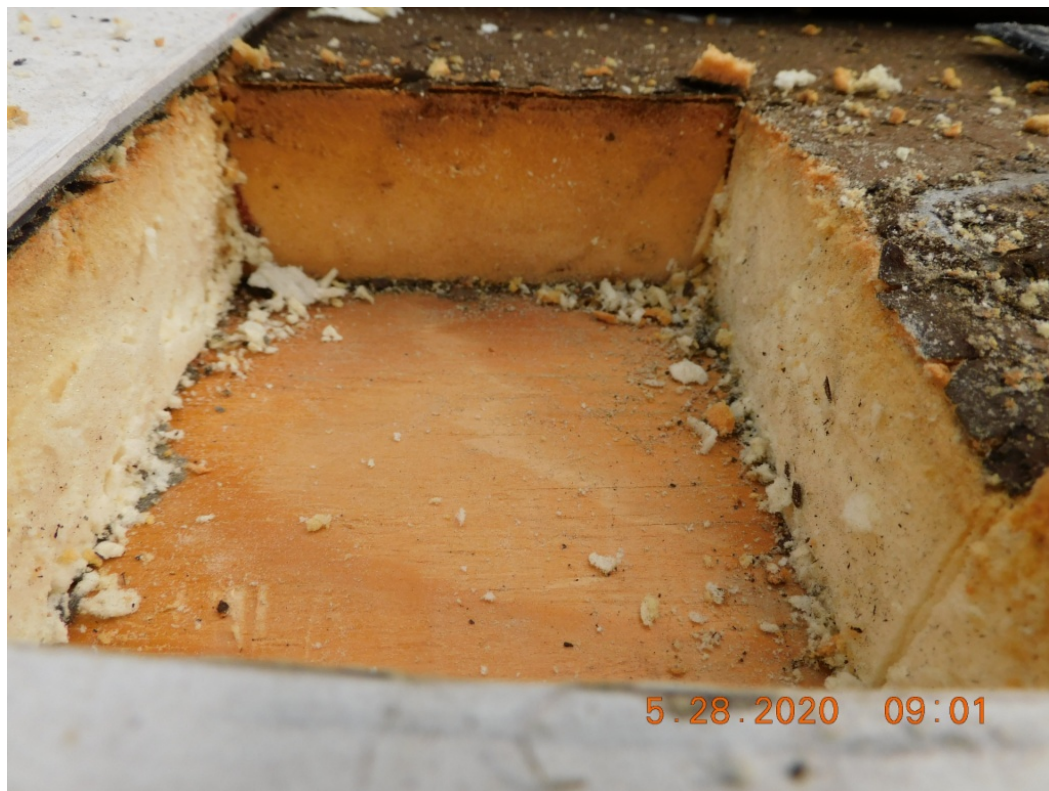
Photo 4

Observed moisture trapped in insulation board fastened to wood deck.

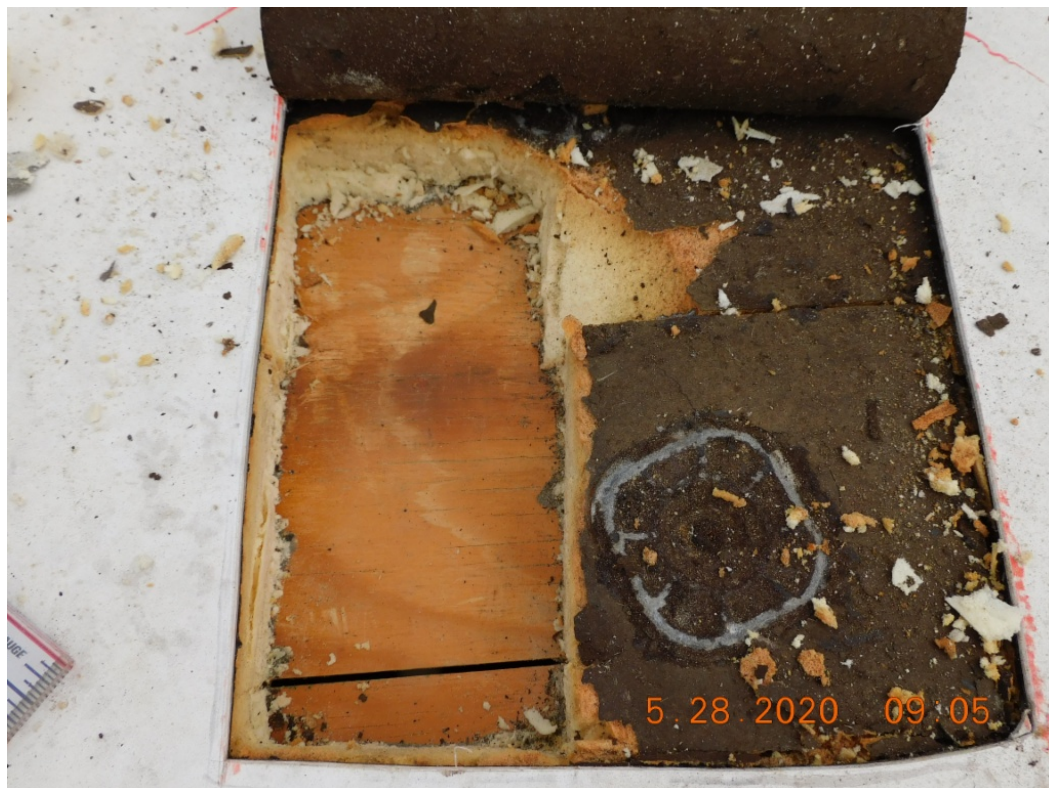
Photo 5

Observed presence of moisture in roof deck.

Observed corroded insulation fastener.

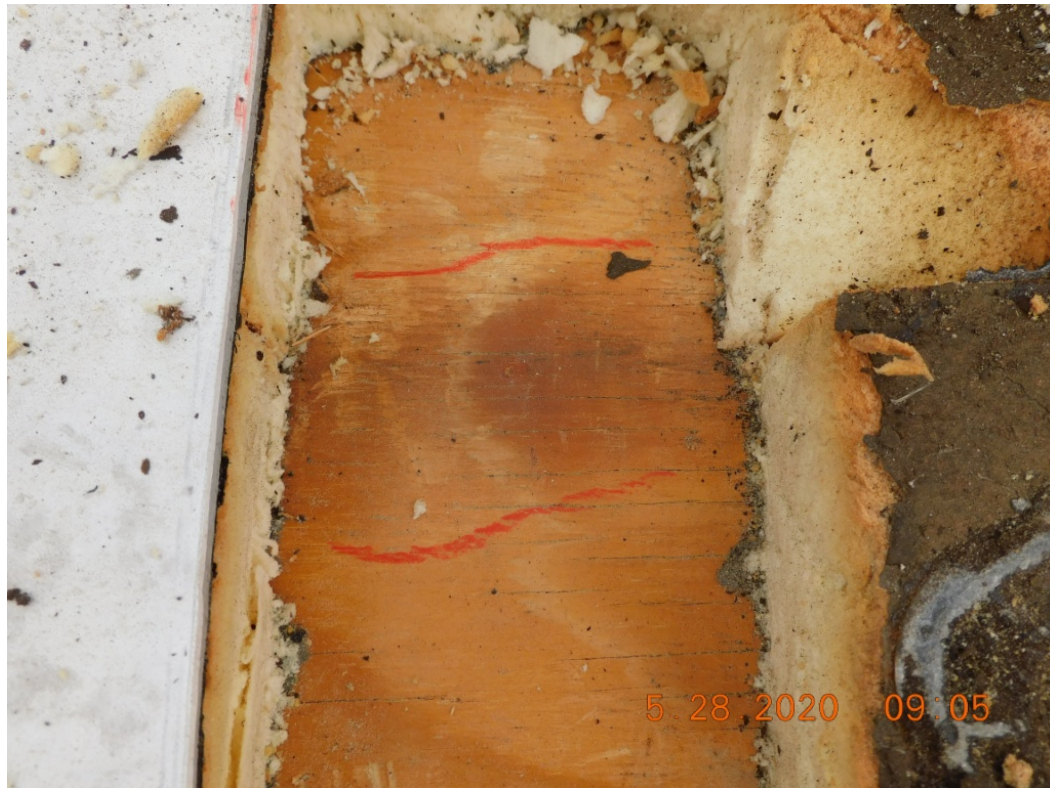
Photo 6

Photograph shows close up view of moisture trapped in roof deck.

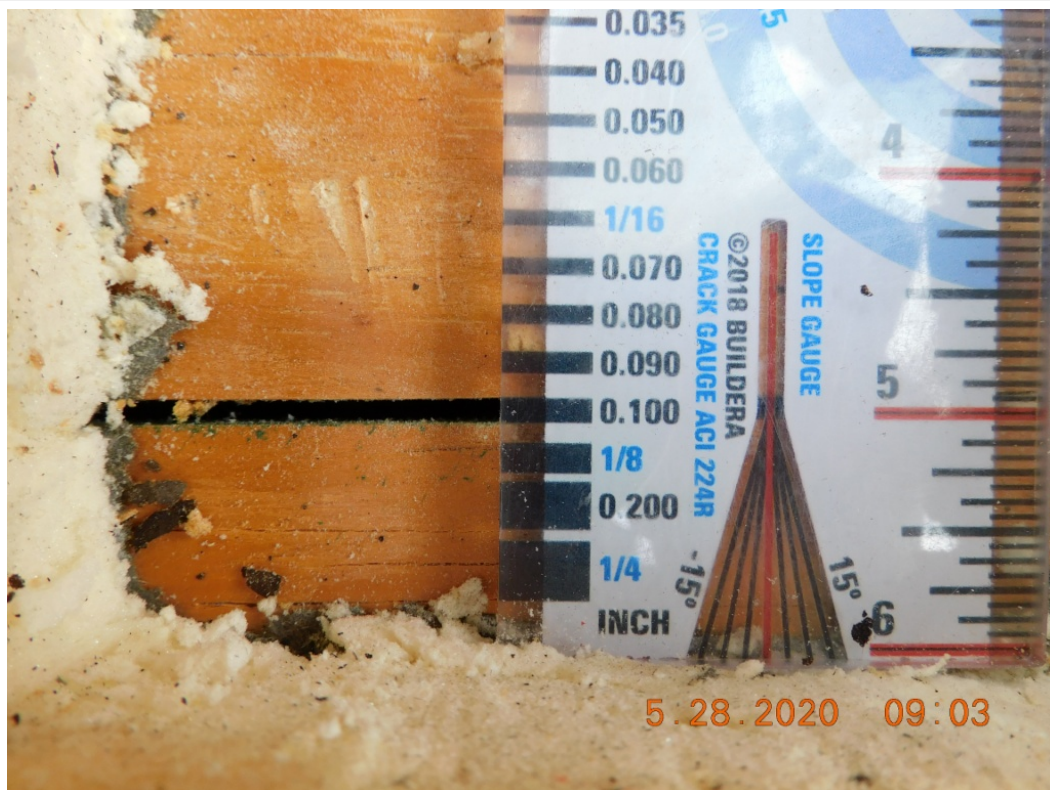
Photo 7

Observed .100" opening between wood decks.

*** During visual inspection cold air from interior of building was continuously migrating out of crack. This air is being trapped in insulation board and transferring to wood deck any time HVAC is active.

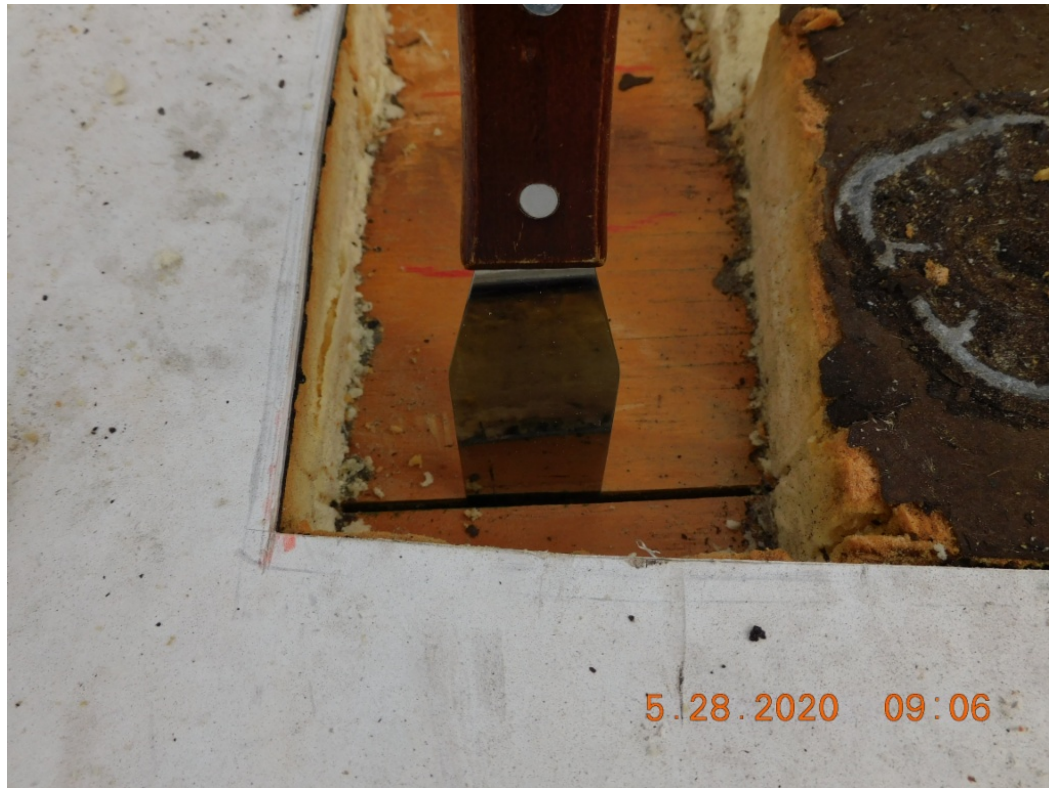
Photo 8

Photograph shows inspection tool penetrating 6" into interior of building.

***Observed missing air barrier is allowing cool conditioned air into existing Roof assembly. Air barrier is designed to prohibit transfer of conditioned air into insulation board.

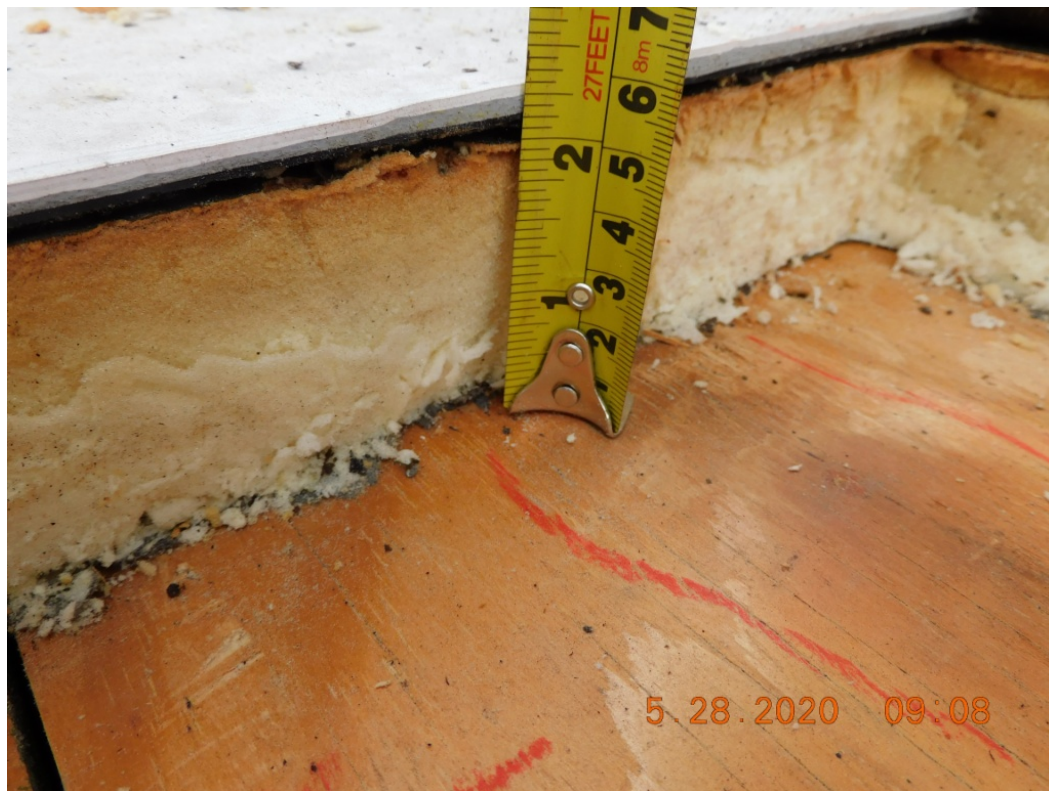
Photo 10

Photograph shows moisture present in top of insulation board (1").

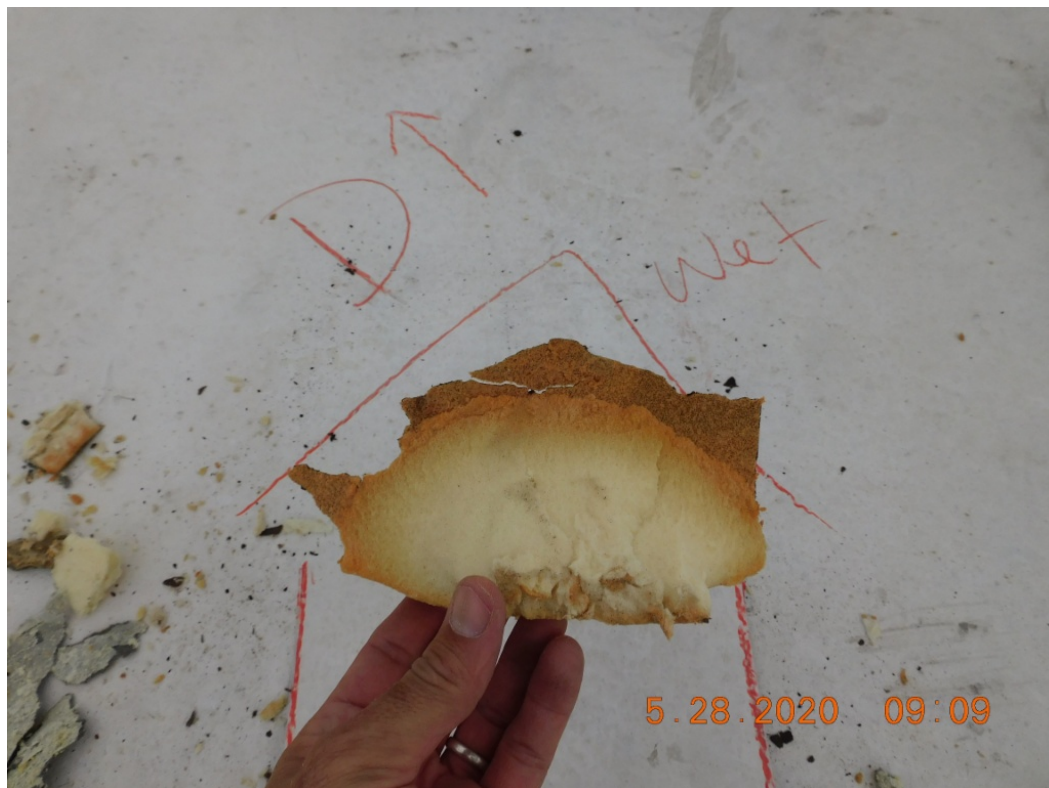
Photo 11

Observed moisture degradation of insulation board.

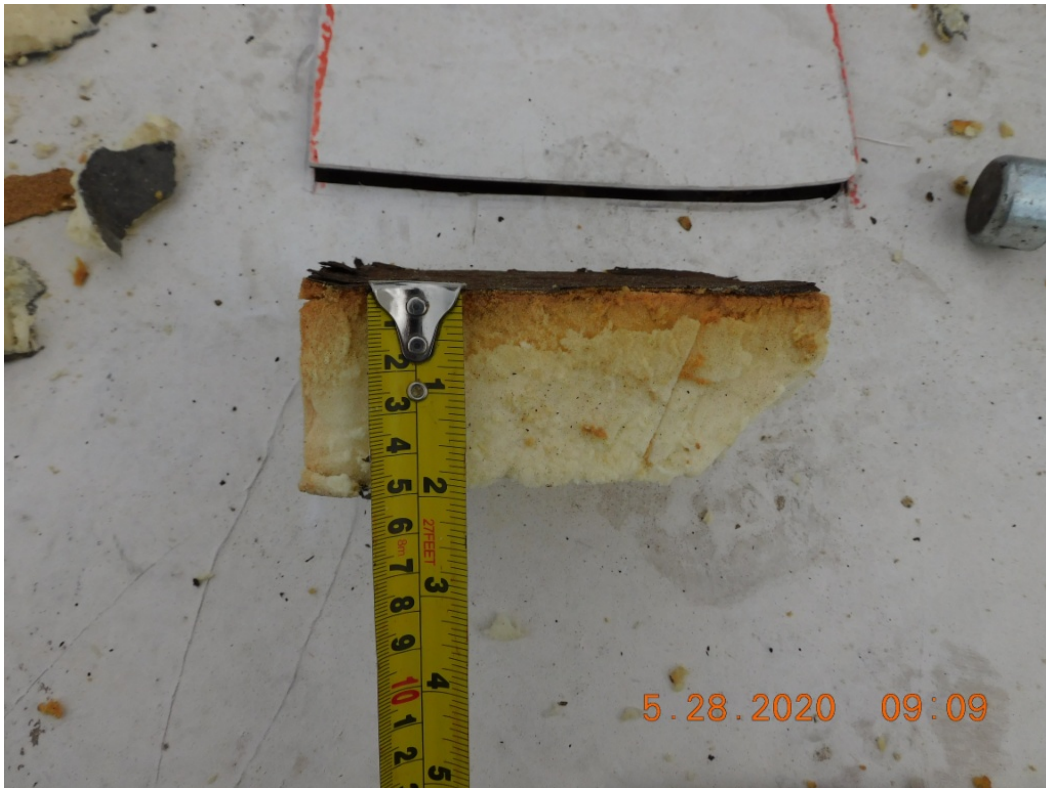
Photo 13

Photograph shows moisture present from bottom of insulation board to top of insulation board surface.

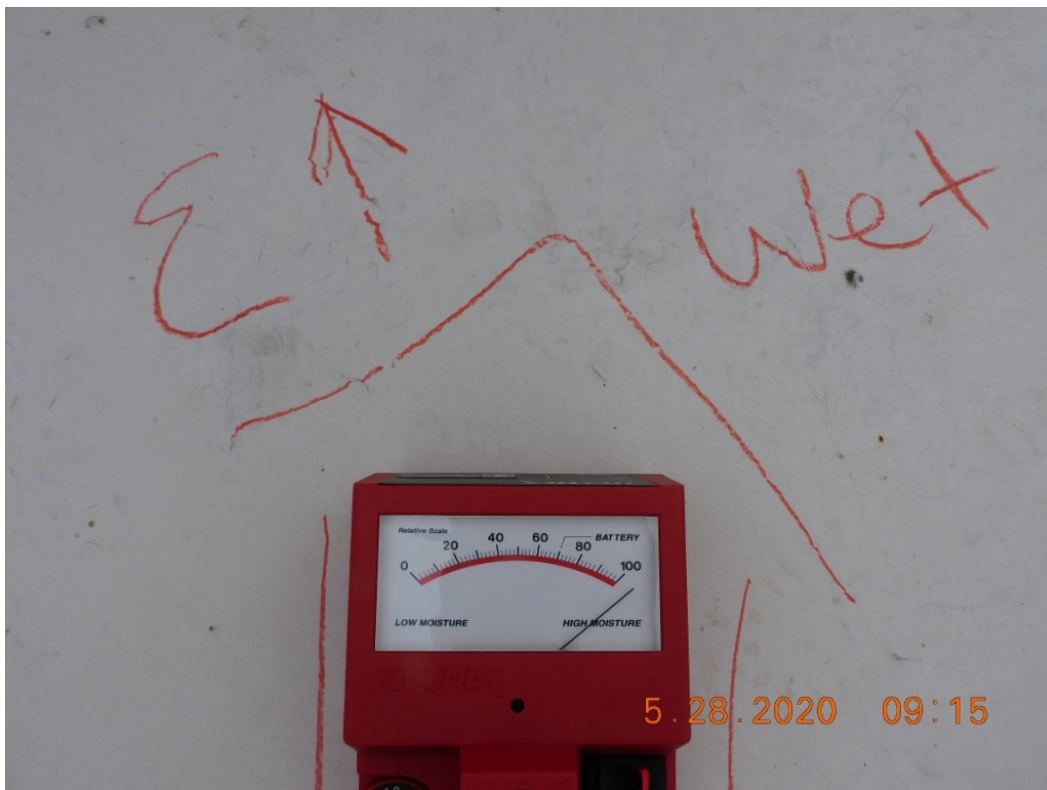
Photo 18

Observed moisture degradation of insulation facer sheet.
