265 Parkway Blvd Roof Conditions & Solutions Report

Case # 0265-01

October 30, 2020

Title: Roof Core Analysis Photographic Report

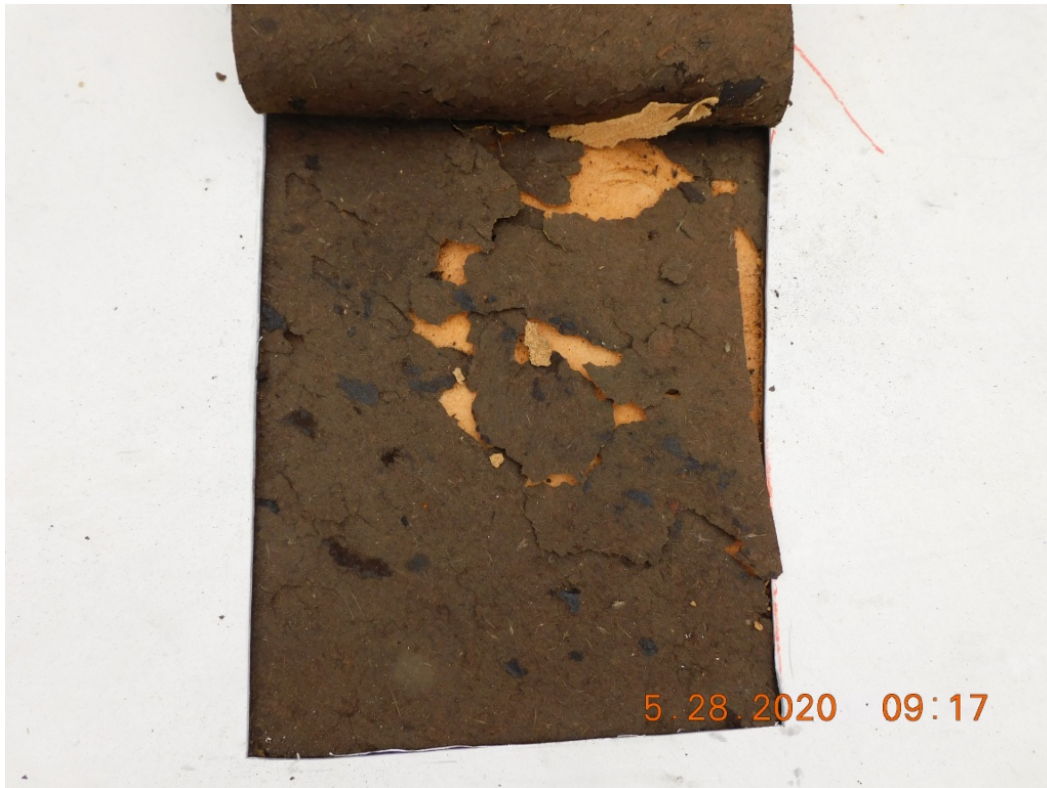
Photo 19

Insulation board facer detached from insulation board from presence of moisture trapped in roof assembly.

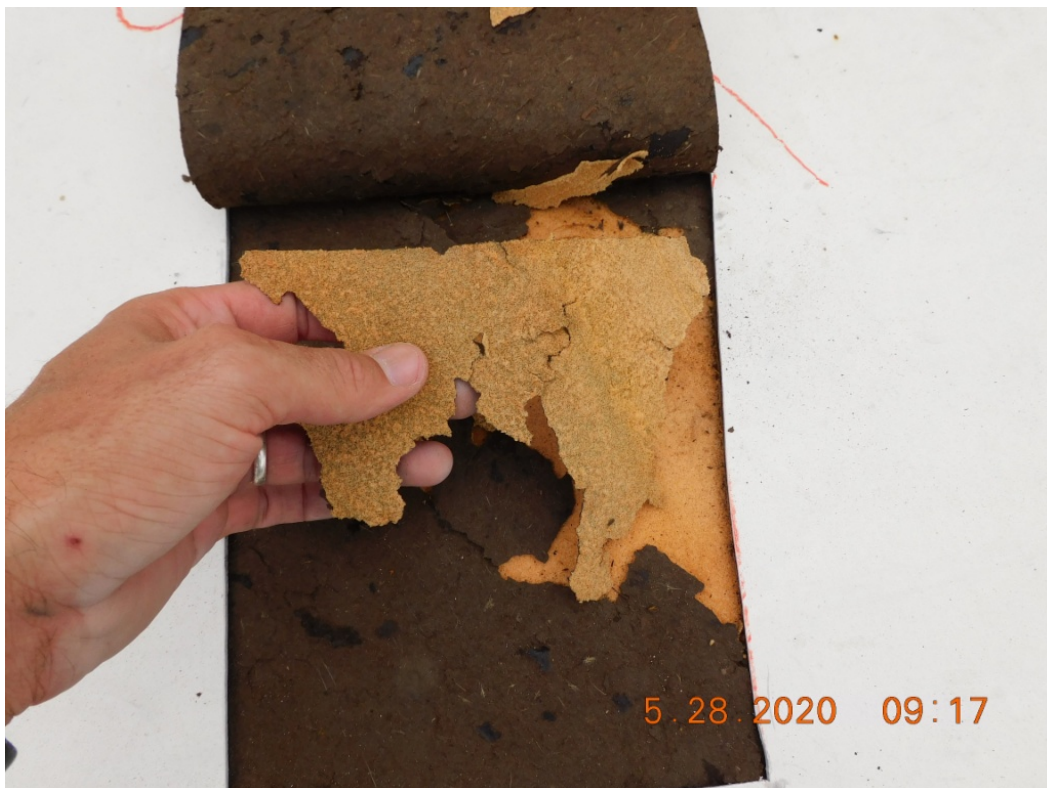
Photo 20

Photograph shows moisture present in top of insulation board (1").
