City of Coppel: Justice Center Reroof Package with TIPS Contract

2022 Reroof Package

Roof Section: Restoration Roof

Title: Roof Conditions Photographic Report

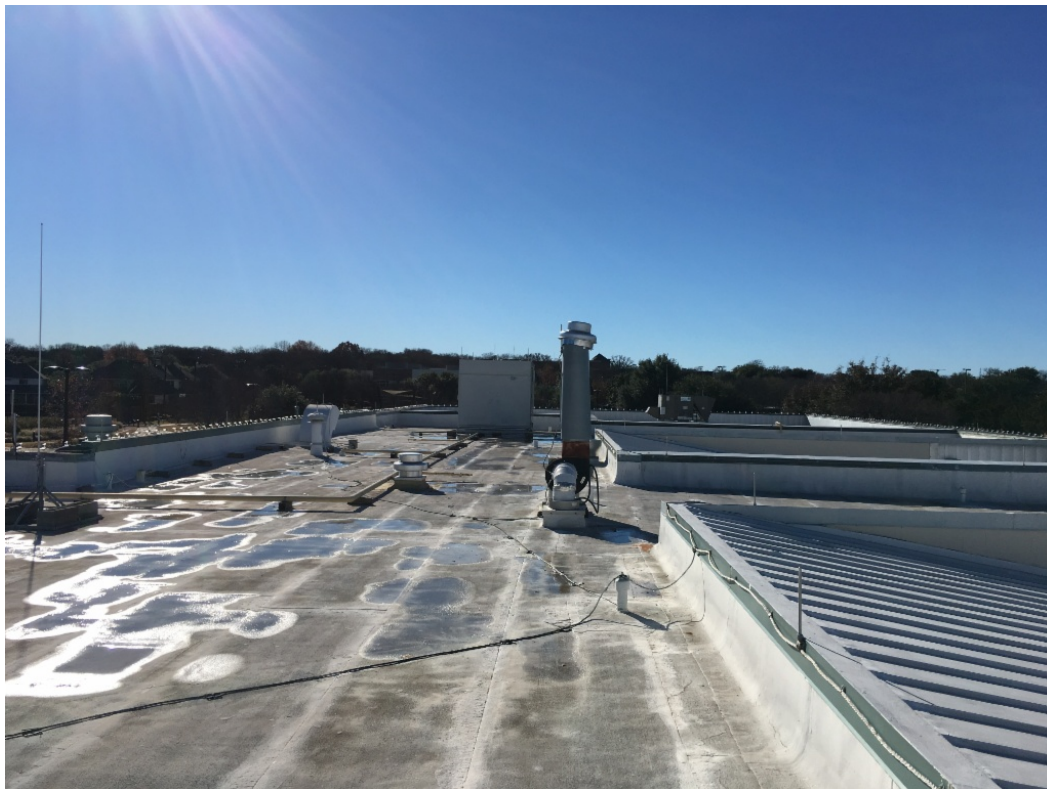
Photo 1

Photograph shows typical roof conditions of restoration coating surface.

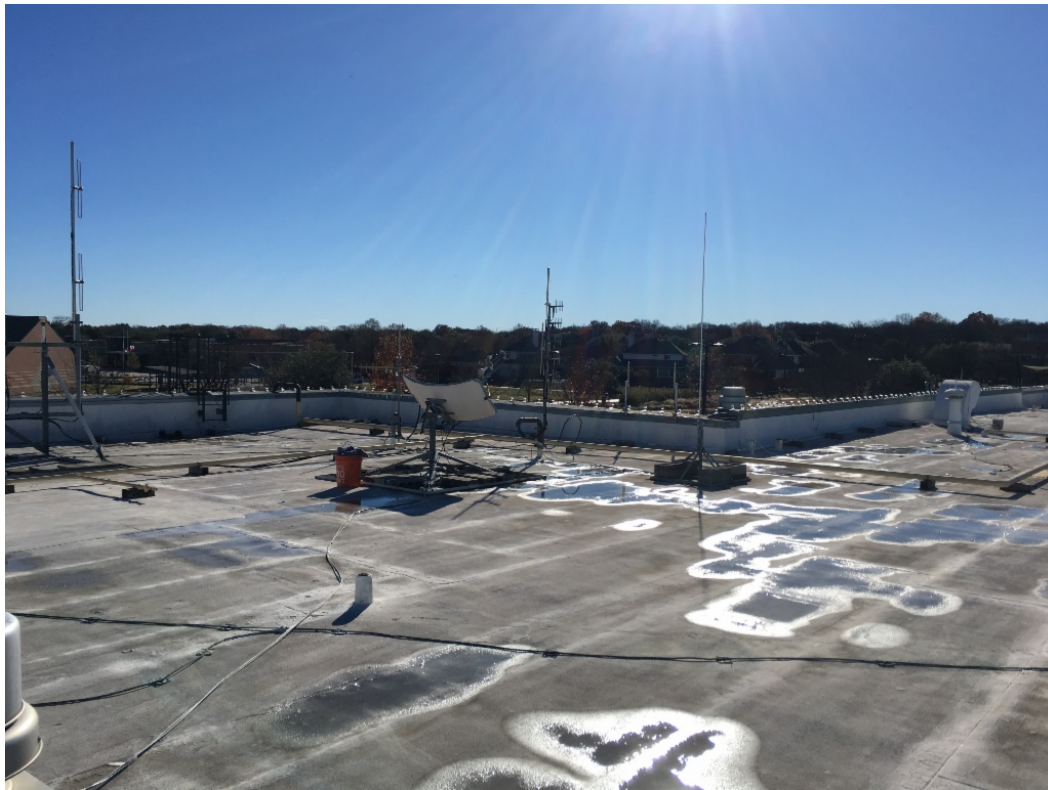
Photo 2

Photograph shows ponding water and typical roof conditions of restoration coating surface.

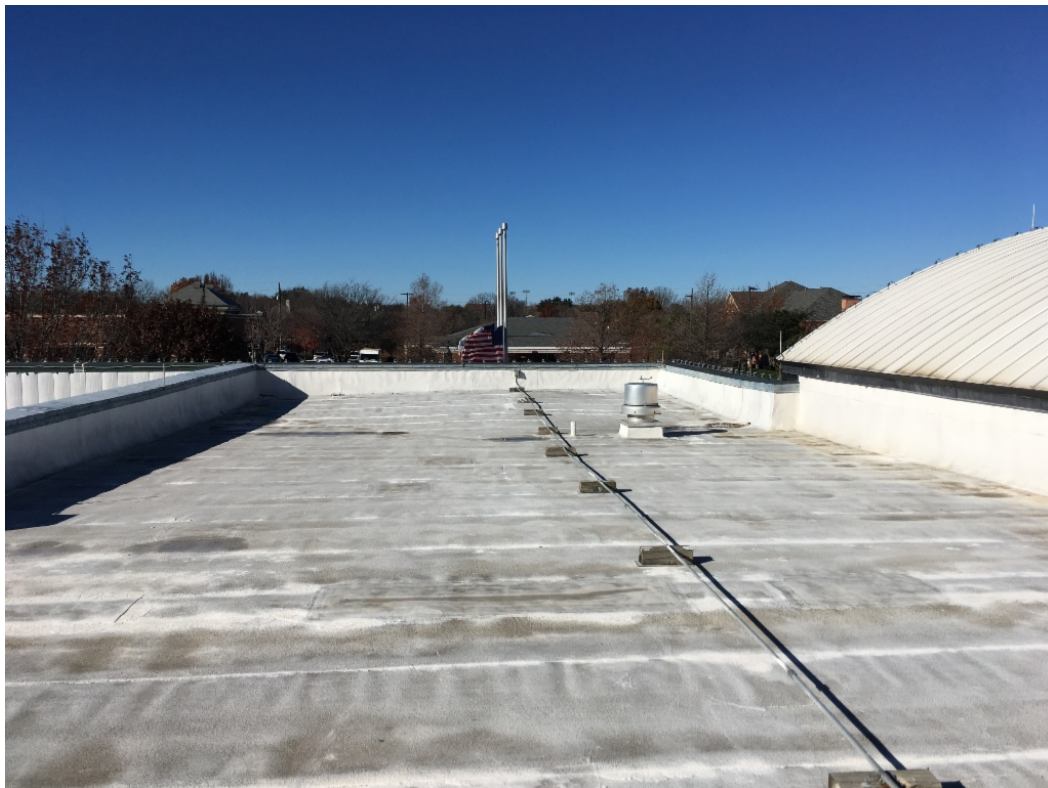
Photo 3

Photograph shows typical roof conditions of restoration coating surface.

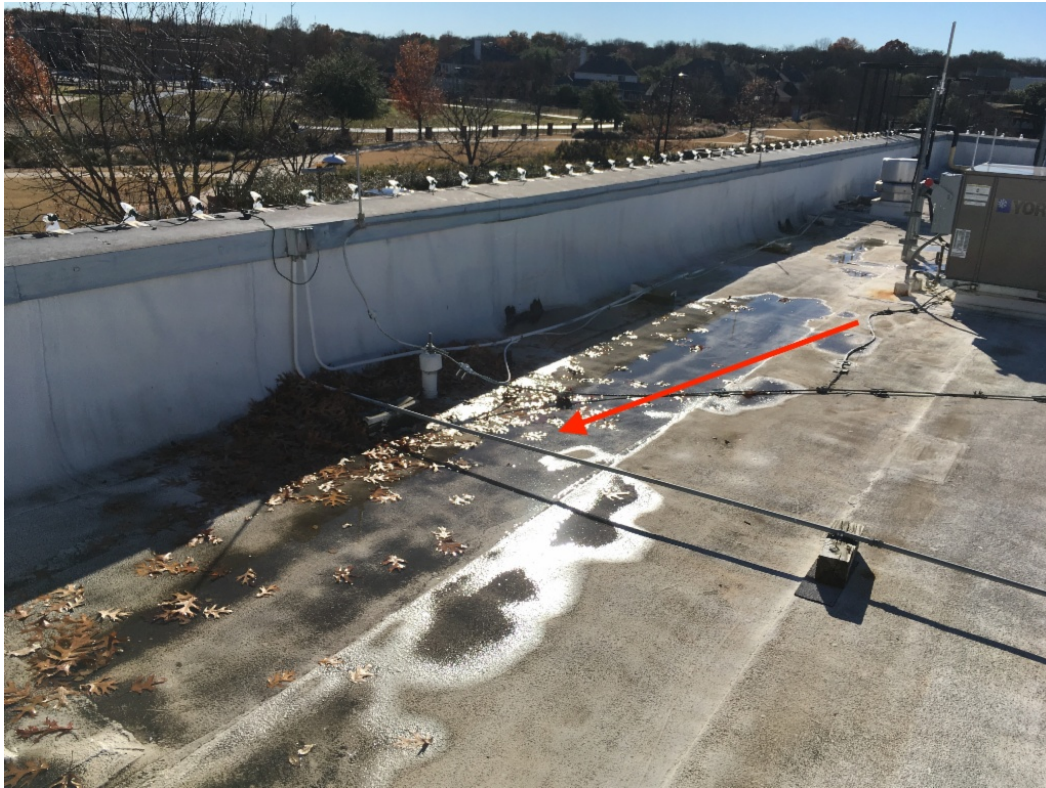
Photo 4

Photograph shows ponding water and typical roof conditions of restoration coating surface.

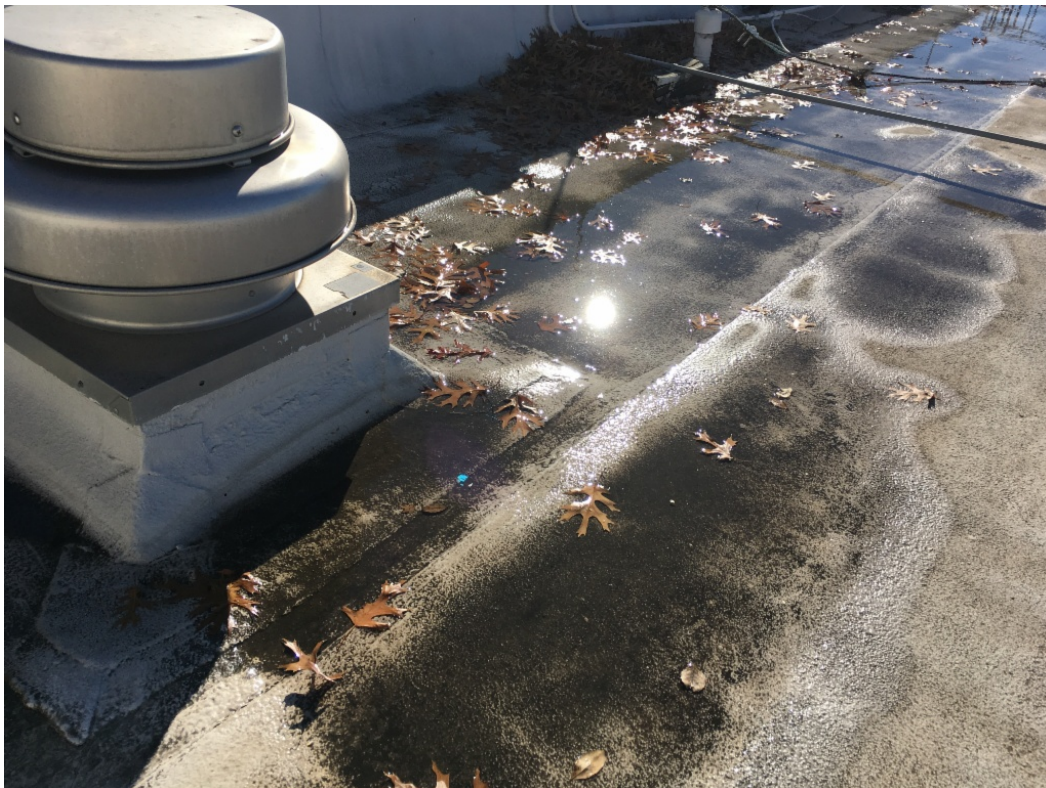
Photo 5

Photograph shows typical roof conditions of restoration coating surface.

*** Note: reflection of sun on surface of ponding water. This condition is also referred to Rapid UV Degradation of roof surface. See Photograph #8 for long term effect of UV Degradation of roof surface.

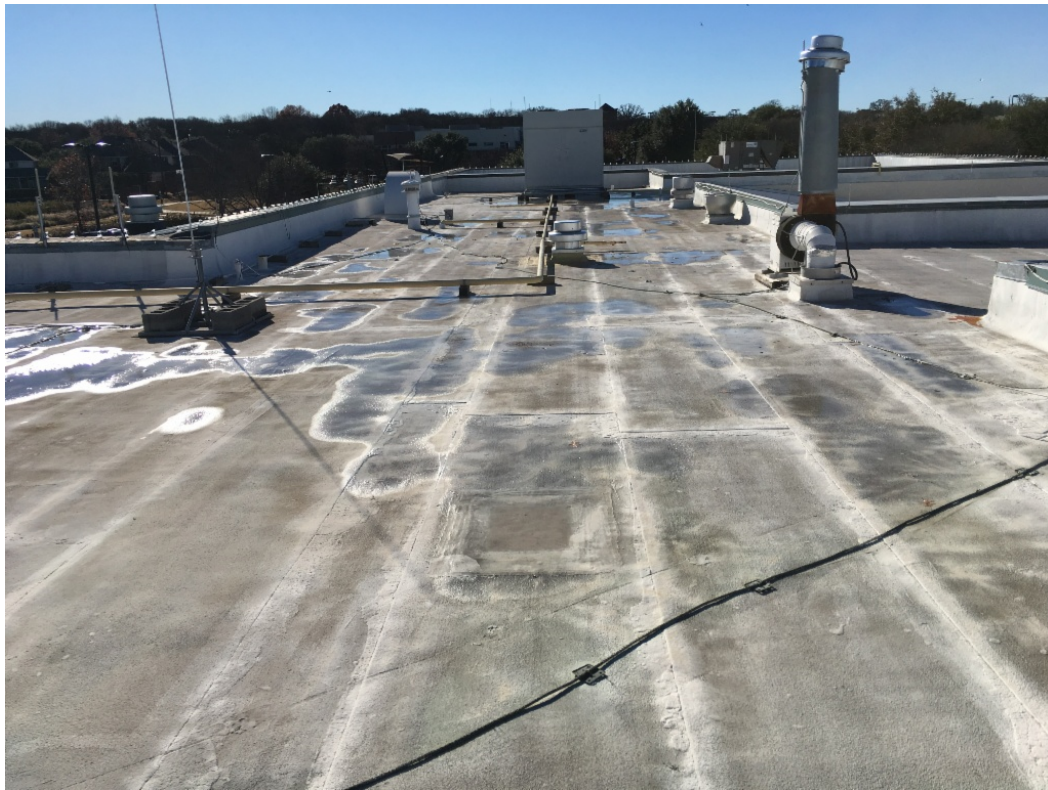
Photo 6

Photograph shows ponding water and typical roof conditions of restoration coating surface.

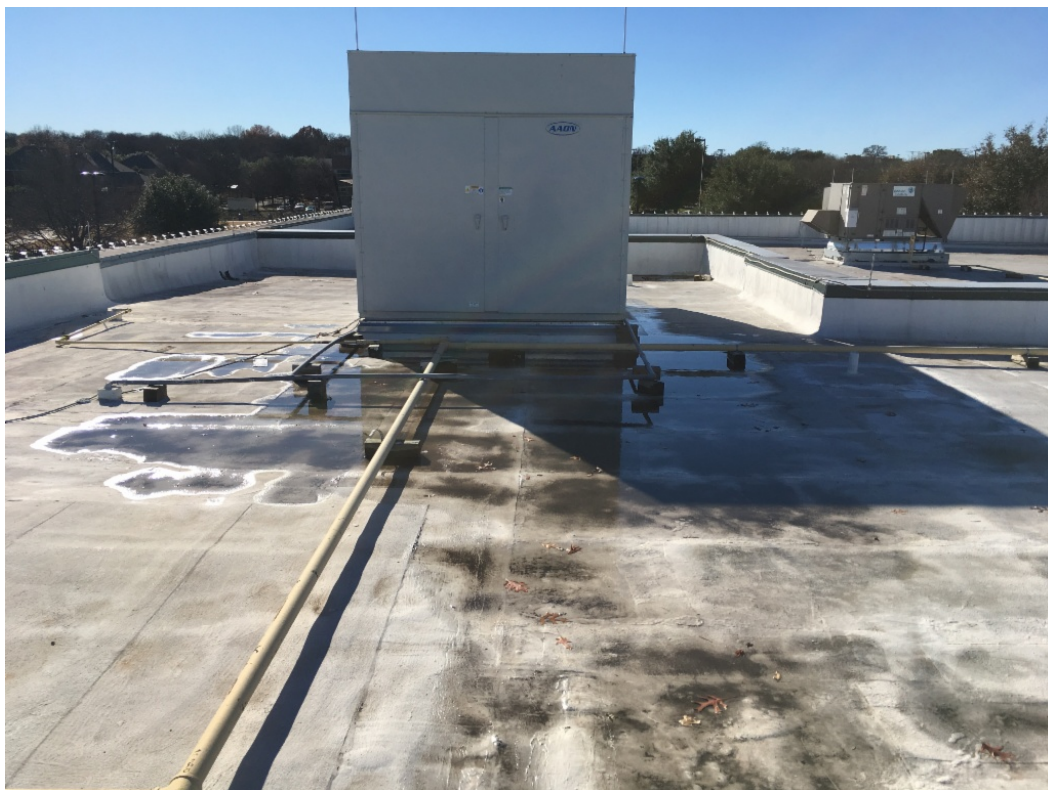
Photo 7

Photograph shows ponding water and typical roof conditions of restoration coating surface.

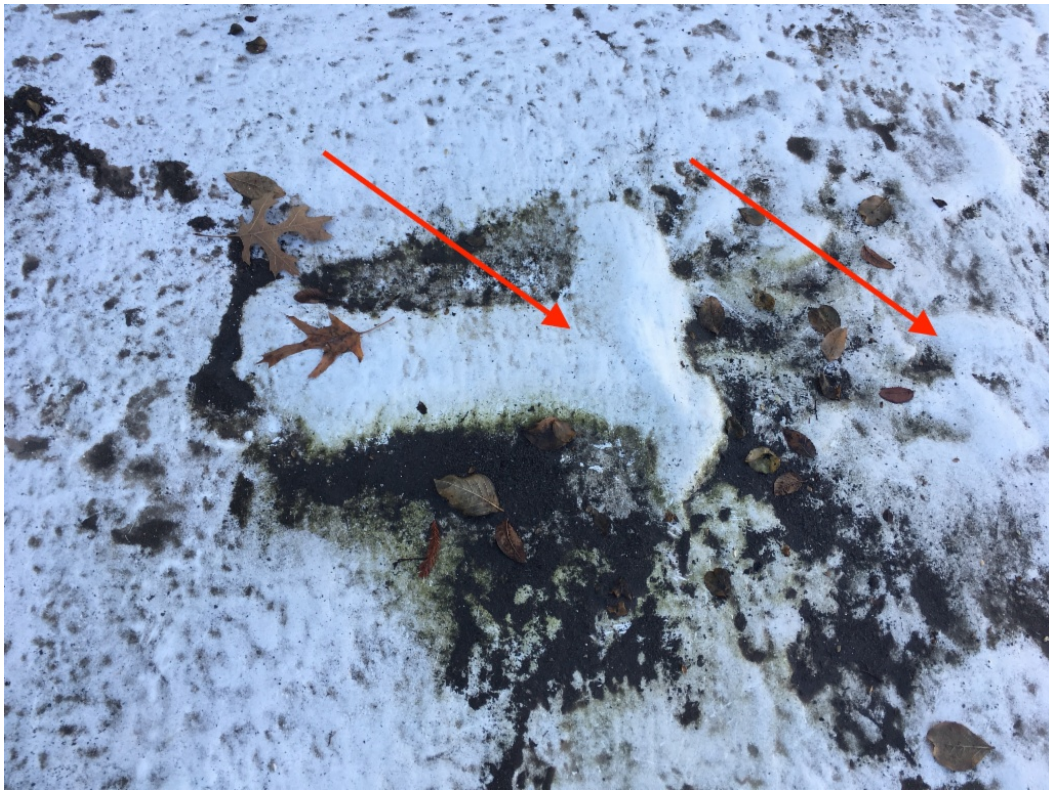
Photo 8

ROOF SECTION A

Observed moisture trapped in roof system.

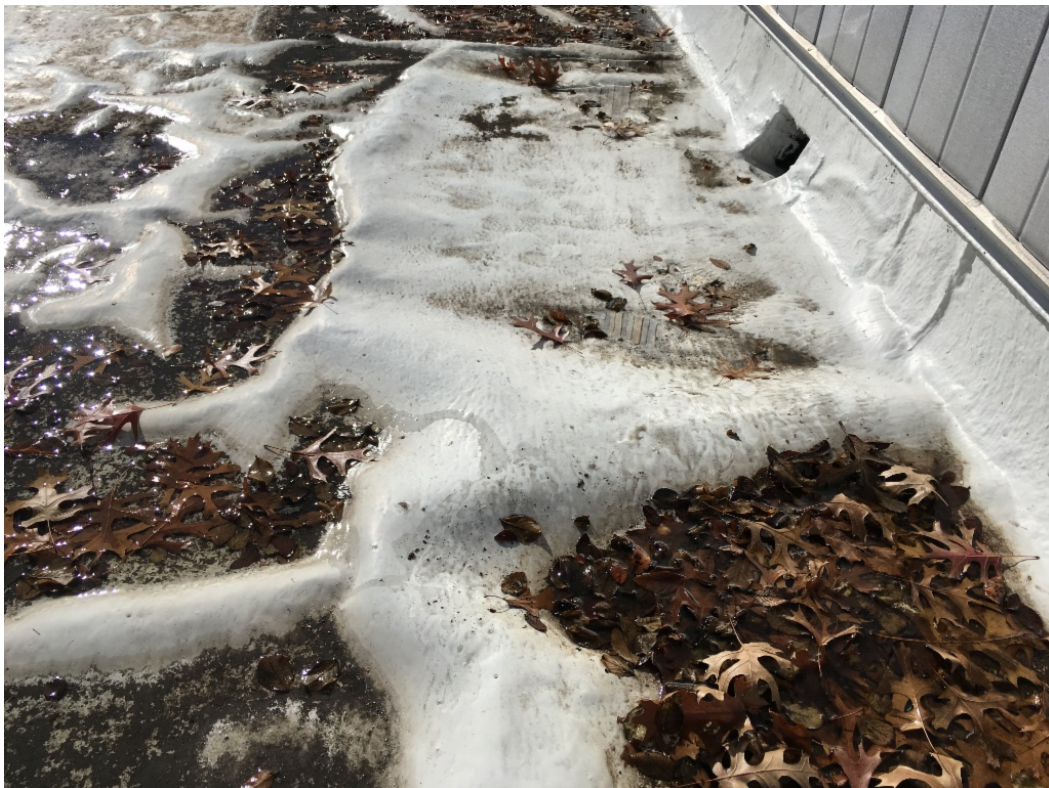
Photo 9

ROOF SECTION A

Observed moisture trapped in roof system.

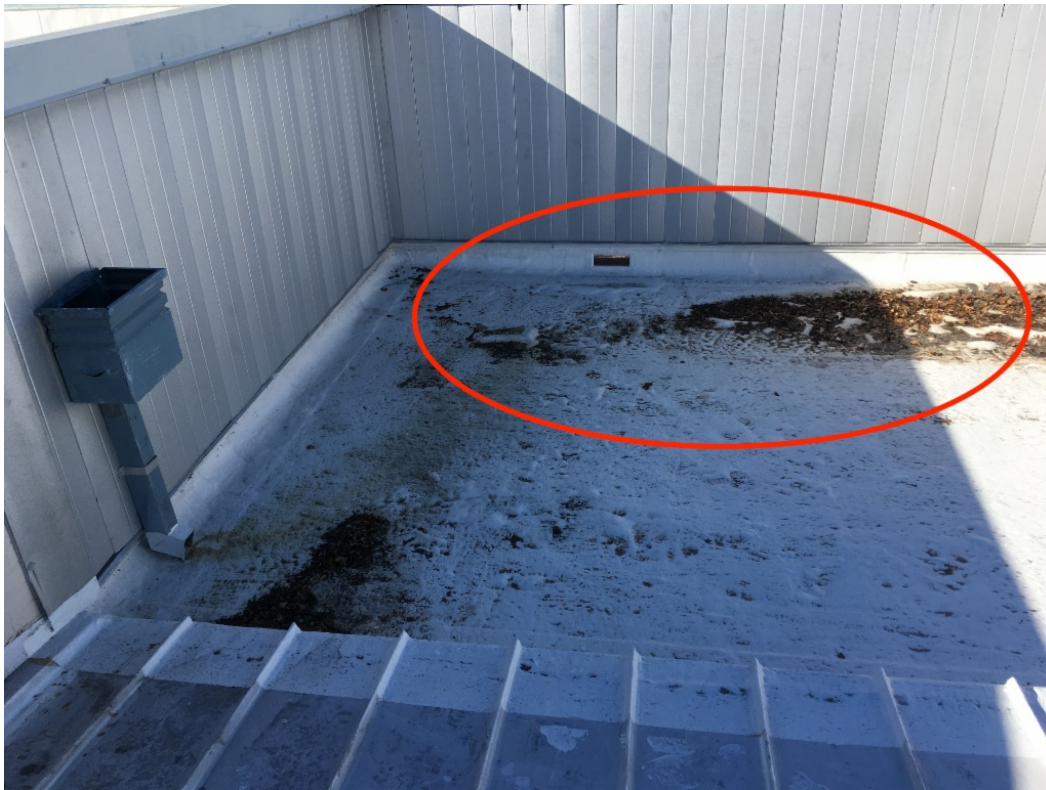
Photo 11

ROOF SECTION A

Observed moisture trapped in roof system.

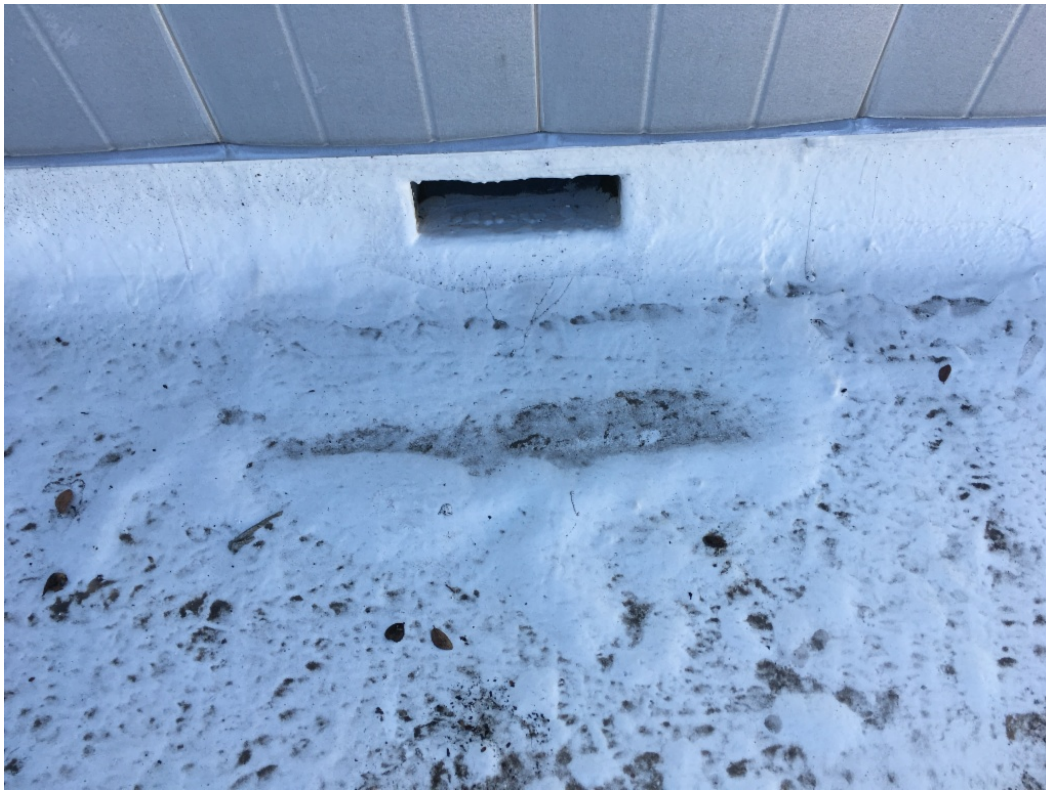
Photo 12

ROOF SECTION B

Observed moisture trapped in roof system.

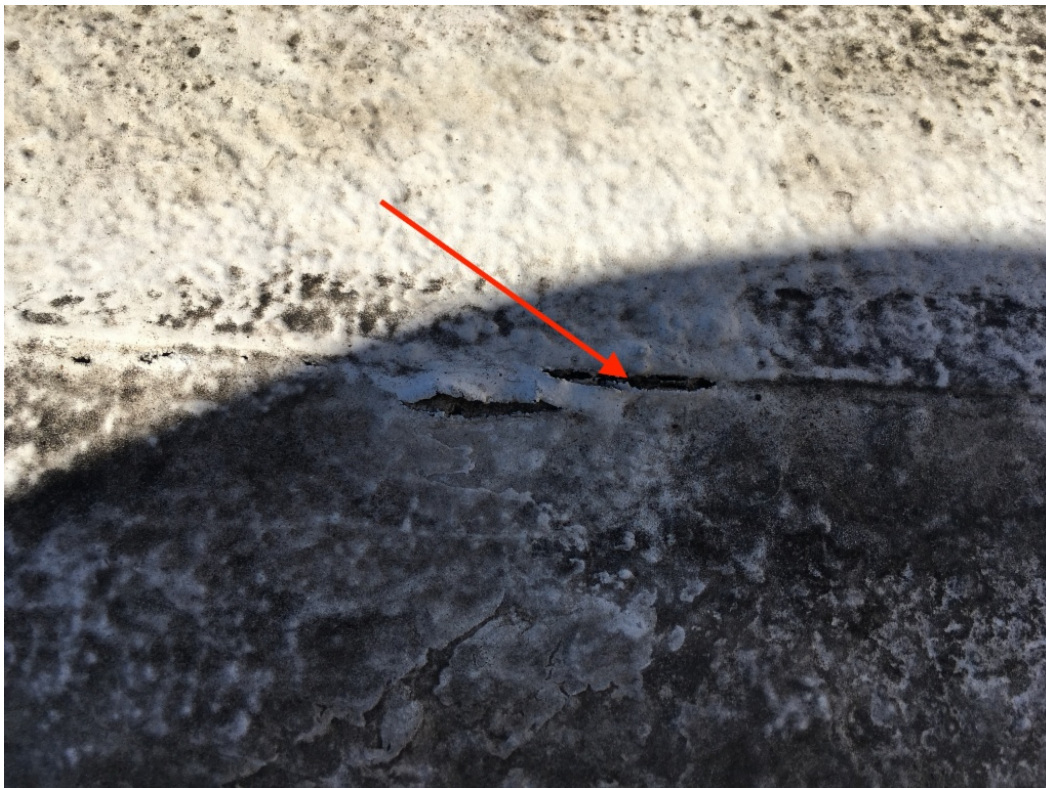
Photo 13

ROOF SECTION B

Observed roof coating separating at seams on original mod bit roof system.

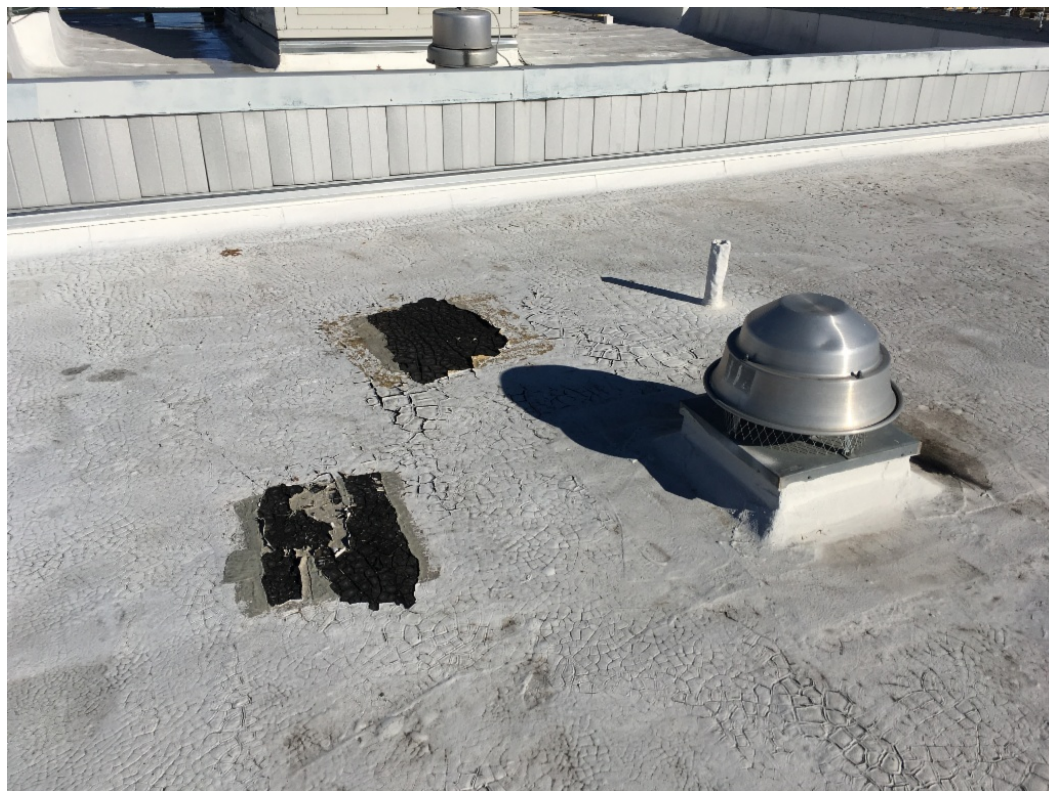
Photo 14

ROOF SECTION C

Observed restoration coating separated from roof membrane. See Photograph #5 for cause of this condition "UV Degradation" and explanation of Effect.

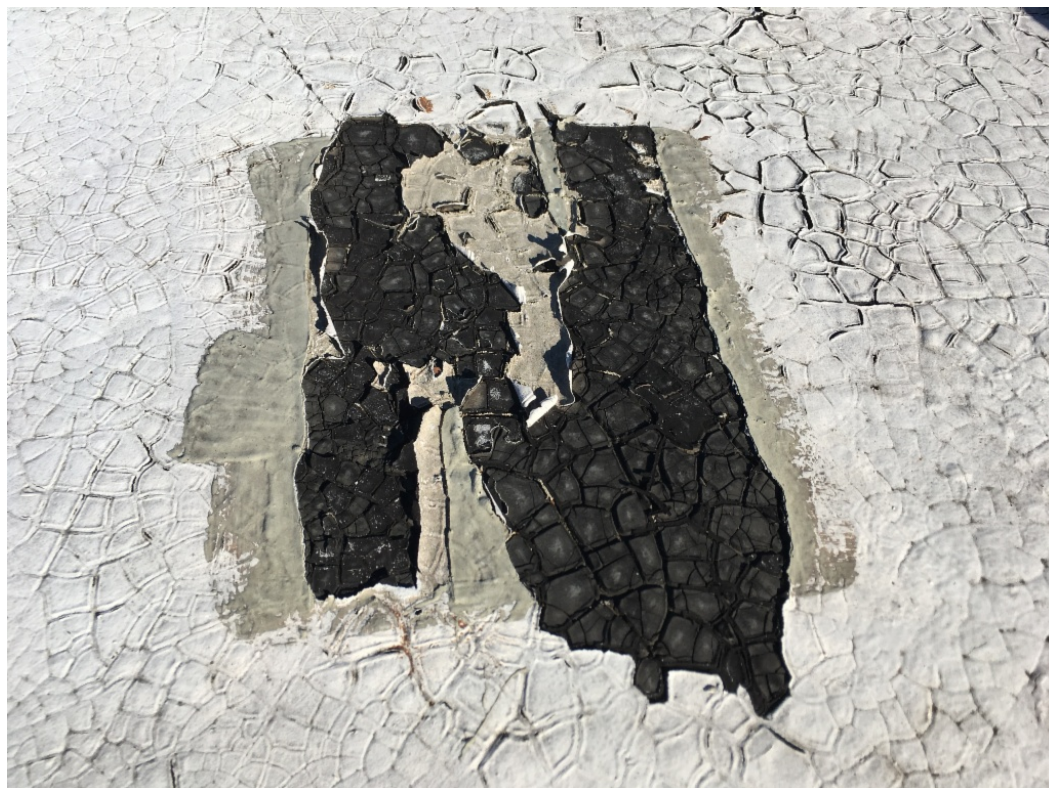
Photo 15

ROOF SECTION C

Photograph shows close view of restoration coating separated from roof membrane.

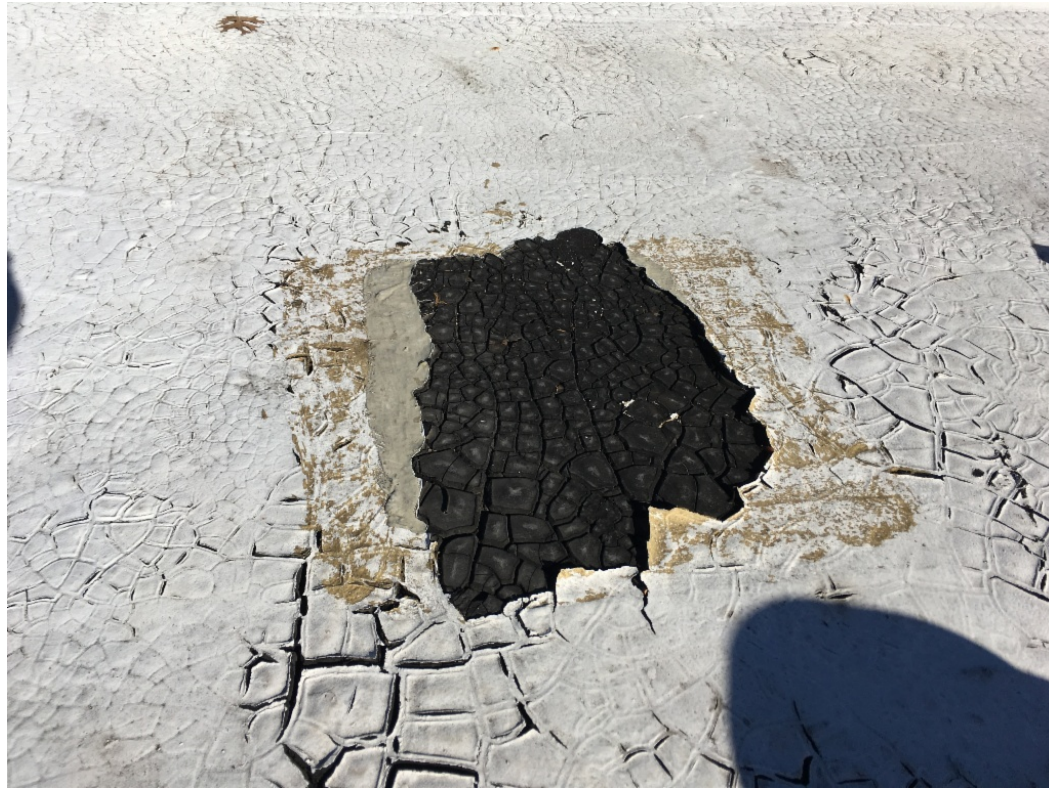
Photo 16

ROOF SECTION C

Observed roof coating surfaces detaching from roof surrounding exposed adhesive.

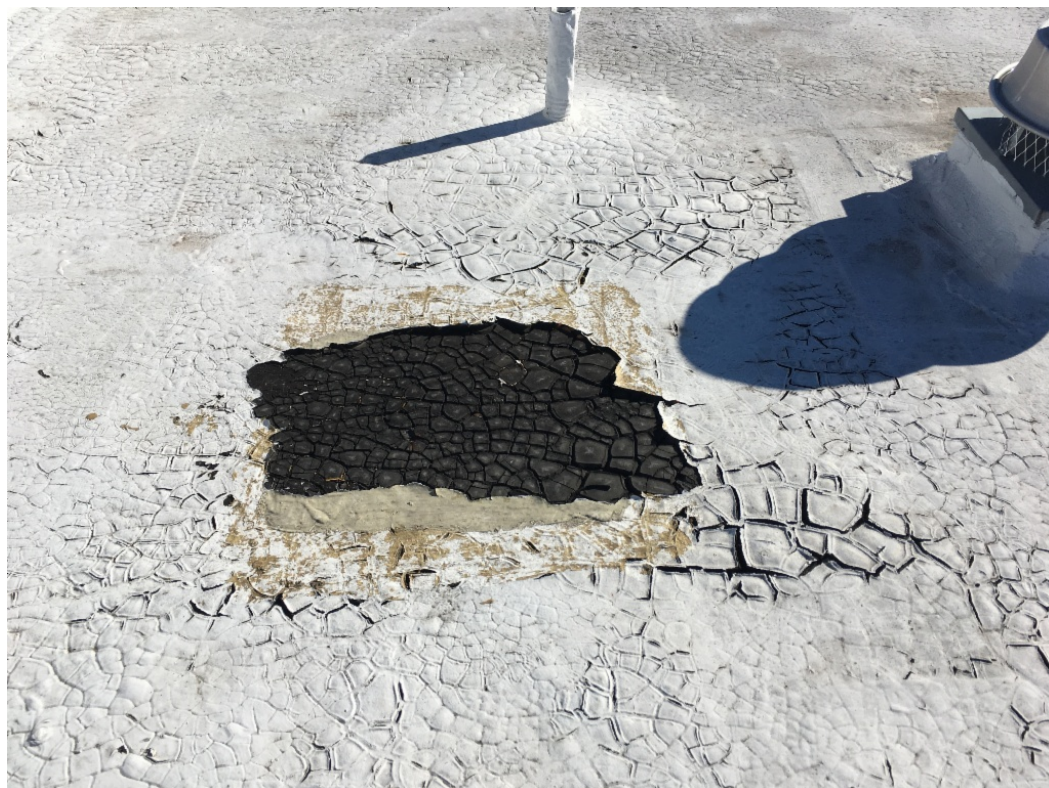
Photo 17

ROOF SECTION C

Observed roof coating surfaces detaching from roof surrounding exposed adhesive.

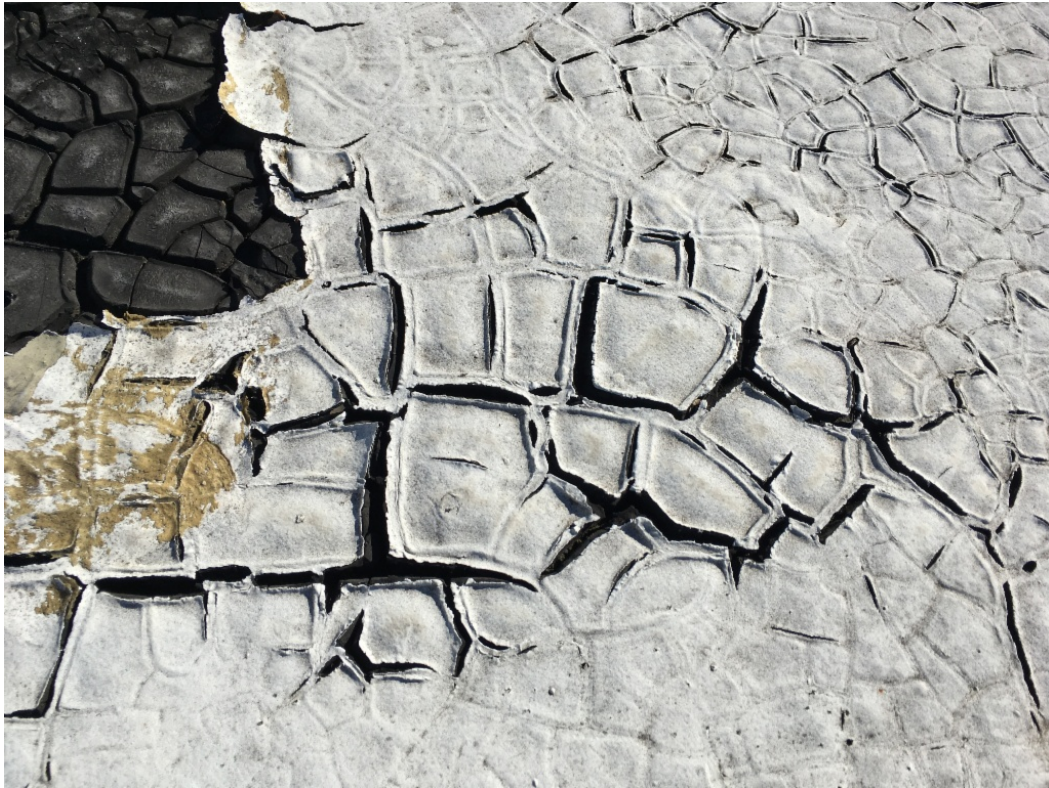
Photo 18

ROOF SECTION C

Observed additional roof surface separating from roof system.

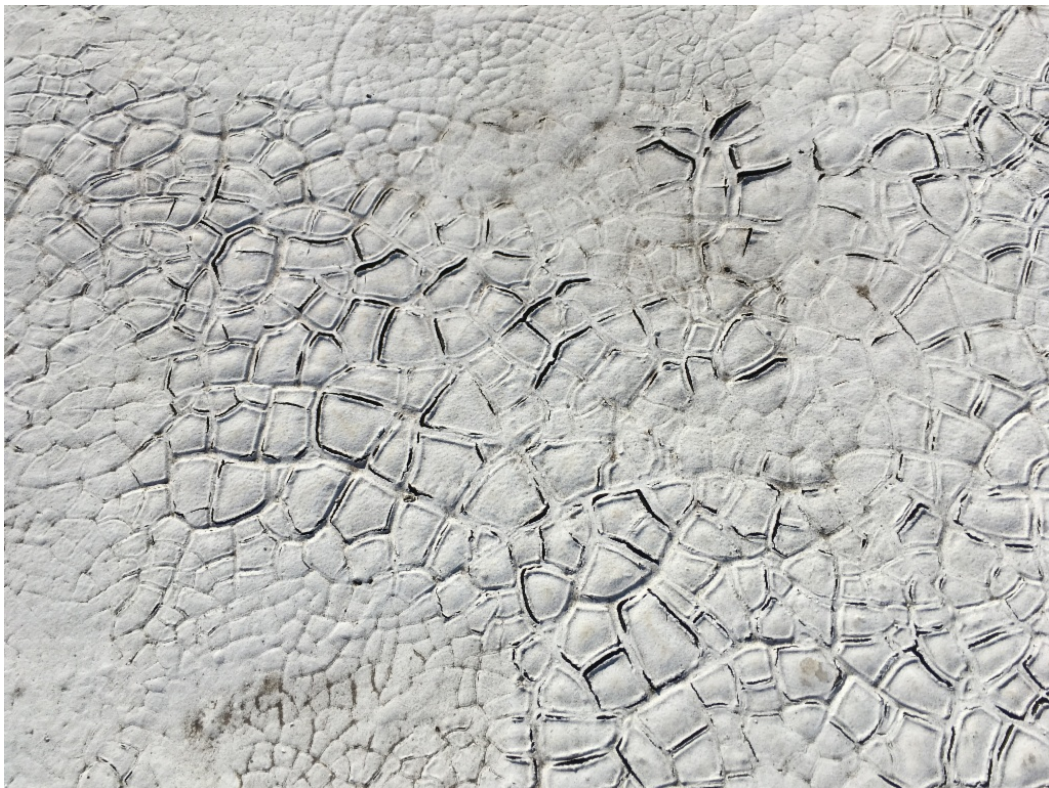
Photo 19

ROOF SECTION C

Observed additional roof surface separating from roof system.

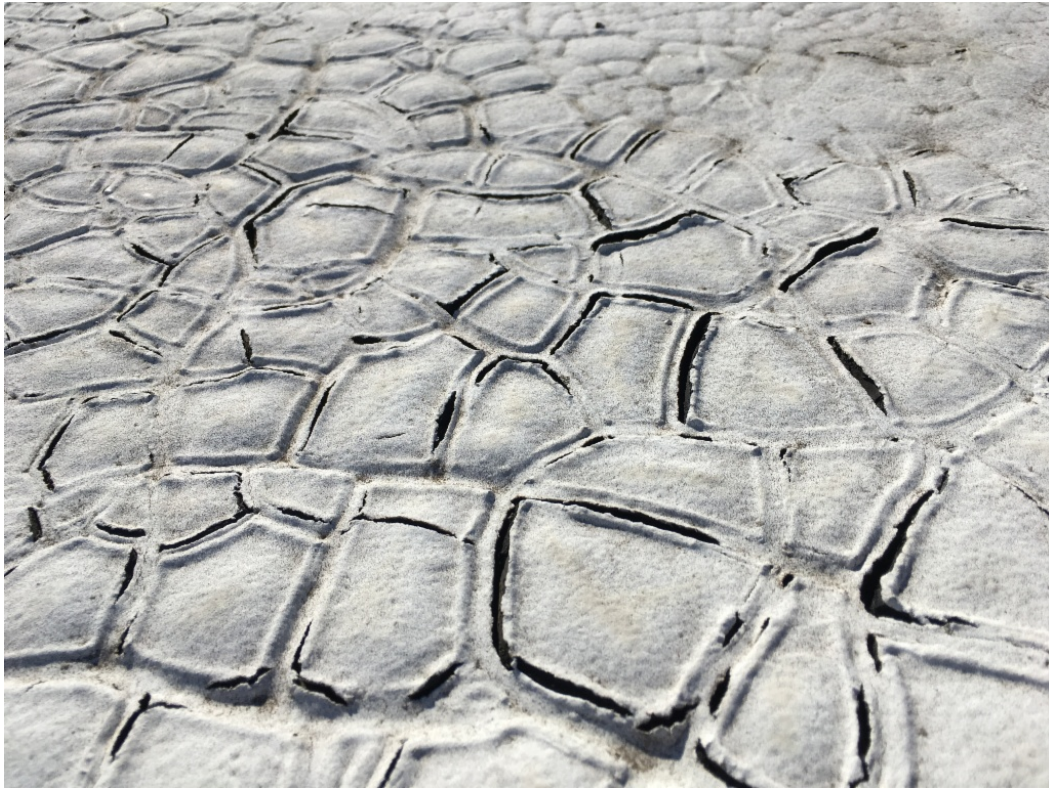
Photo 20

ROOF SECTION C

Observed additional roof surface separating from roof system.

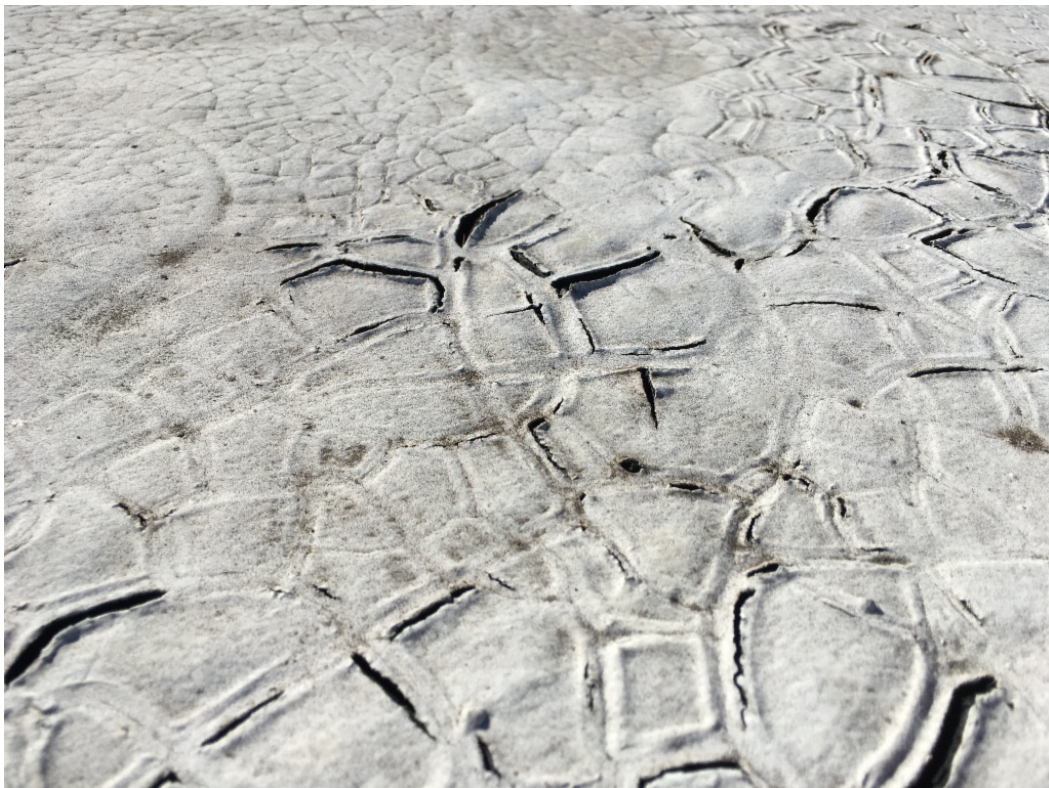
Photo 21

ROOF SECTION C

Observed additional roof surface separating from roof system.

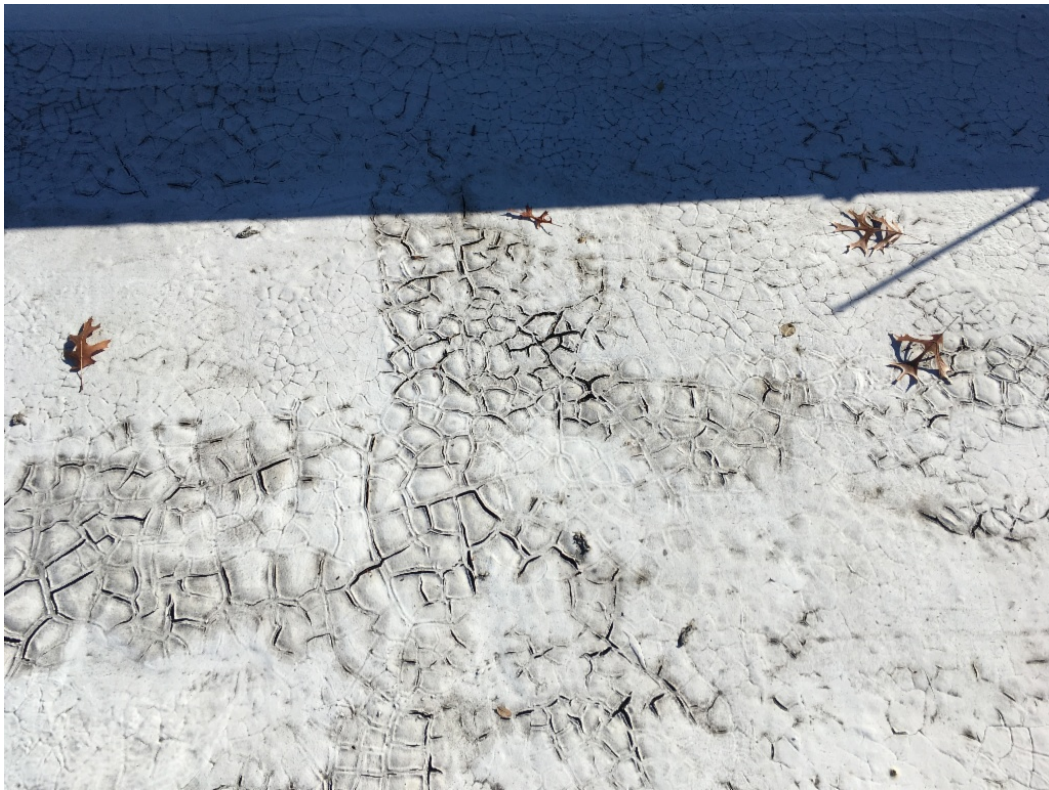
Photo 22

ROOF SECTION C

Observed additional roof surface separating from roof system.

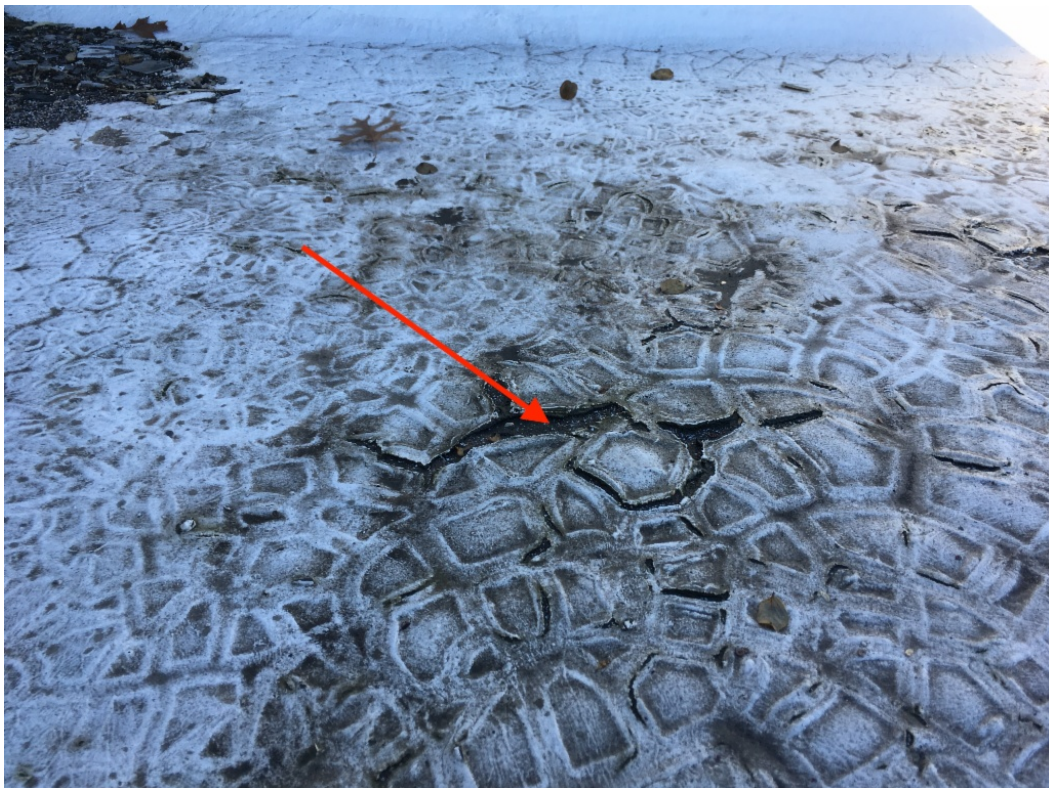
Photo 23

ROOF SECTION C

Observed exposed roof surface where restoration coating has detached.

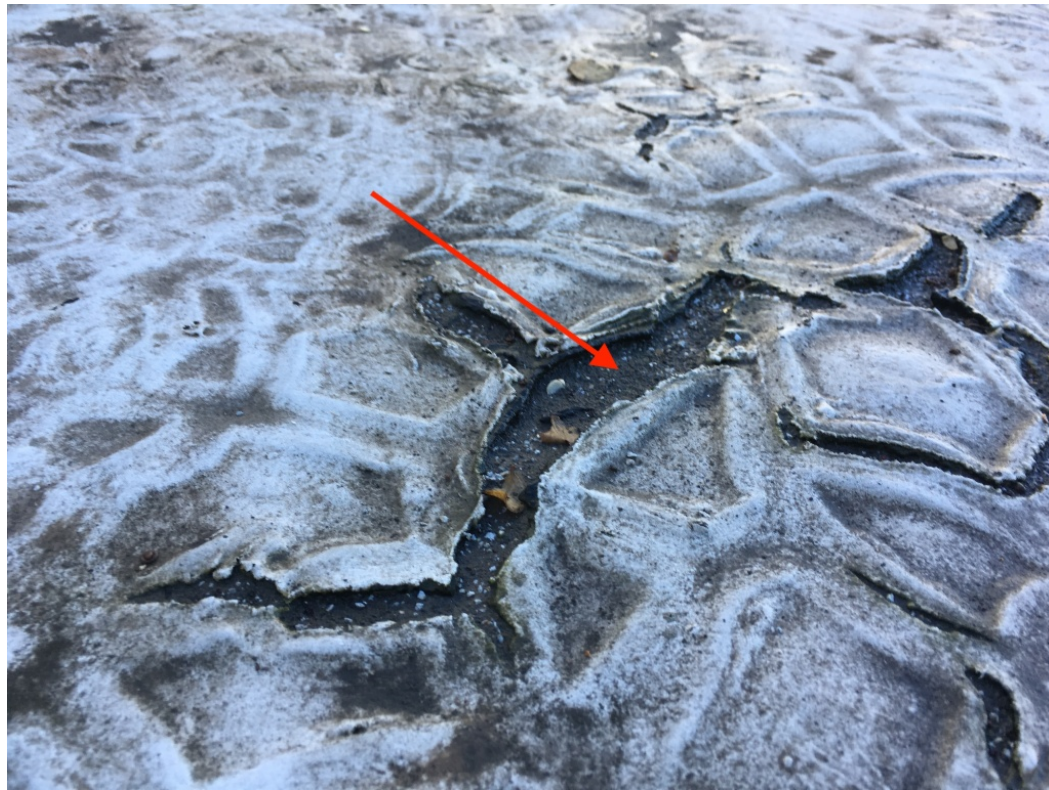
Photo 24

ROOF SECTION C

Observed exposed mineral roof surface where restoration coating has detached.

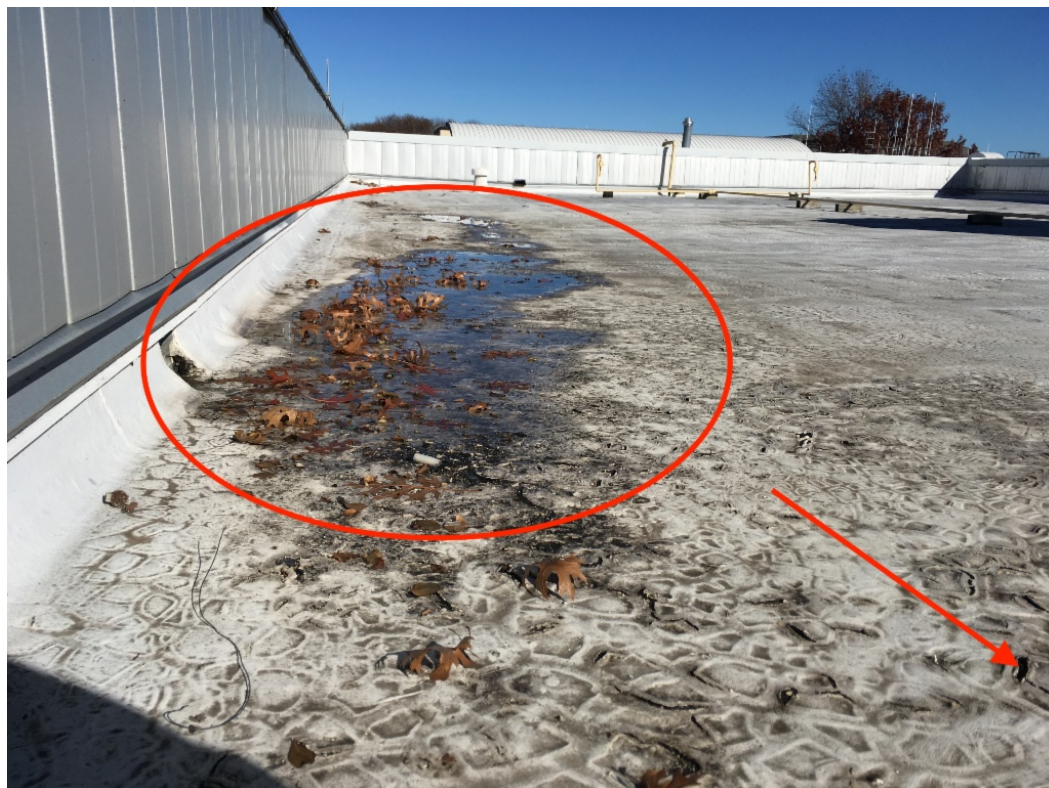
Photo 25

ROOF SECTION C

Observed ponding water along with separation of restoration coating at through wall drain.

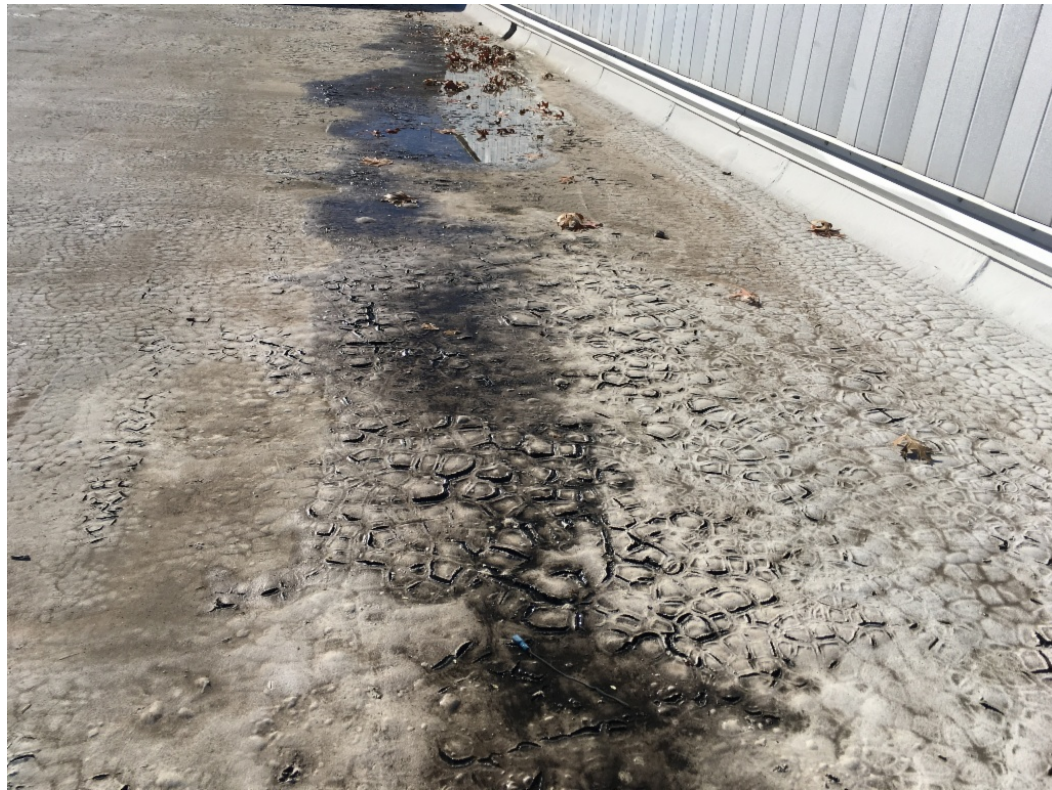
Photo 26

ROOF SECTION C

Observed ponding water along with separation of restoration coating at through wall drain.

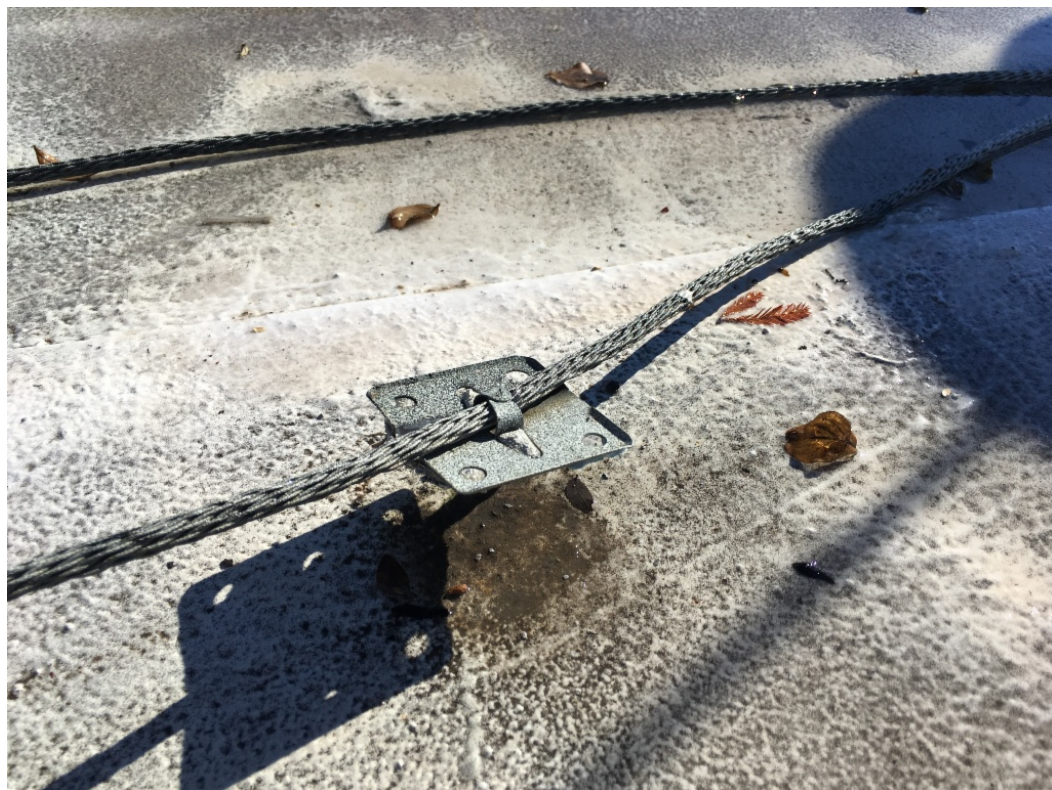
Photo 27

Observed lightning rod protection components detached from roof surface.

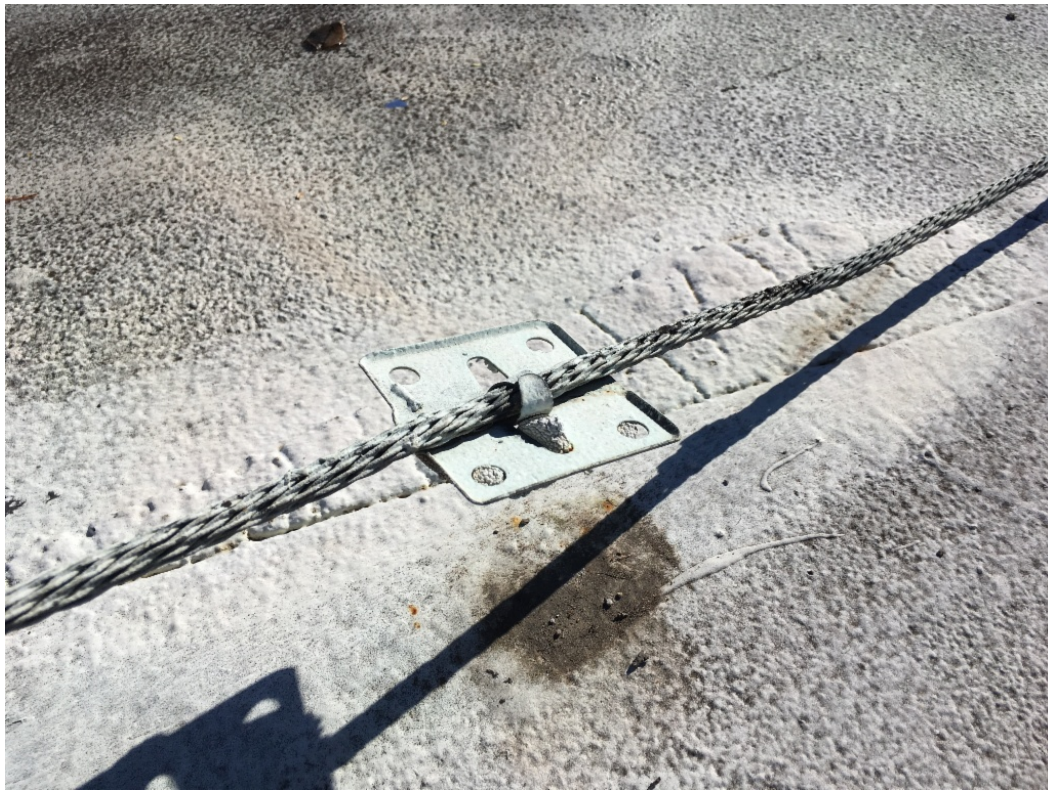
Photo 28

Observed lightning rod protection components detached from roof surface.
