City of Coppel: Justice Center Reroof Package with TIPS Contract

2022 Reroof Package

Roof Section: Restoration Roof

Title: Roof Conditions Photographic Report

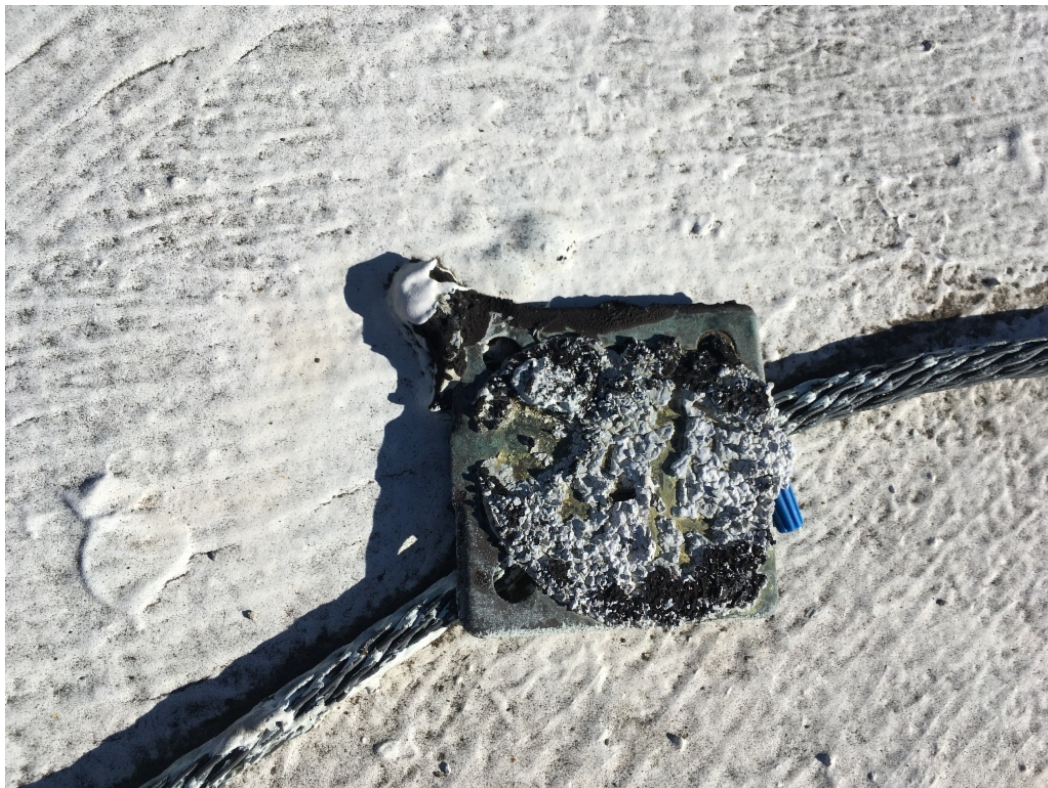
Photo 29

Observed adhesive on bottom surface of lightning rod components from original roof system.

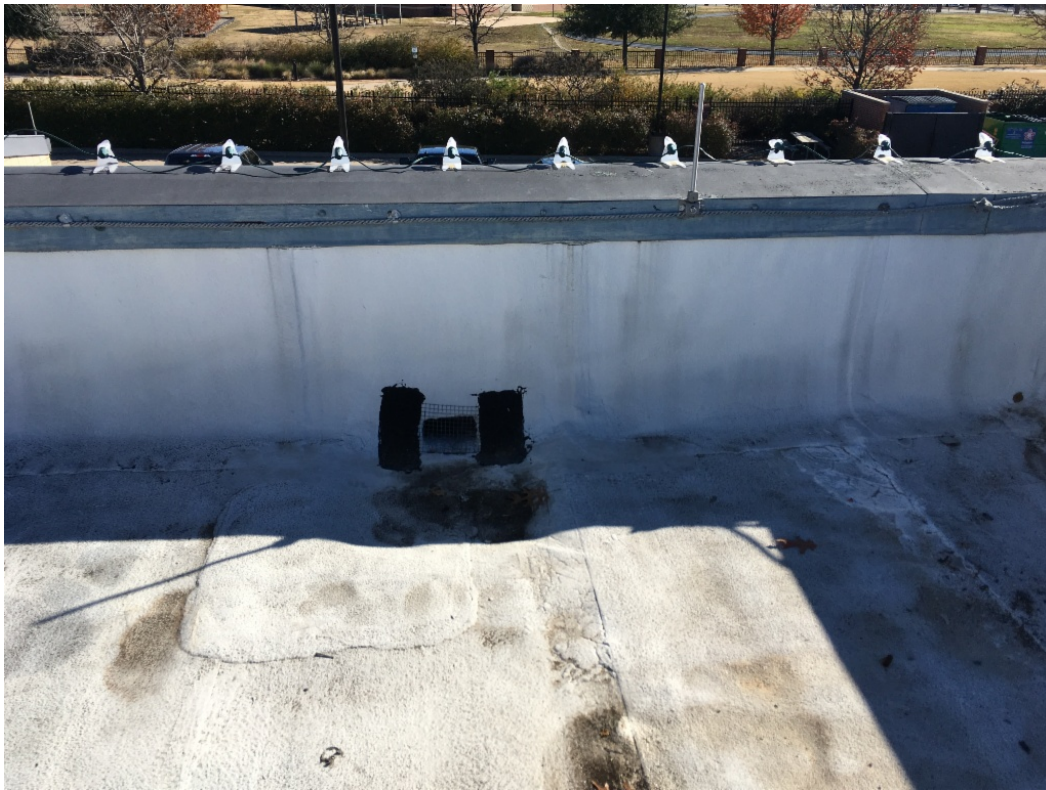
Photo 30

Observed deficient repairs installed on through wall drains.

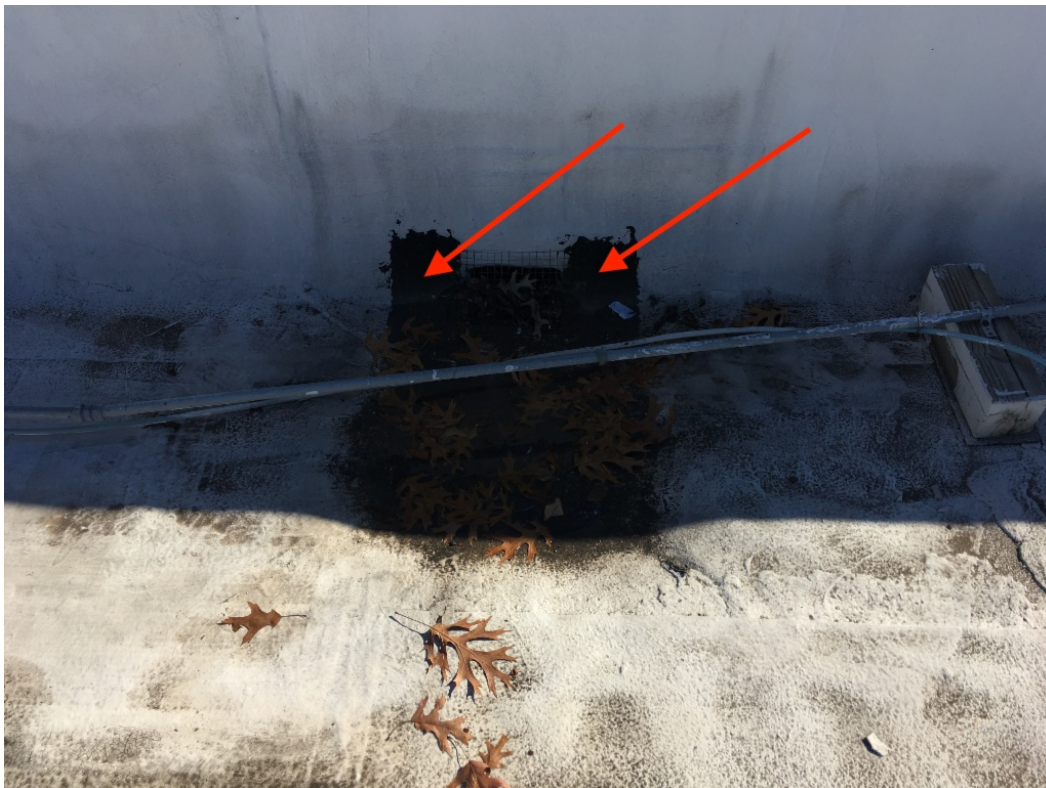
Photo 31

Observed additional deficient repairs installed on through wall drains.

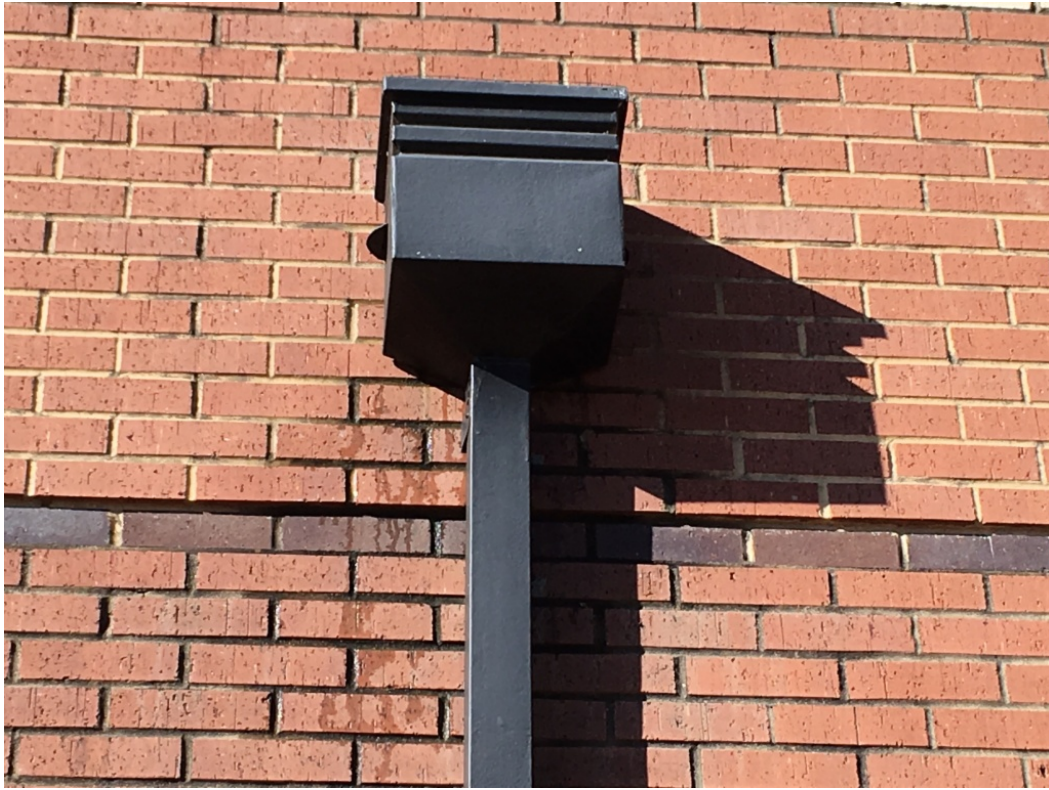
Photo 32

Photograph shows **effect** of deficient repairs observed in previous photo.
