**City of Coppel – Cozby Library**  
**ASSESSMENT**  
**DATE OF SITE VISIT 7/30/25**

**INTRODUCTION**

DRYTEC made a site visit to provide a roof assessment for this facility located at 177 N Heartz Rd, Coppell, TX 75019. This assessment was based on visual observations made during the visit. No existing drawings were provided. No formal or informal testing such as water penetration testing was conducted as a part of this assessment.

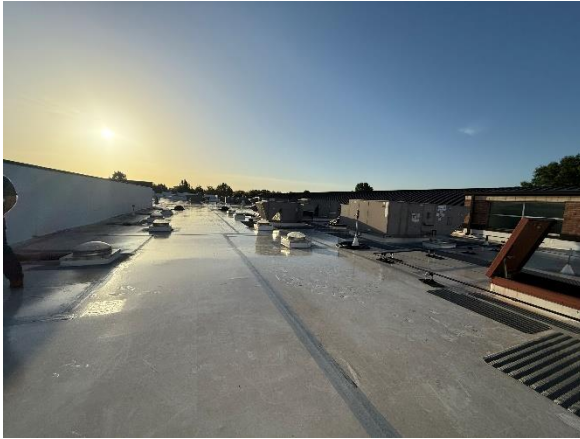
Photo 1 – Overview of Roof Area A

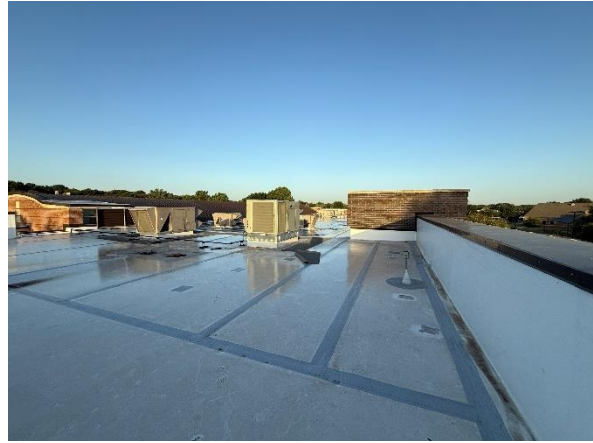
Photo 2 – Overview of Roof Area B.

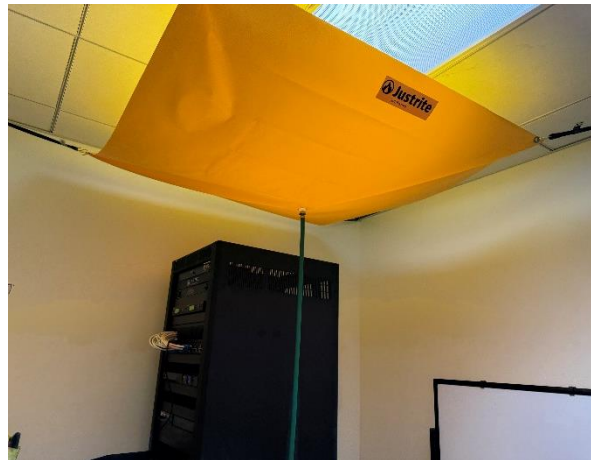
Photo 22 – Protection over server.
