## CORE Roof Conditions & Solutions Report

**Facility:** Aquatic & Recreation Center- CORE

**Roof Section:** Flat Roof- Built Up Roof

**Report Date:** 04/25/2019

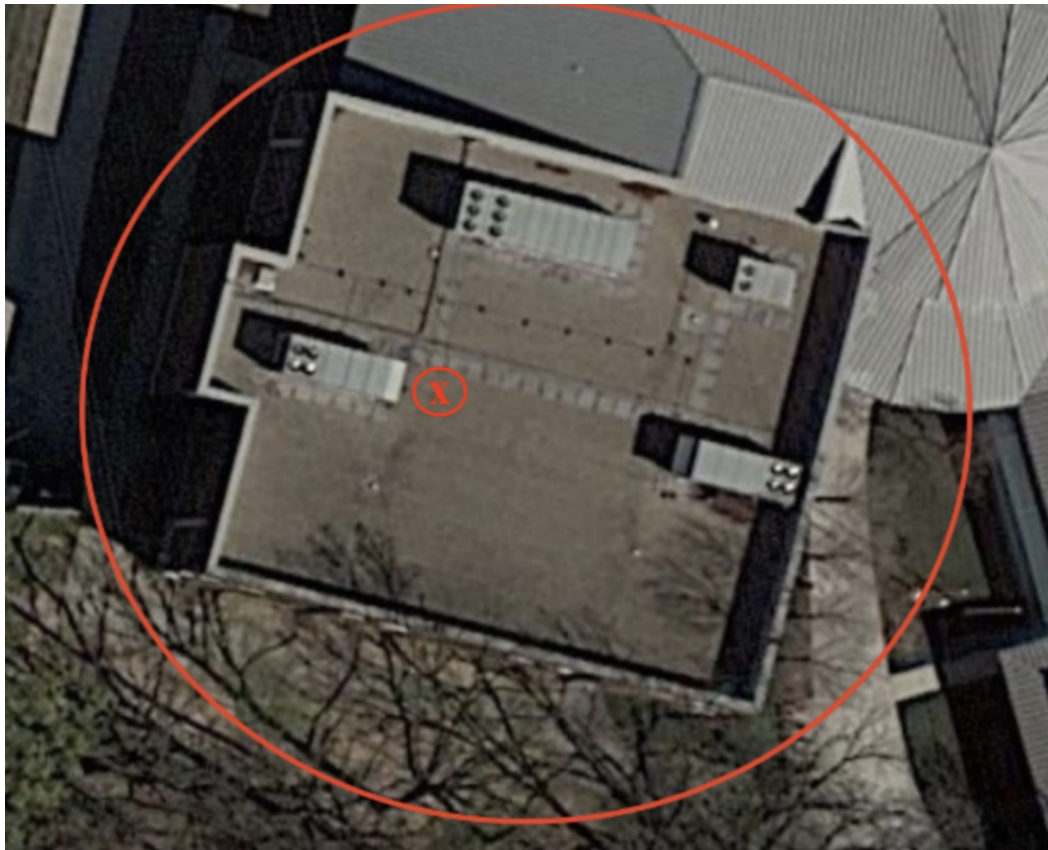
*Photo 1*

Photograph shows location of roof where destructive test was completed.

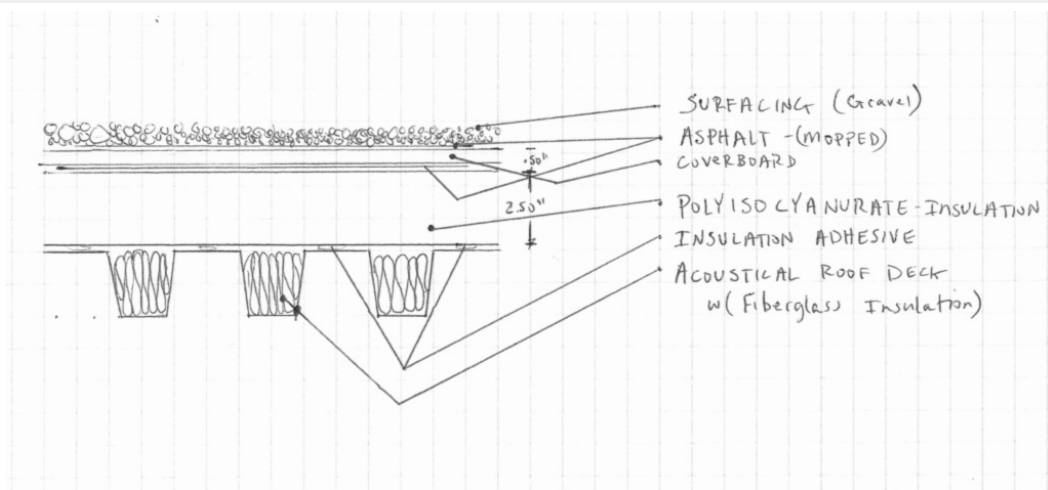
*Photo 2*

On-site shop drawing showing roof system currently installed over gym area only.

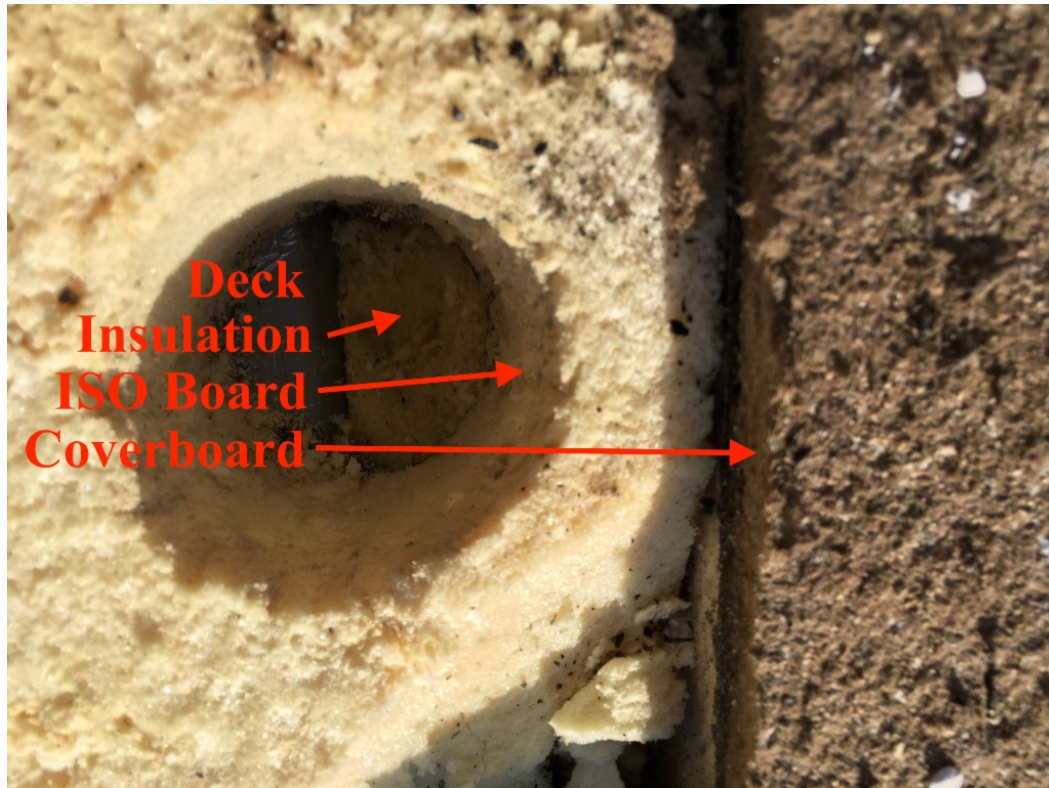
*Photo 3*

Photograph shows roof components currently installed over gym.

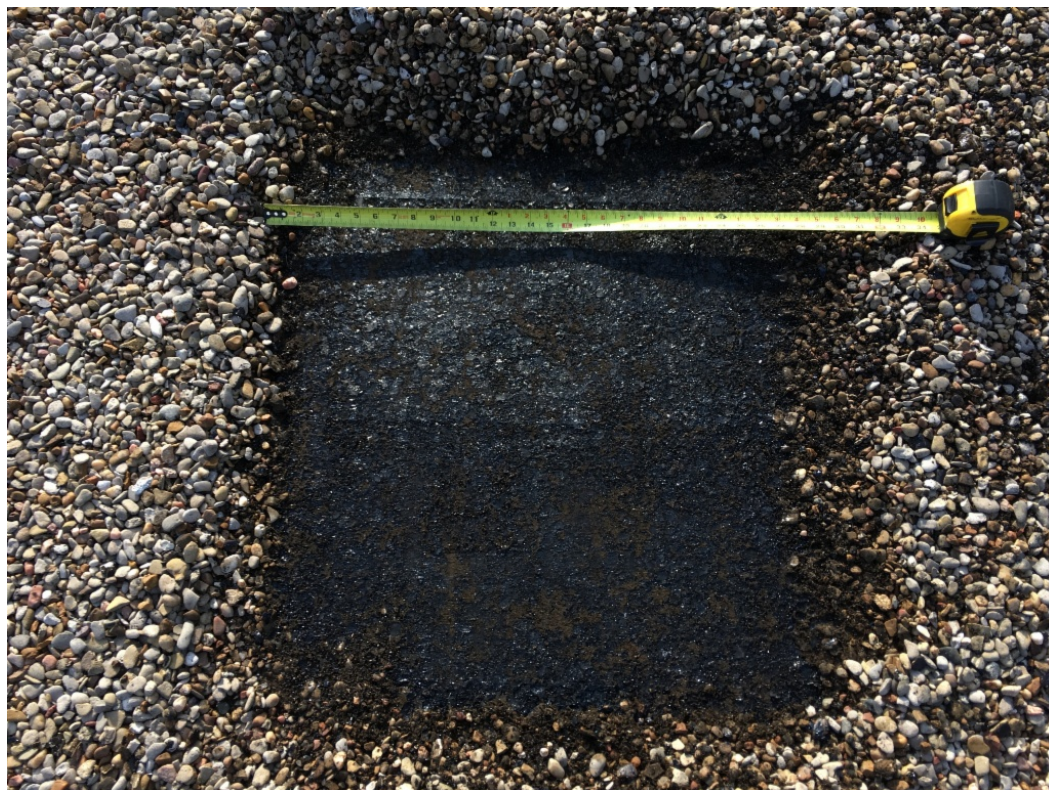
*Photo 4*

Photograph shows before photo of destructive test location dimensions before extraction process began.

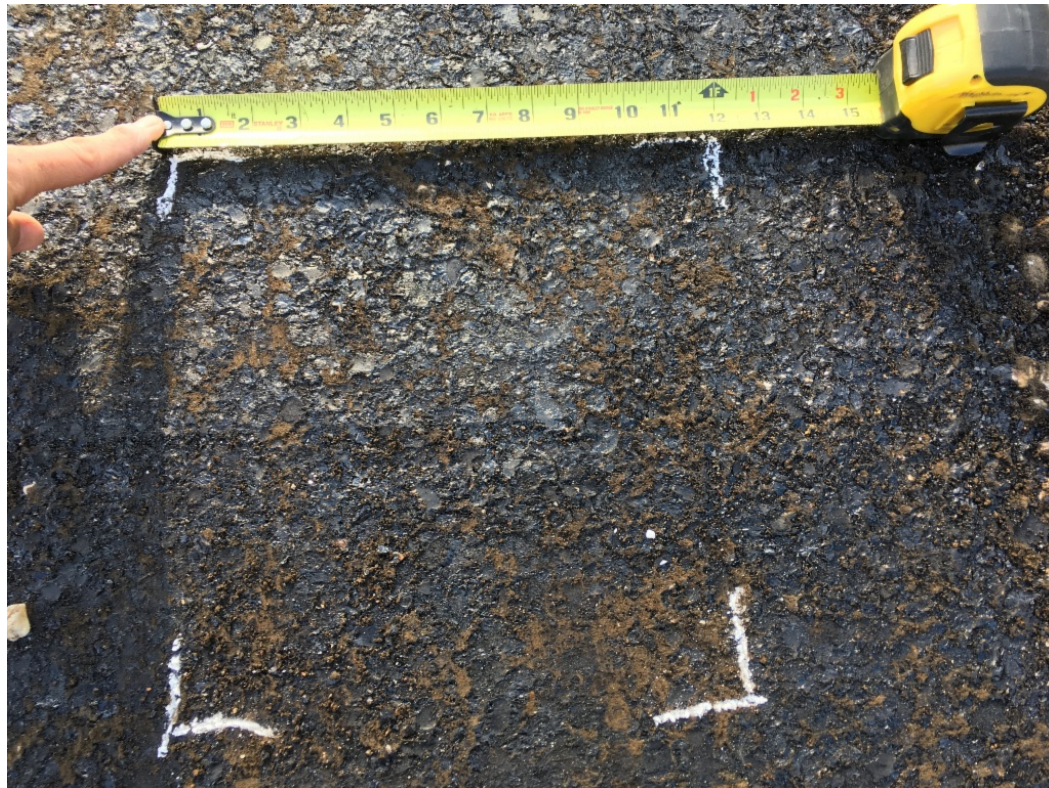
*Photo 5*

Photograph shows dimension of roof sample scheduled to be removed from roof system.

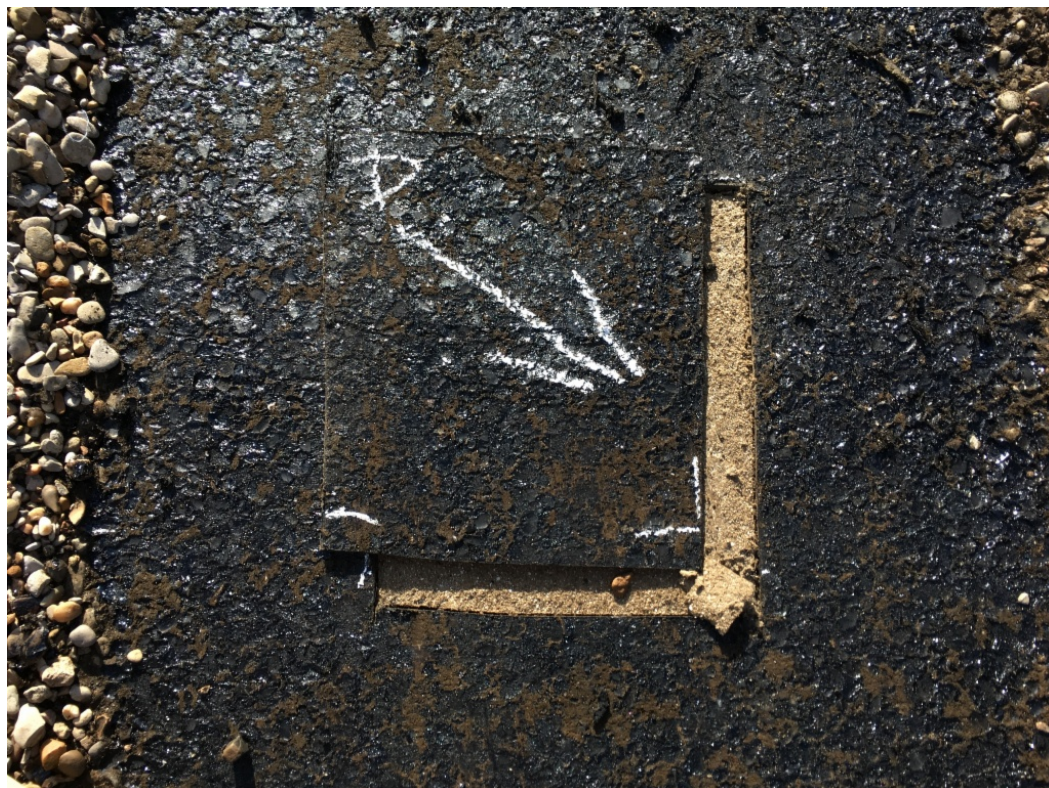
*Photo 6*

Photograph shows test sample extracted from roof with slope direction marked.

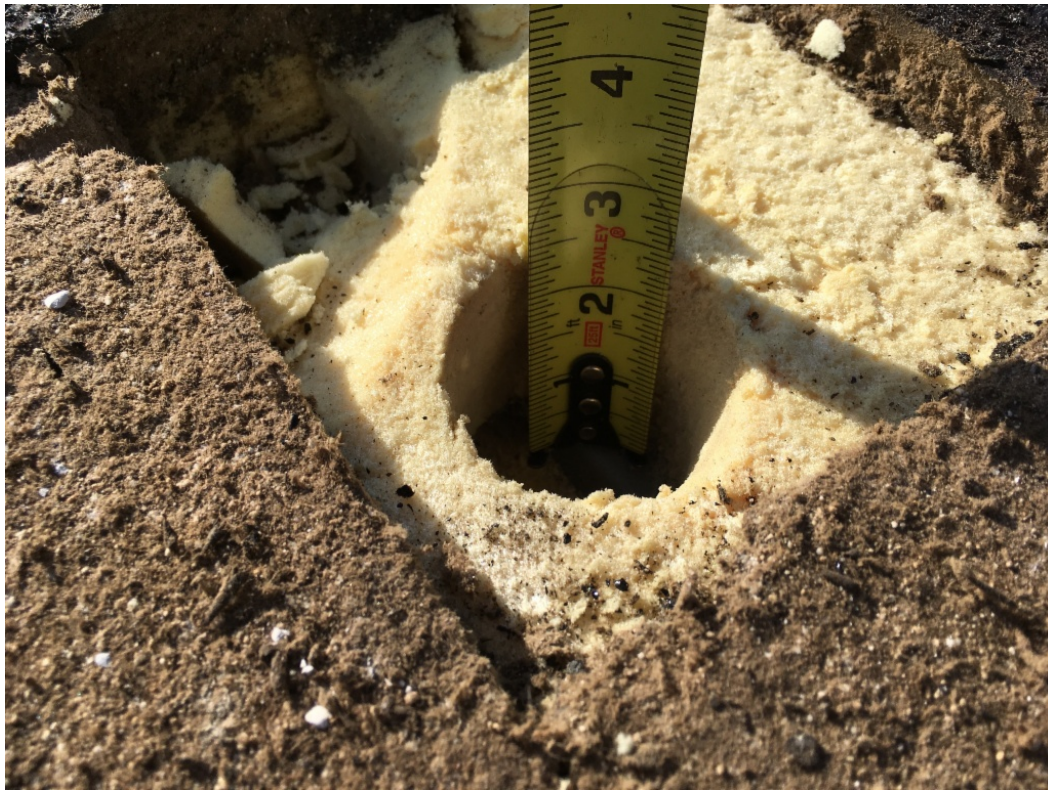
*Photo 7*

Photograph shows depth of roof system components installed over gym location.

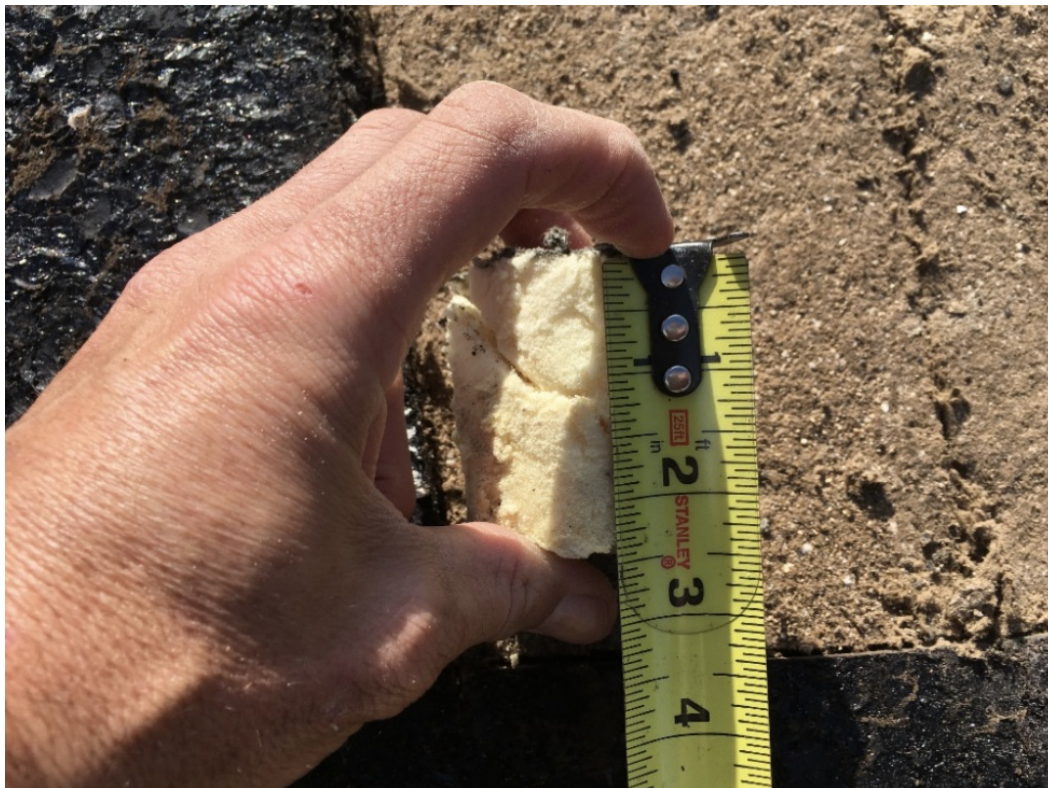
*Photo 8*

Photograph shows existing insulation (polyisocyanurate) board installed over gym location.

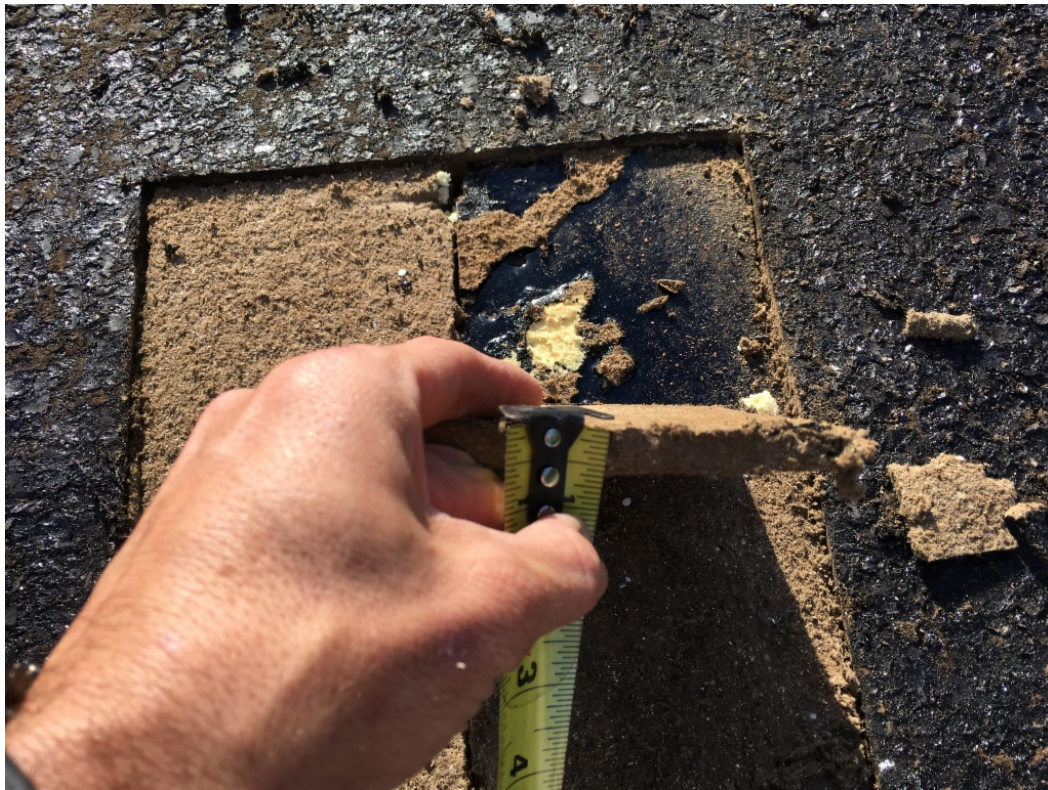
*Photo 9*

Photograph shows existing cover board dimension hot mopped to insulation board over gym location.

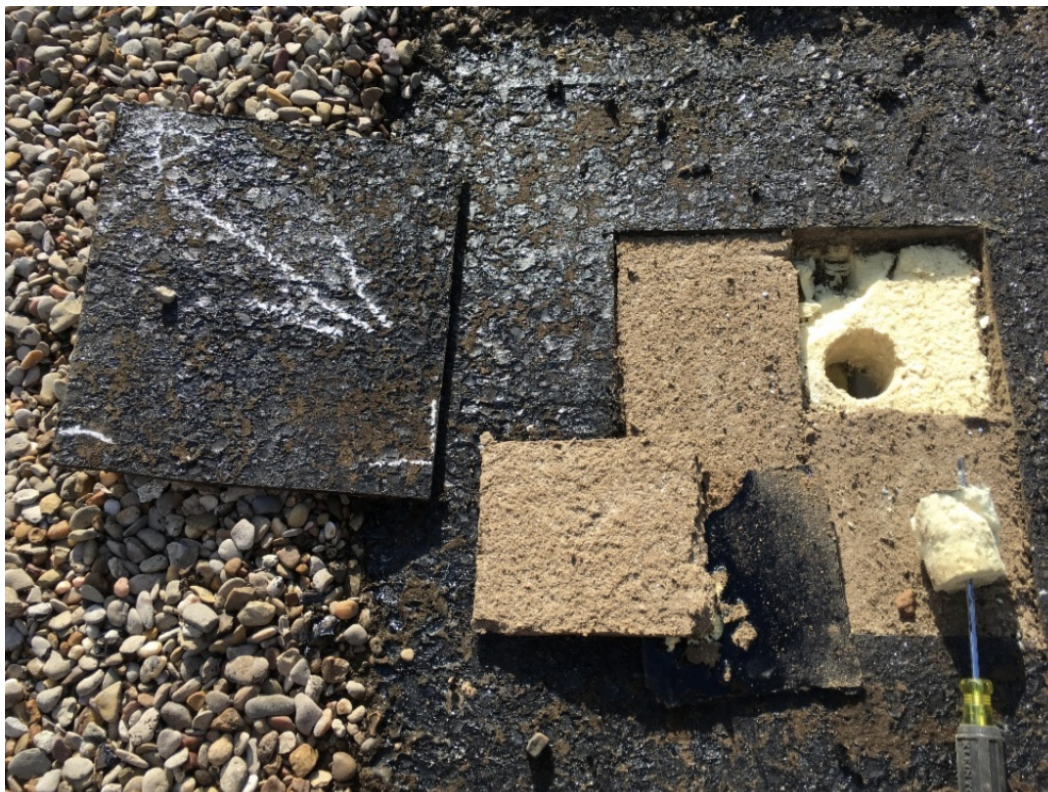
*Photo 10*

Photograph shows all roof components installed in roof system over gym location. Roof components listed from roof surface down to deck below:

- a) Surfacing- 3/8" gravel
- b) 3 plies felt built up roof cap sheet
- c) 1/2" cover board
- d) 2.5" insulation board
- e) metal deck (core location)

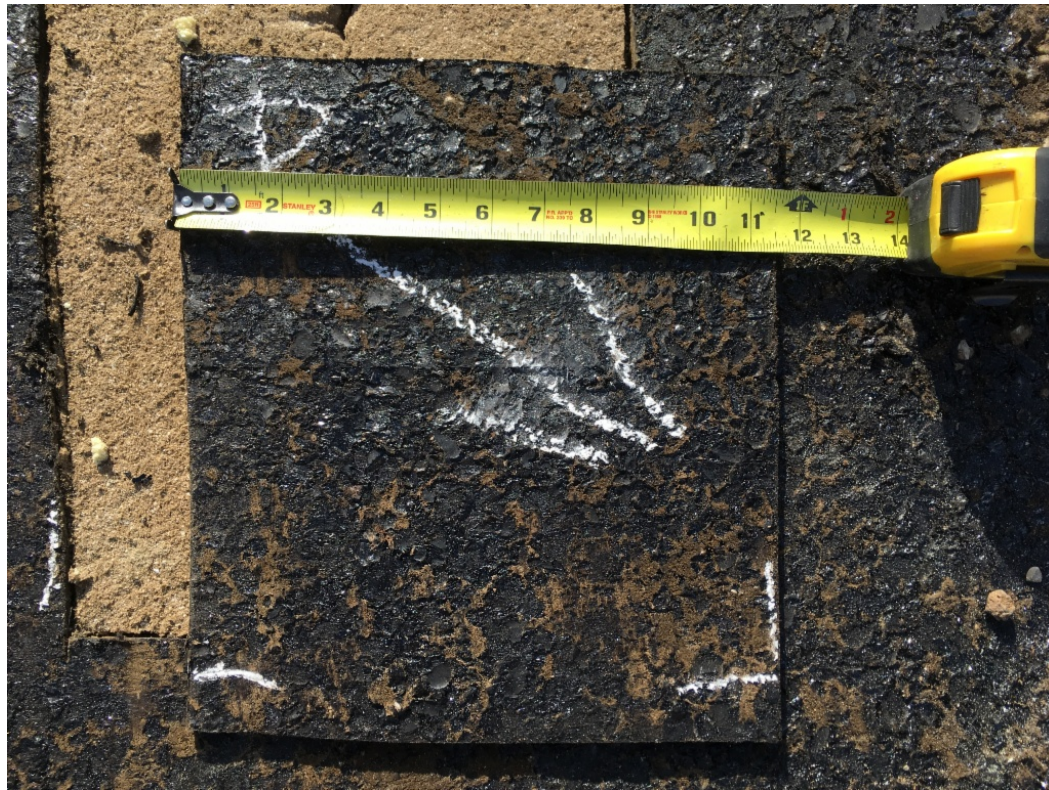
*Photo 11*

Photograph shows dimension an slope of test sample removed from roof system.

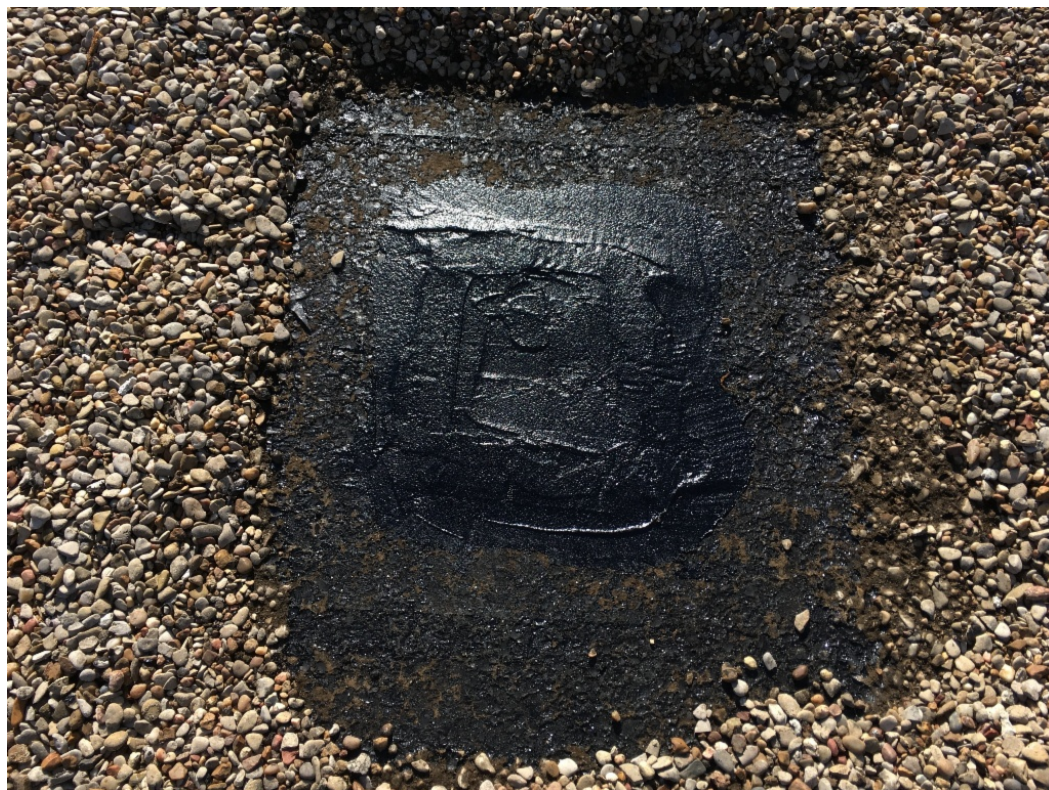
*Photo 12*

Photograph shows repair completed on roof system at destructive test location.

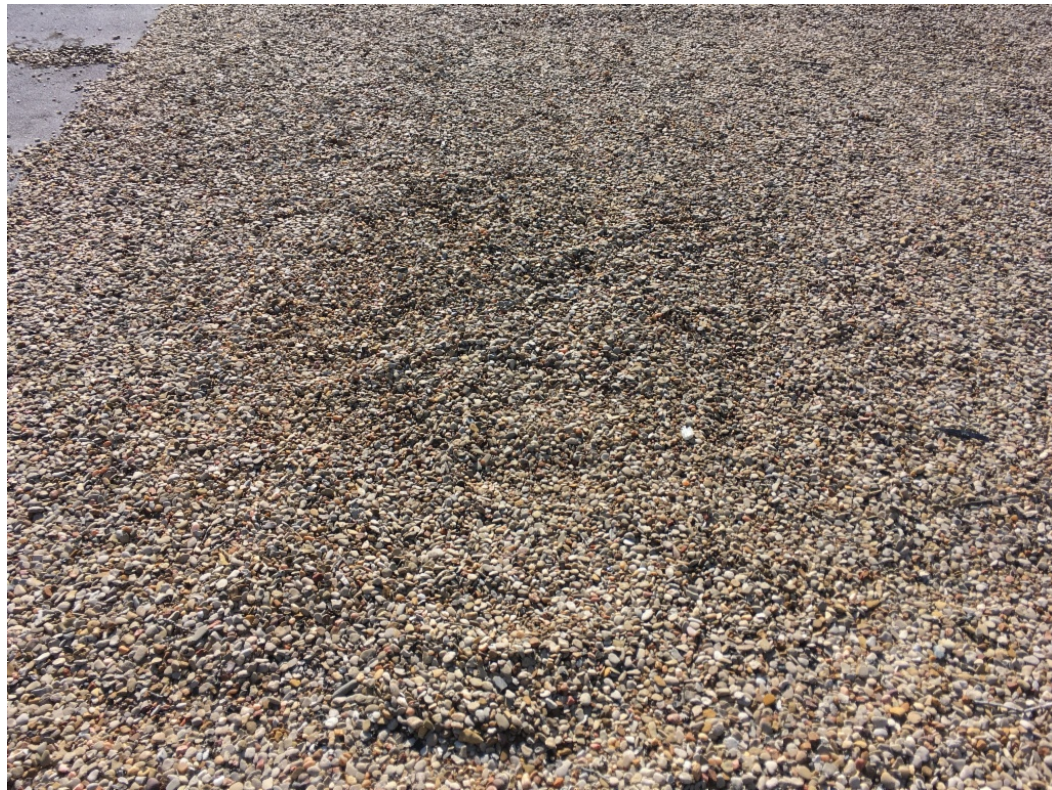
*Photo 13*

Photograph shows gravel (surfacing) placed over repair location.

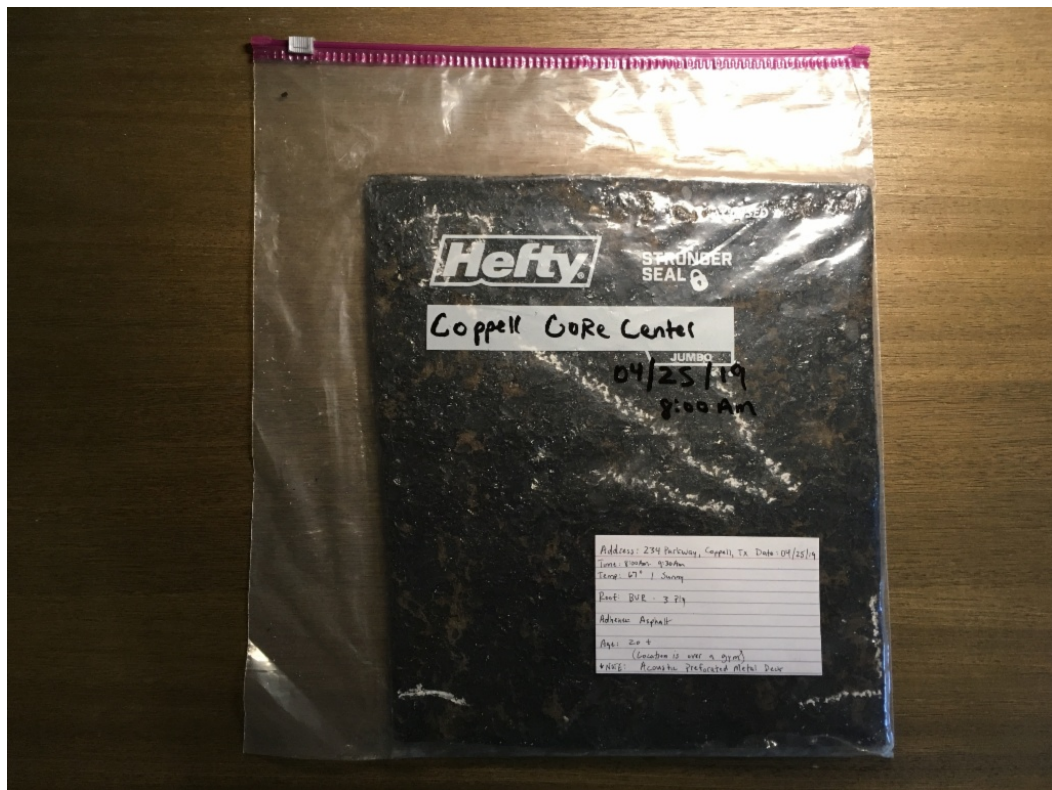
*Photo 14*

The core received is a three-ply built up roof with a flood and gravel surfacing and inter-ply glass mat applied in hot asphalt. The surface of the roof is very weathered and shows signs of alligatoring. The flood and gravel surfacing acts as an important UV protectant for the asphalt; this loss of minerals and surface cracking will potentially lead water penetration though to the roof deck below.

The average softening point of the inter-ply asphalt was 281.5°F with a pen of 7. Standard Type III asphalt has a softening point of 185-205°F and a pen of 15-35. This asphalt sample tested above the ASTM D 312-00 specifications listed above. This could be due to the asphaltic oils baking out over time from weathering and heat cycling, leading to an increased softening point and more brittle asphalt. The loss of oil leads to overall brittleness, cracking and crazing of the roof system, especially in climates with temperature variation between seasons.

In accordance with the Recommended Performance Criteria for Modified Bitumen Roof Membrane Systems, bitumen roof systems should have a minimum of 2.5% elongation, and 200 lbf/in tensile strength to ensure adequate field performance. This roof core had a tensile strength of 189.5 lbf/in and an elongation of 1.3%. Both the tensile strength and elongation are not within the recommended criteria. This can be related to the degraded roof system not being solidly adhered to reach the full tensile strength and the brittle asphalt reducing its overall elasticity.

Based on the analysis of the core provided and from our observations, the overall construction of the core has sufficient integrity and adhesion qualities; the aged asphalt has negatively affected the total system strength. The softening point of the asphalt for both cores was very high, indicating degradation of the asphalt. As a result, the physical properties of this roof core exhibit that the roof is toward the end of its life cycle and will continue to deteriorate with time.

Photograph shows test sample and identification card that were mailed to laboratory for ASTM D 2829-07 testing.

Based on ASTM D 2523, ASTM D 2829 test results, physical roof discoveries and moisture migrating through existing failing roof system our recommendation is to remove roof surfacing, prepare existing roof membrane and apply new roof system over existing roof system. This proposed solution will ensure interior conditions of gym are not compromised and will avoid raising all roof top units to install new applicable IECC/ASHRAE requiring R-25 continues insulation on roof deck.
