Re: Pre-rehabilitation inspection and evaluation for the 2-million-gallon Wagon Wheel elevated storage tank located in Coppell, TX.

**Field Inspection Report**  
**Dunham Engineering, Inc. TX F-22537**  
**(979) 690-6555**

Tank ID: Wagon Wheel CET  
Owner: City of Coppell  
Inspector: Joe Seiter, Trey Biddy  
and Peyton Gorman  
Date of Inspection: (08/13/2021)  
Tank Description: 2 Million Gallon CET

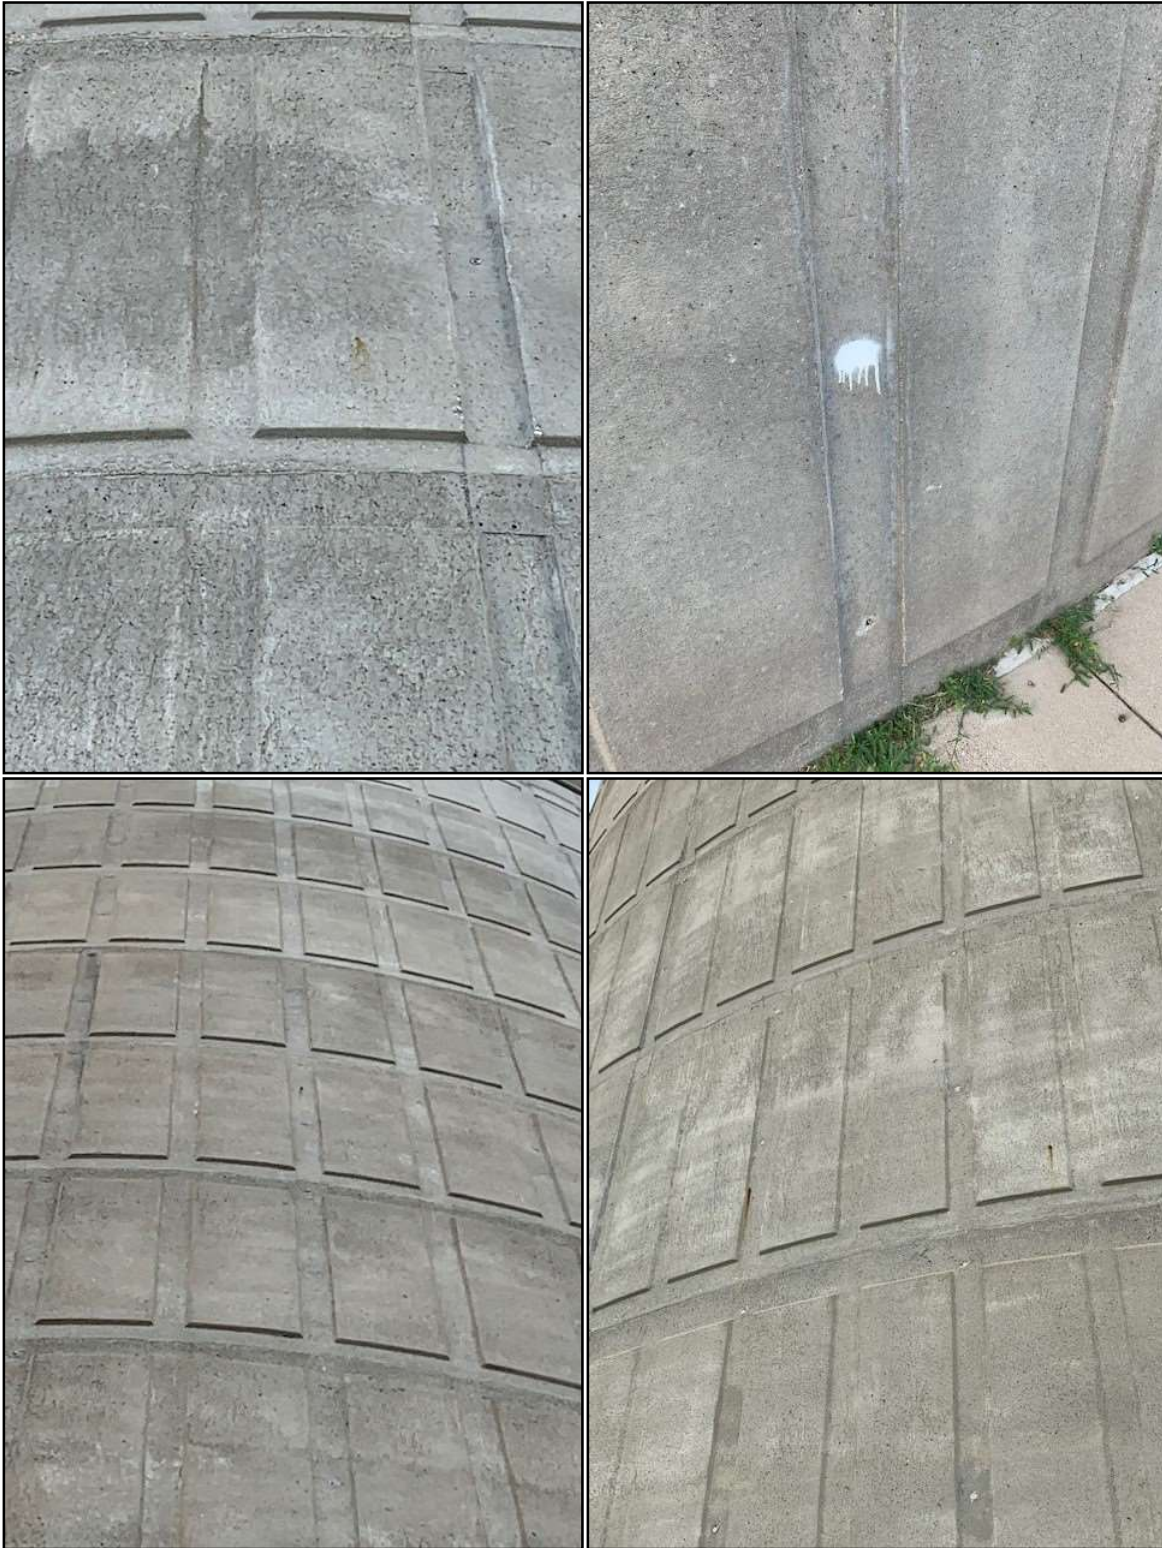
Attributes	
Title	Wagon Wheel CET
Inspection Item	Concrete
Condition	Fair-Element performs intended function with small reduction of reliability
Notes/Dimensions	Concrete pedestal exhibits localized corrosion at exposed rebar extruding from the concrete
Inspector	JAS, TWB, PJG

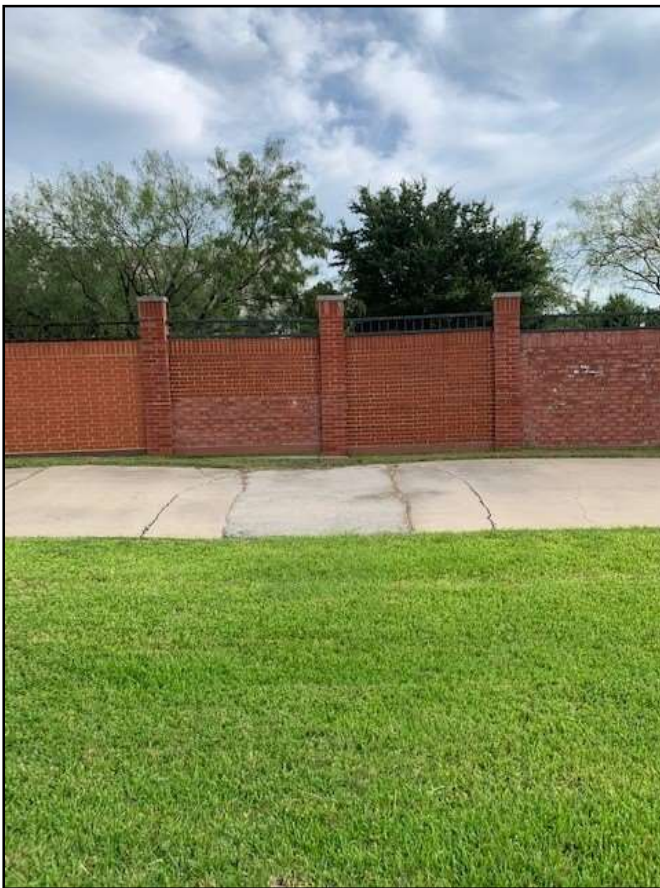
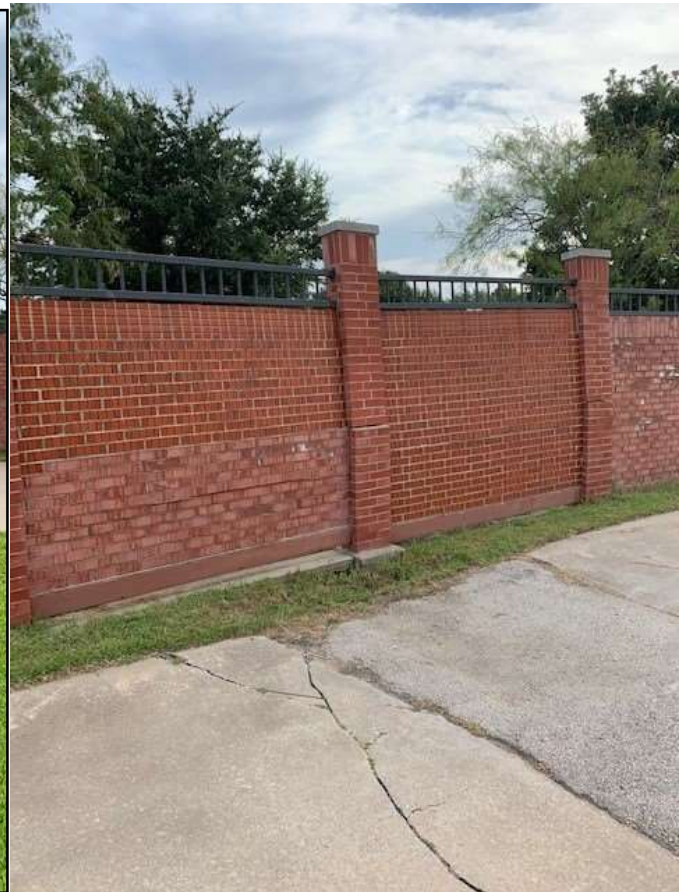
- The tank is in fair to poor overall condition.
- Site fencing is secure with gate lock.
- Settling around site has caused cracking in pavement and brick fence.

Attributes	
Title	Wagon Wheel CET
Inspection Item	Site and Fencing
Condition	Fair-Element performs intended function with small reduction of reliability
Notes/Dimensions	Settling has occurred near site fencing, resulting in cracking in both pavement and fencing. Previous repairs are evident.
Inspector	JAS, TWB, PJG

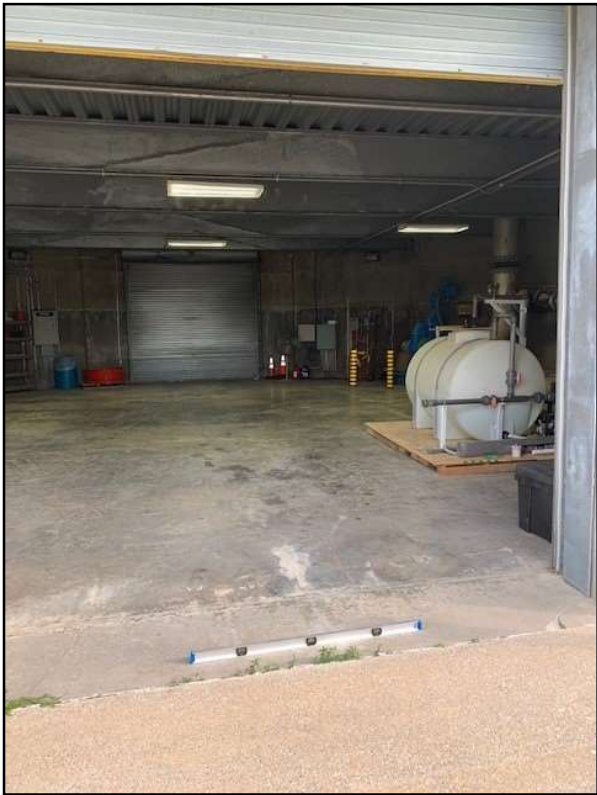
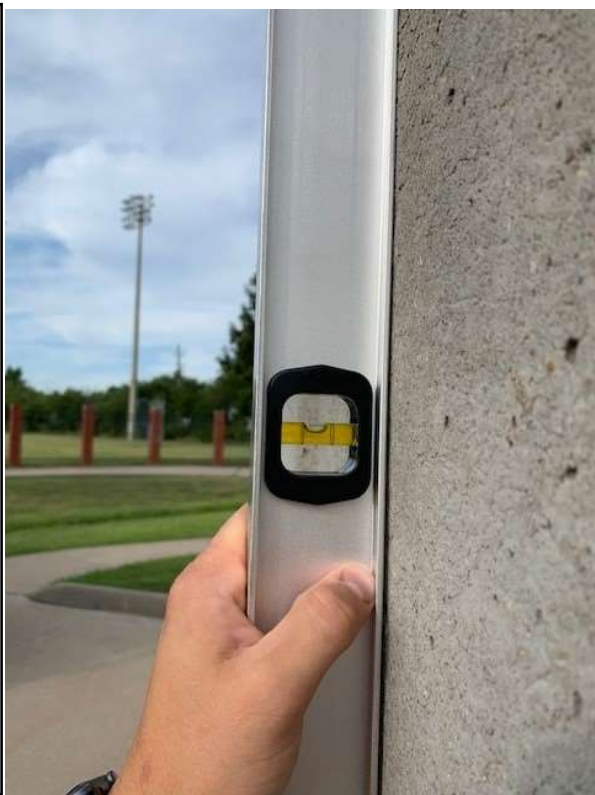
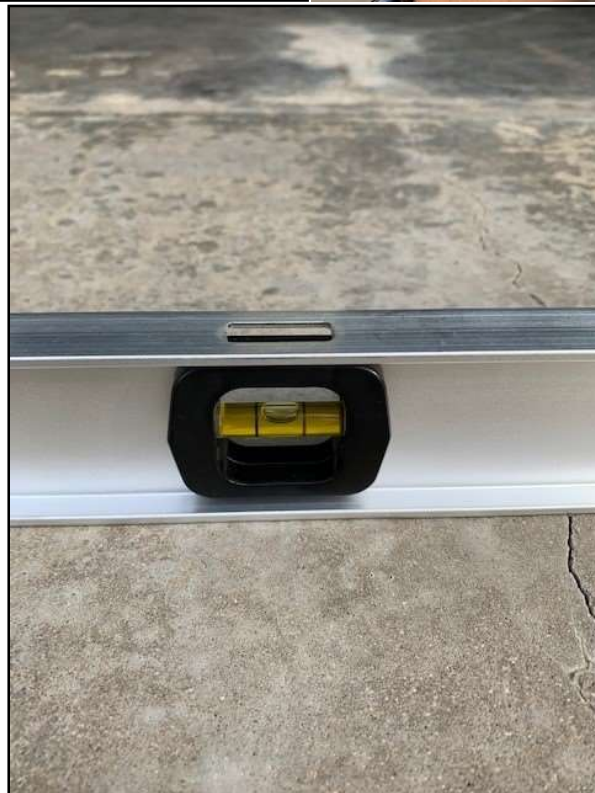
Attributes	
Title	Wagon Wheel CET
Inspection Item	Foundation
Condition	Good-Element performs intended function with high degree of reliability
Notes/Dimensions	Foundation is level and concrete pedestal is plumb. Some minor cracking is present.
Inspector	JAS, TWB, PJG

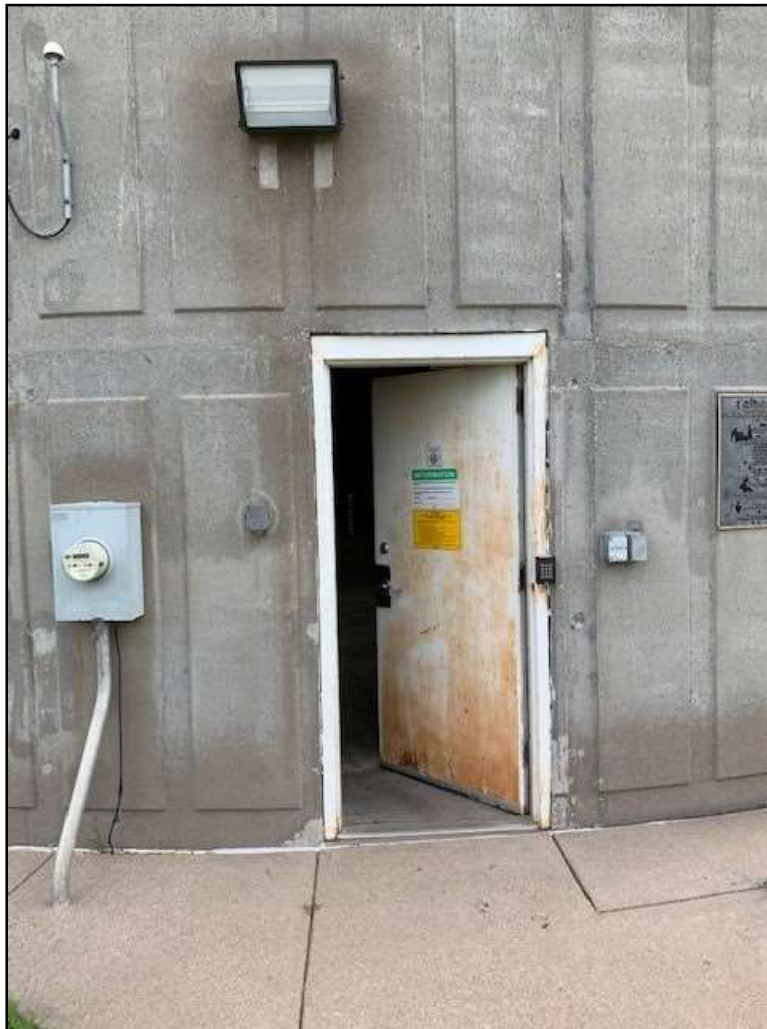
Attributes	
Title	Wagon Wheel CET
Inspection Item	Man Door
Condition	Poor-Element performs intended function with a significant reduction of reliability
Notes/Dimensions	Door functions and can be secured and locked. General corrosion is present over majority of the door.
Inspector	JAS, TWB, PJG

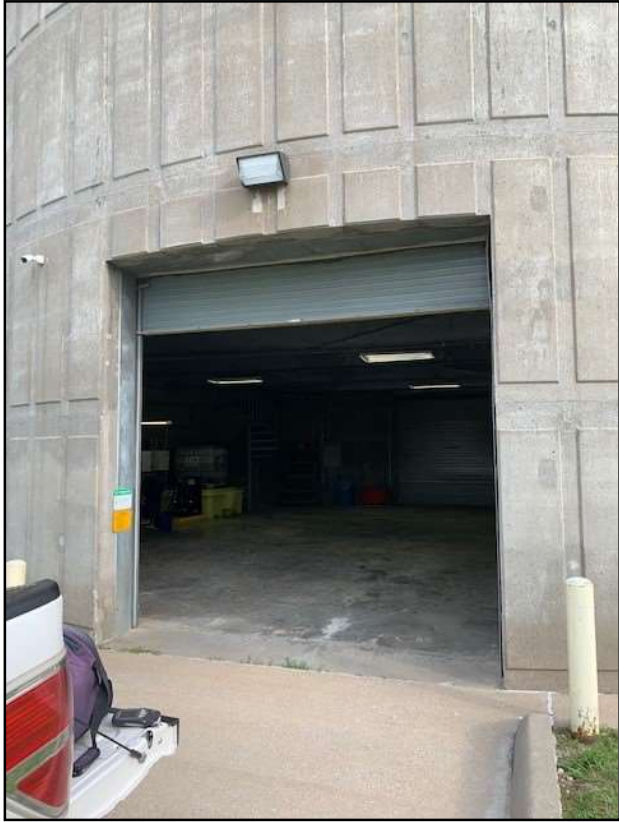
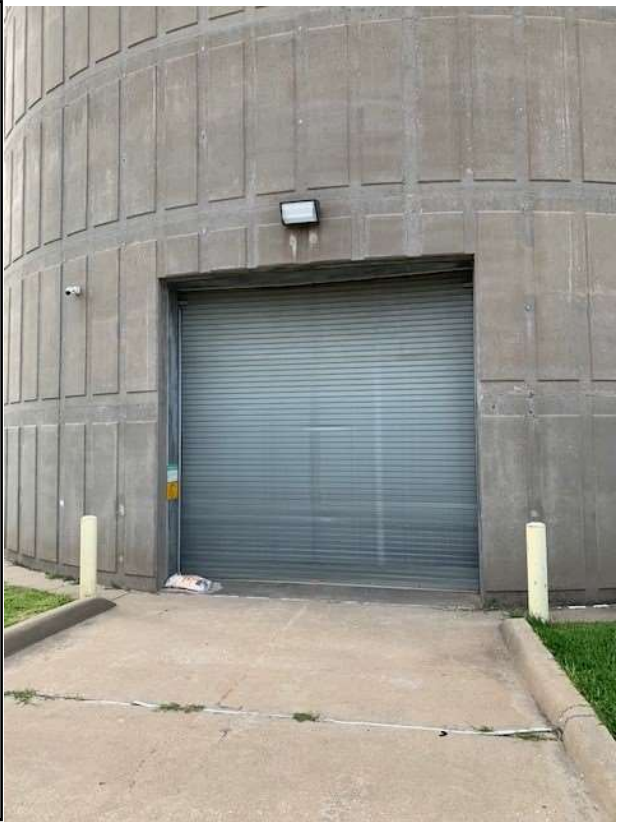
Attributes	
Title	Wagon Wheel CET
Inspection Item	Overhead Door
Condition	Fair-Element performs intended function with small reduction of reliability
Notes/Dimensions	Door functions and can be secured and locked. Dents in door are present.
Inspector	JAS, TWB, PJG

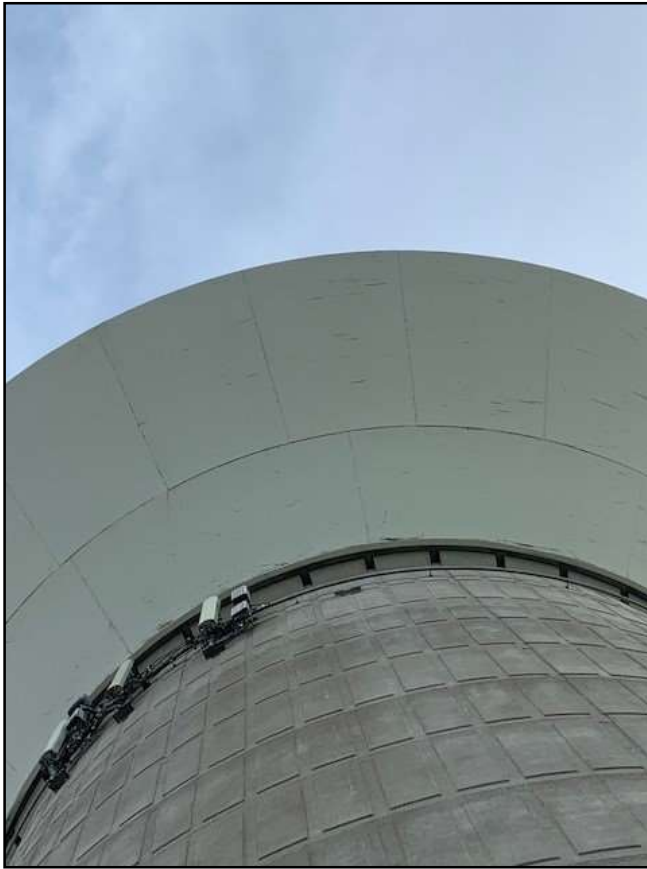
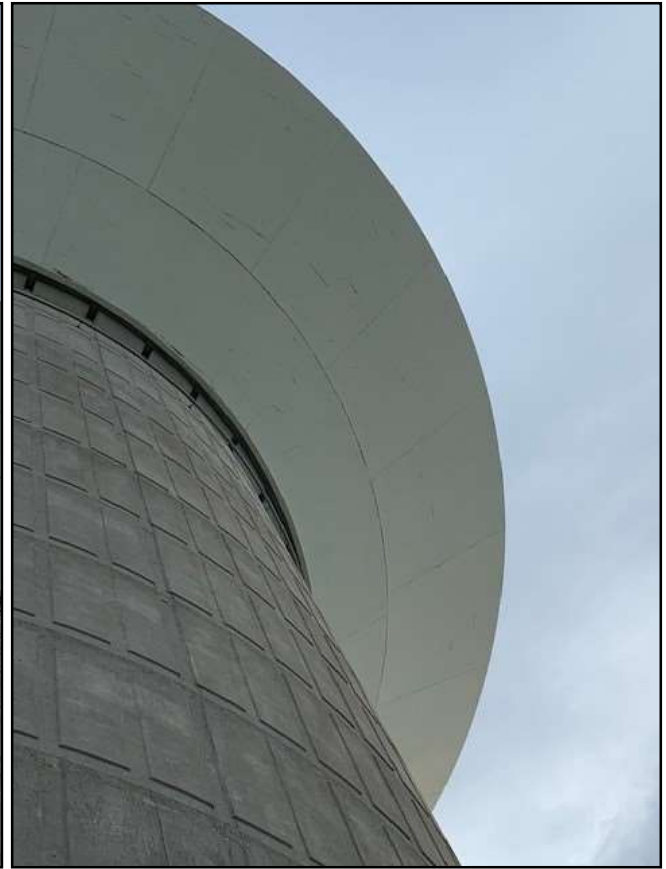
- Roof plate thickness is acceptable. UT reading=0.244"
- Exterior coating of reverse cone of tank is in poor condition due to coating failure. Sidewall and roof exterior coating exhibits localized corrosion. DFT average reading of 10.246 mils was measured. Chalking is present on exterior coating. Mold is present on exterior coating.

Attributes	
Title	Wagon Wheel CET
Inspection Item	Exterior Coating-Bottom Side of Bowl
Condition	Poor-Element performs intended function with a significant reduction of reliability
Notes/Dimensions	Coating failures are present. Chalking of exterior coating is present. Areas of mold are present.
Inspector	JAS, TWB, PJG

- Lead content of interior and exterior coatings is below TCEQ threshold of 1000 ppm. Lab results follow in report.
- Suggest full rehabilitation of tank within 1-year.

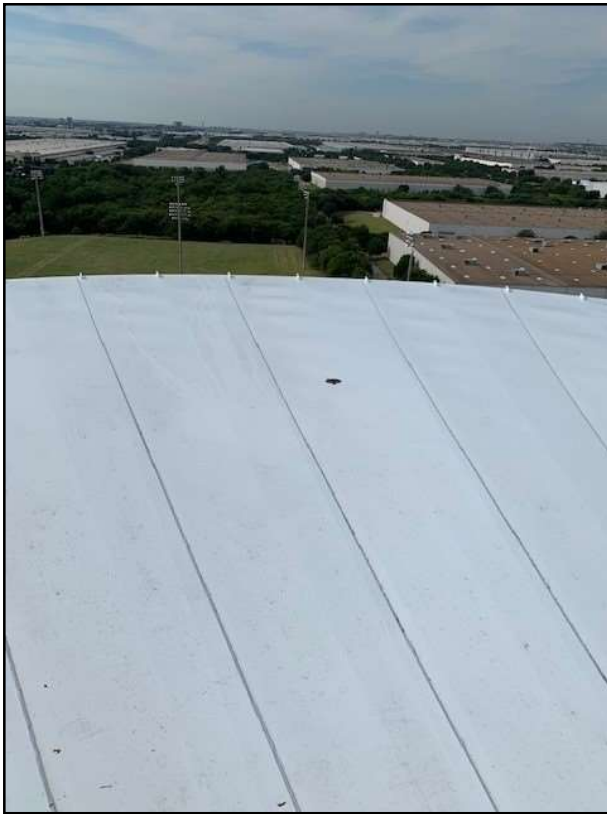
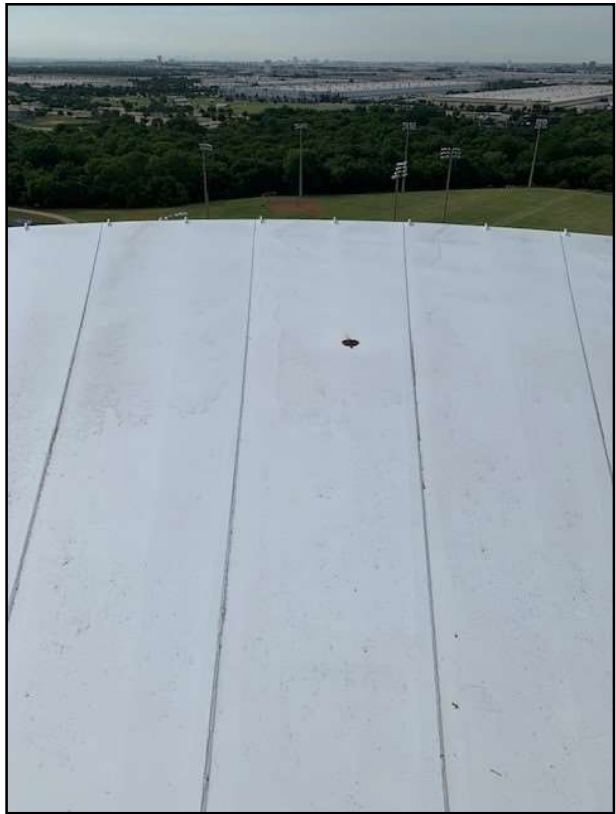
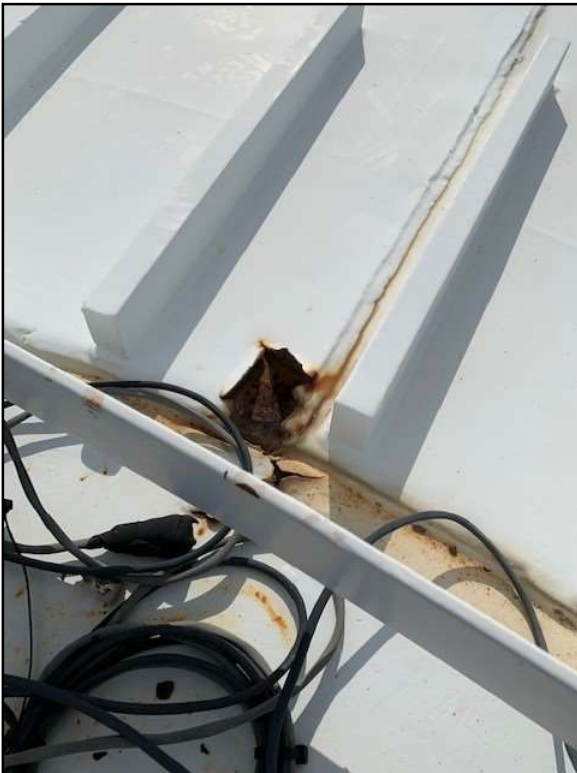
Attributes	
Title	Wagon Wheel CET
Inspection Item	Exterior Coating- Top of Tank
Condition	Poor-Element performs intended function with a significant reduction of reliability
Notes/Dimensions	Localized corrosion is present. Roof exhibits no low spots. Chalking of exterior coating is present. Areas of mold are present.
Inspector	JAS, TWB, PJG

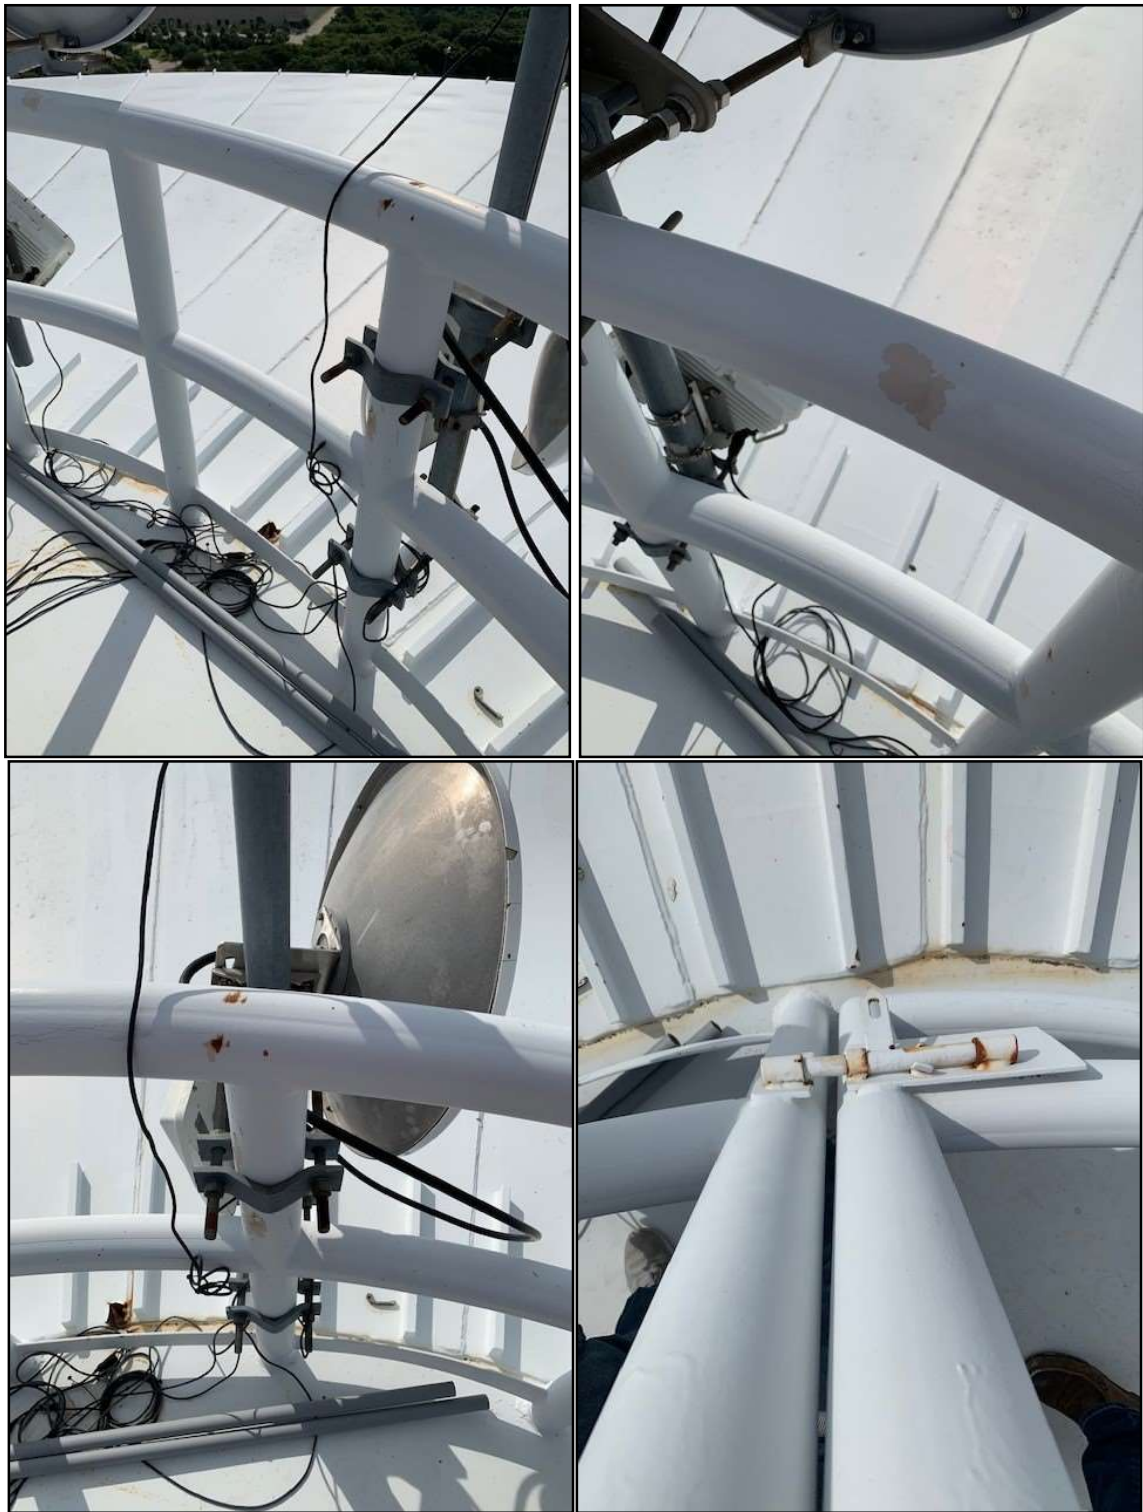
Attributes	
Title	Wagon Wheel CET
Inspection Item	Exterior Coating-Top Rail
Condition	Poor-Element performs intended function with a significant reduction of reliability
Notes/Dimensions	Localized corrosion is present. Coating failures are present.
Inspector	JAS, TWB, PJG

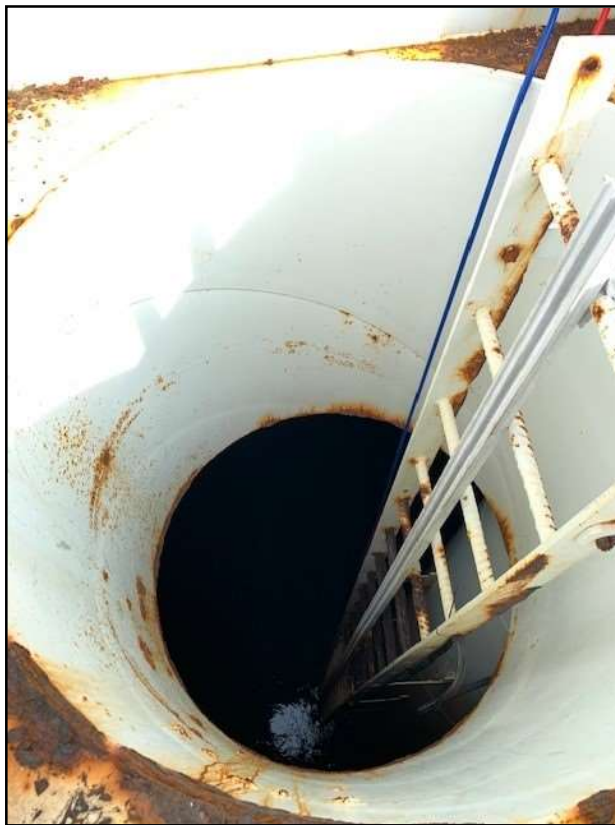
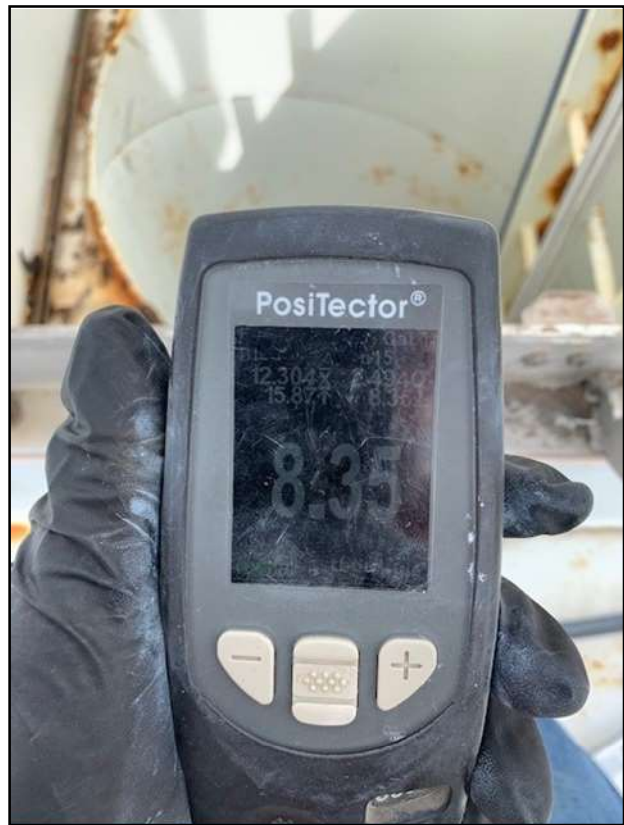
Attributes	
Title	Wagon Wheel CET
Inspection Item	Roof Hatch and Entry Coating
Condition	Poor-Element performs intended function with a significant reduction of reliability
Notes/Dimensions	DFT average = 12.304. Severe localized corrosion present.
Inspector	JAS, TWB, PJG

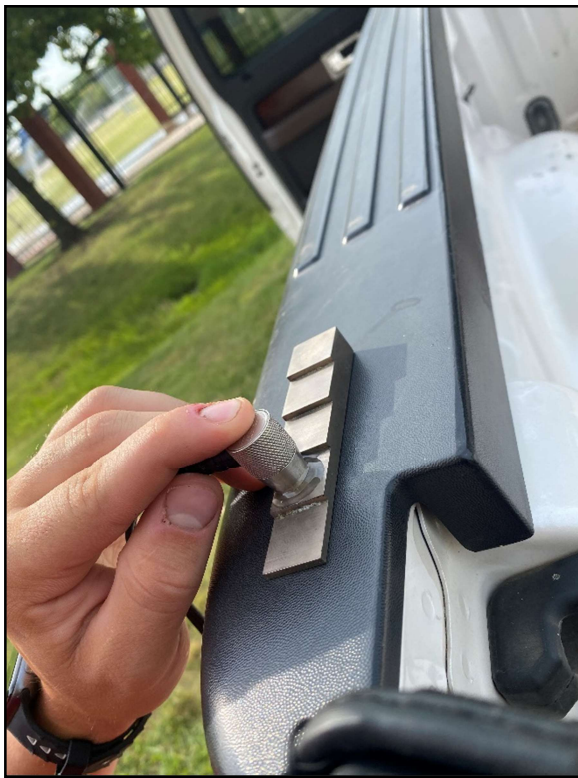
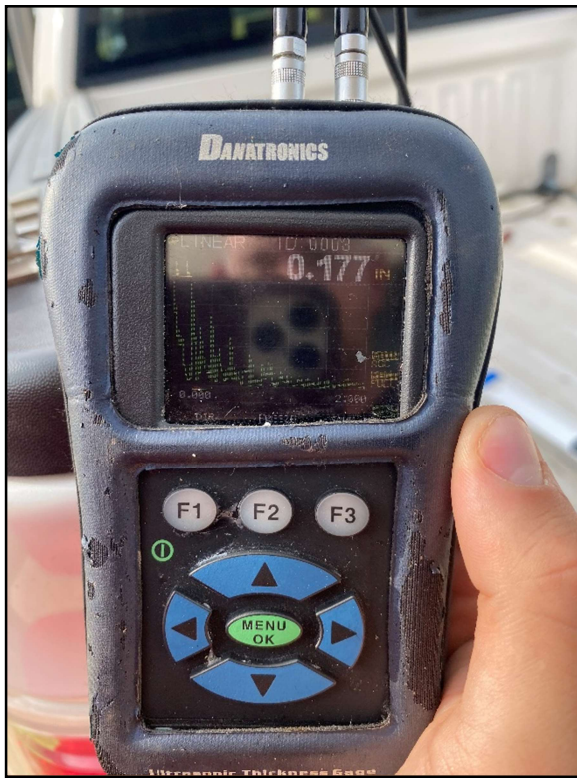
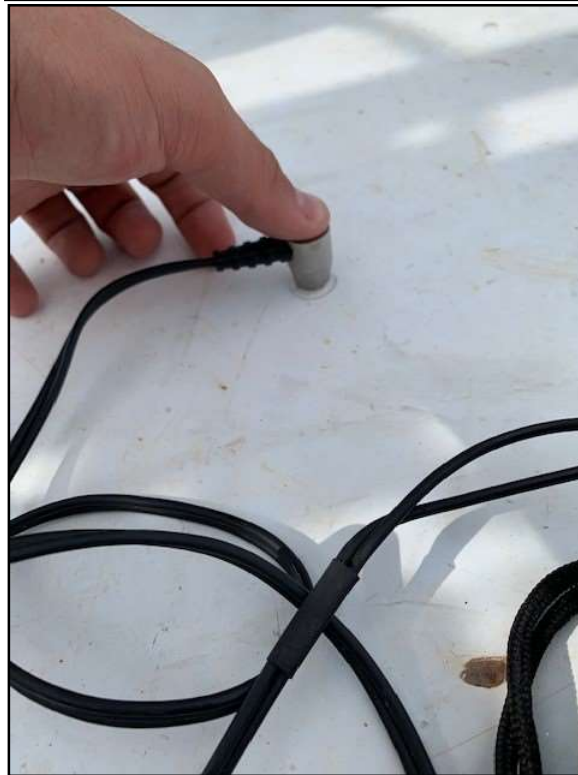
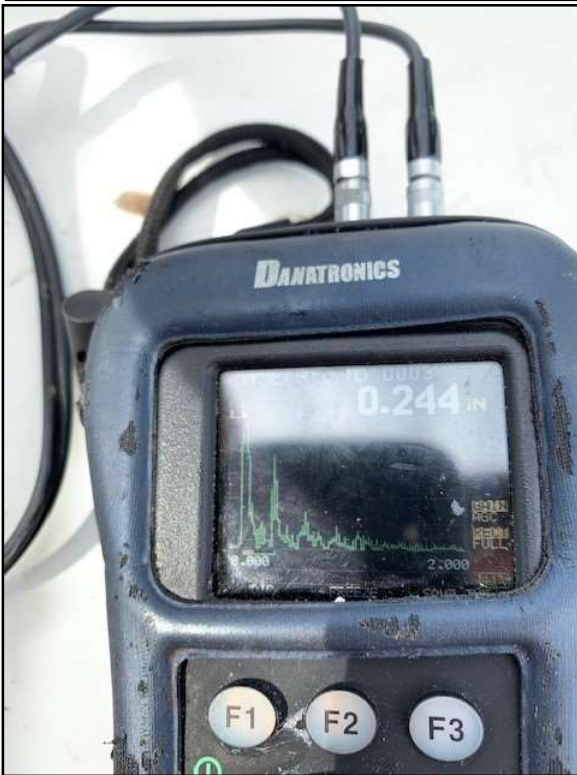
Attributes	
Title	Wagon Wheel CET
Inspection Item	UT Reading Roof Shell Thickness
Condition	Good-Element performs intended function with high degree of reliability
Notes/Dimensions	UT meter calibration test performed. Roof shell thickness= 0.244"
Inspector	JAS, TWB, PJG

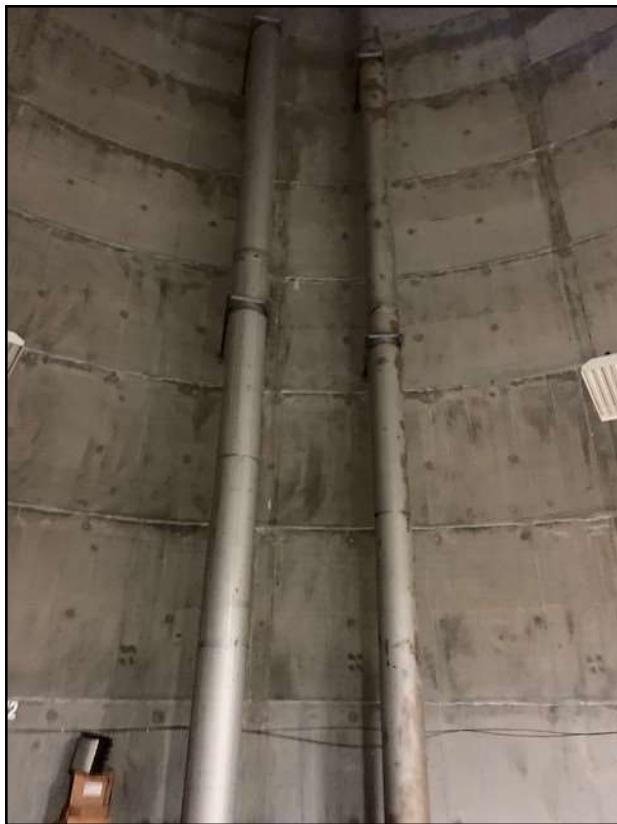
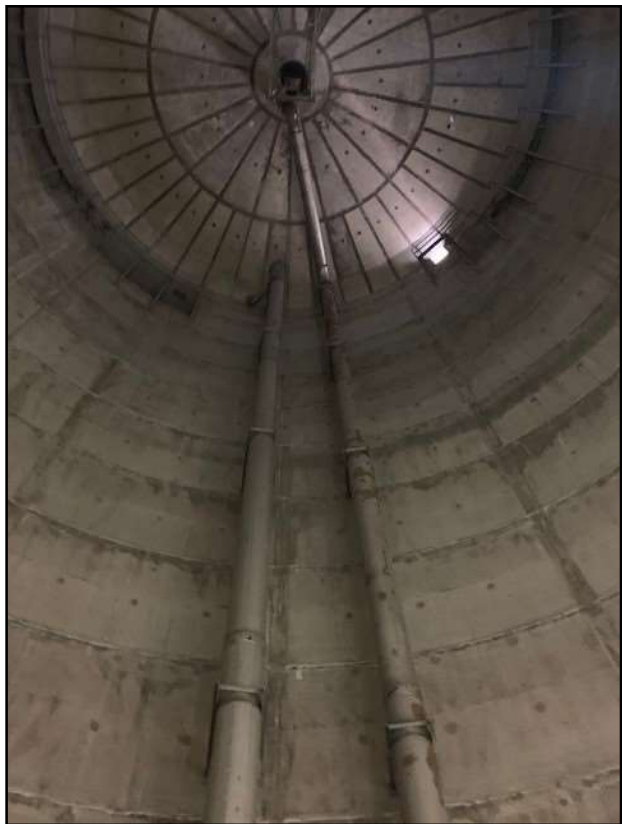
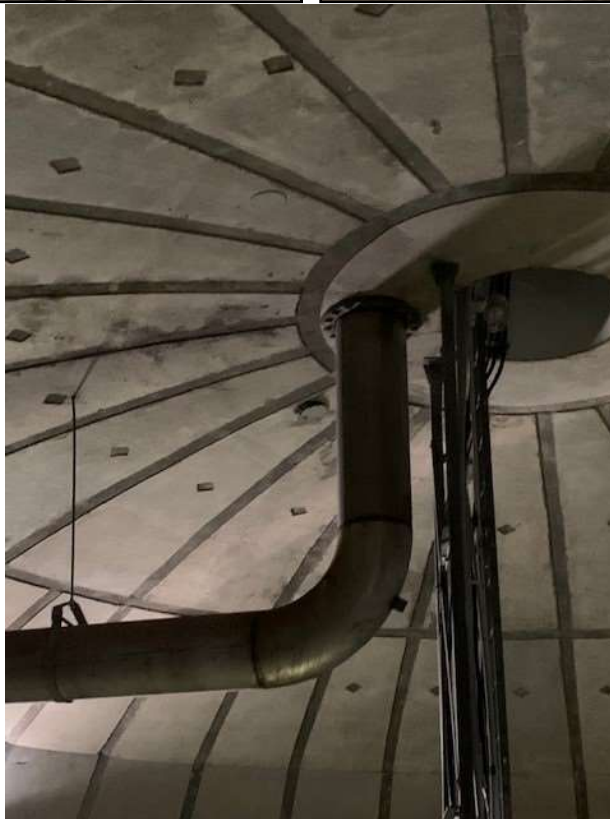
- Interior dry coating in dry riser appears to be in overall good condition.
- Flap valve is present on overflow pipe discharge. No screen is present on overflow pipe discharge. Washout under foundation of the overflow pipe discharge is present.

Attributes	
Title	Wagon Wheel CET
Inspection Item	Overflow Pipe and Flap Valve
Condition	Poor-Element performs intended function with a significant reduction of reliability
Notes/Dimensions	Flap valve present. Internal portion of overflow pipe exhibits general corrosion. No screen is present. Washout under foundation of the overflow pipe discharge is present.
Inspector	JAS, TWB, PJG

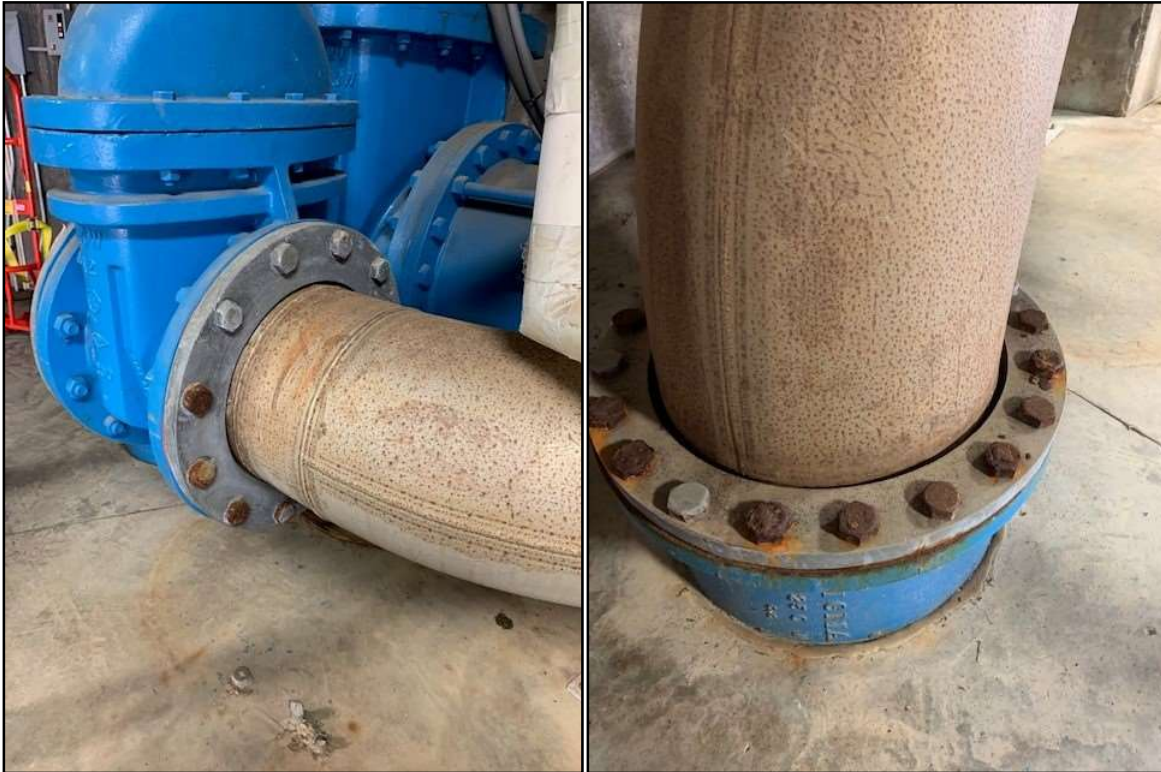
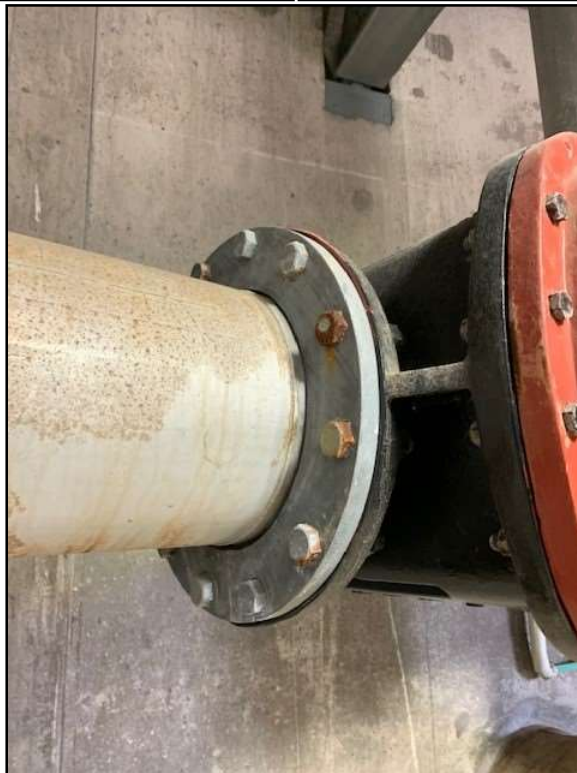
Attributes	
Title	Wagon Wheel CET
Inspection Item	Inlet Outlet Piping
Condition	Poor-Element performs intended function with a significant reduction of reliability
Notes/Dimensions	Corrosion is present on bolt heads.
Inspector	JAS, TWB, PJG

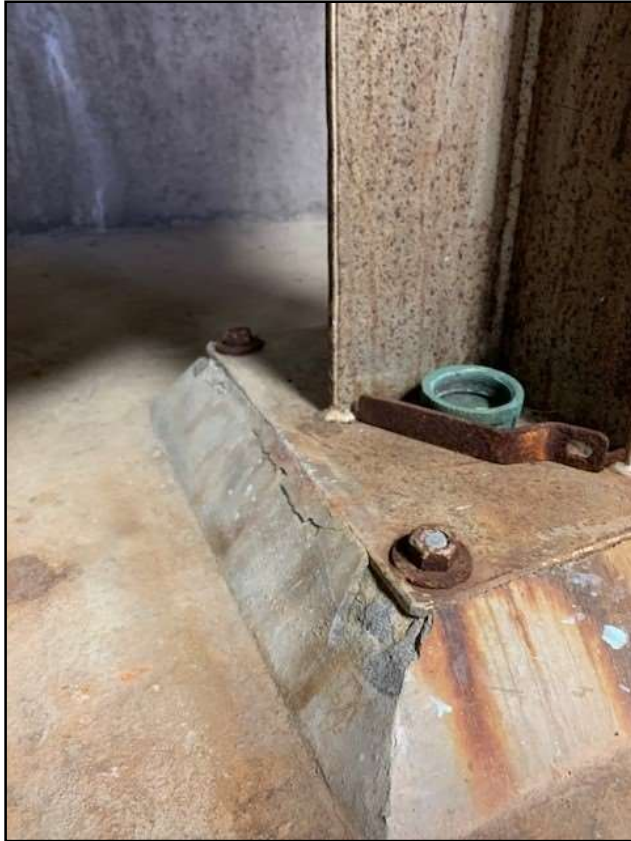
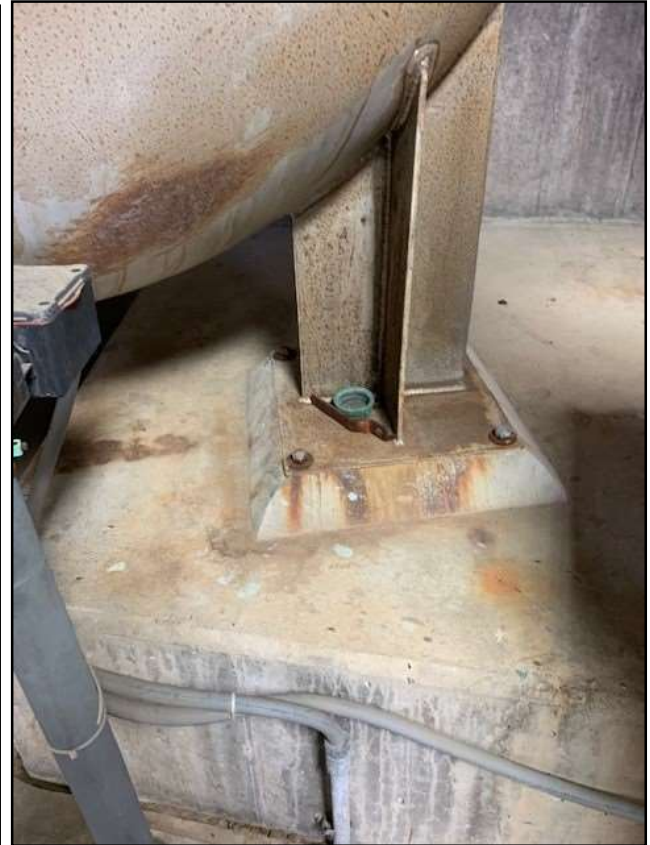
Attributes	
Title	Wagon Wheel CET
Inspection Item	Inlet/Outlet Piping Foundation
Condition	Fair-Element performs intended function with small reduction of reliability
Notes/Dimensions	Cracking and spalling is present.
Inspector	JAS, TWB, PJG

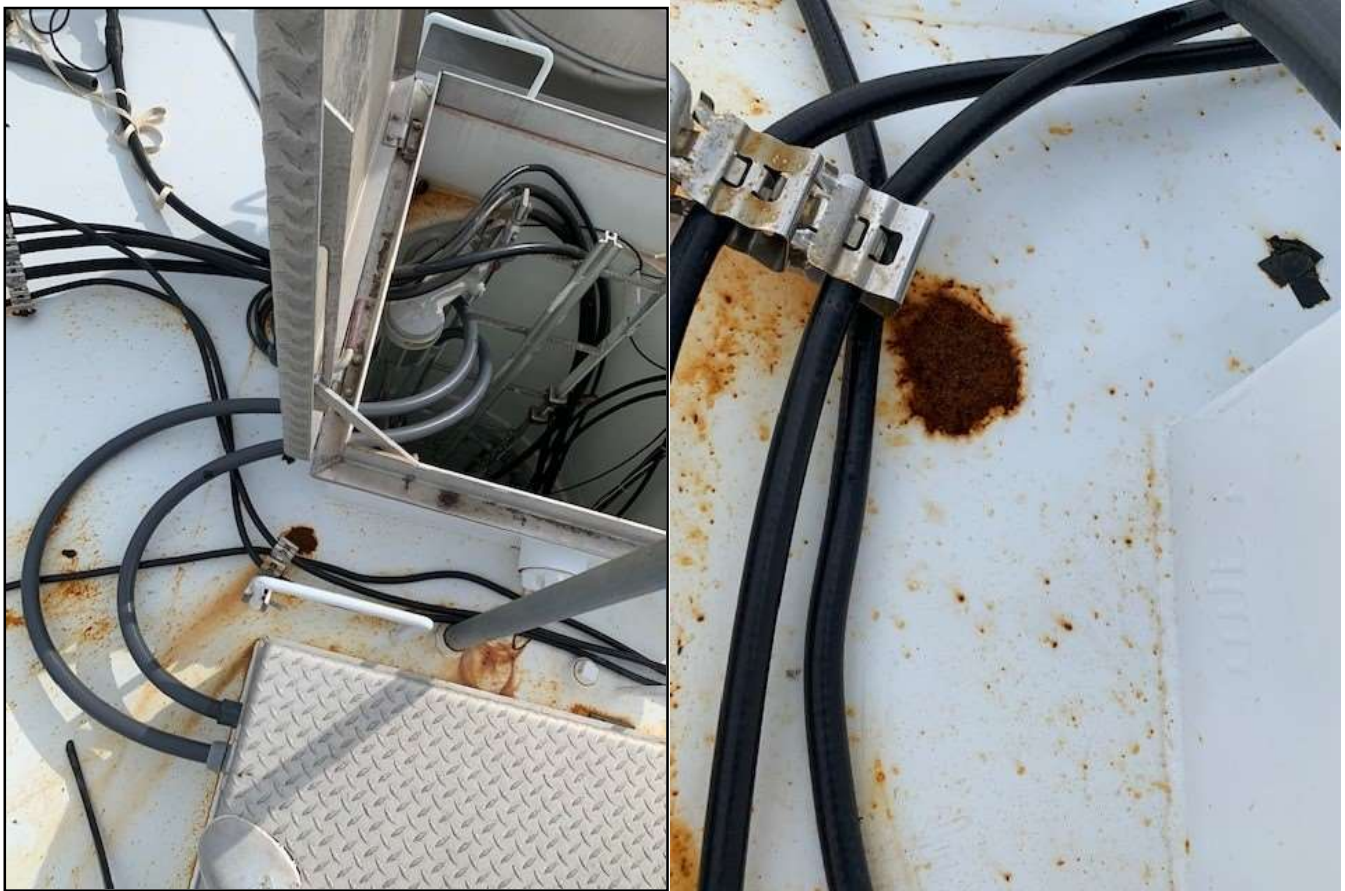
Attributes	
Title	Wagon Wheel CET
Inspection Item	Exterior Coating Roof of Tank
Condition	Poor-Element performs intended function with a significant reduction of reliability
Notes/Dimensions	Localized corrosion is present.
Inspector	JAS, TWB, PJG

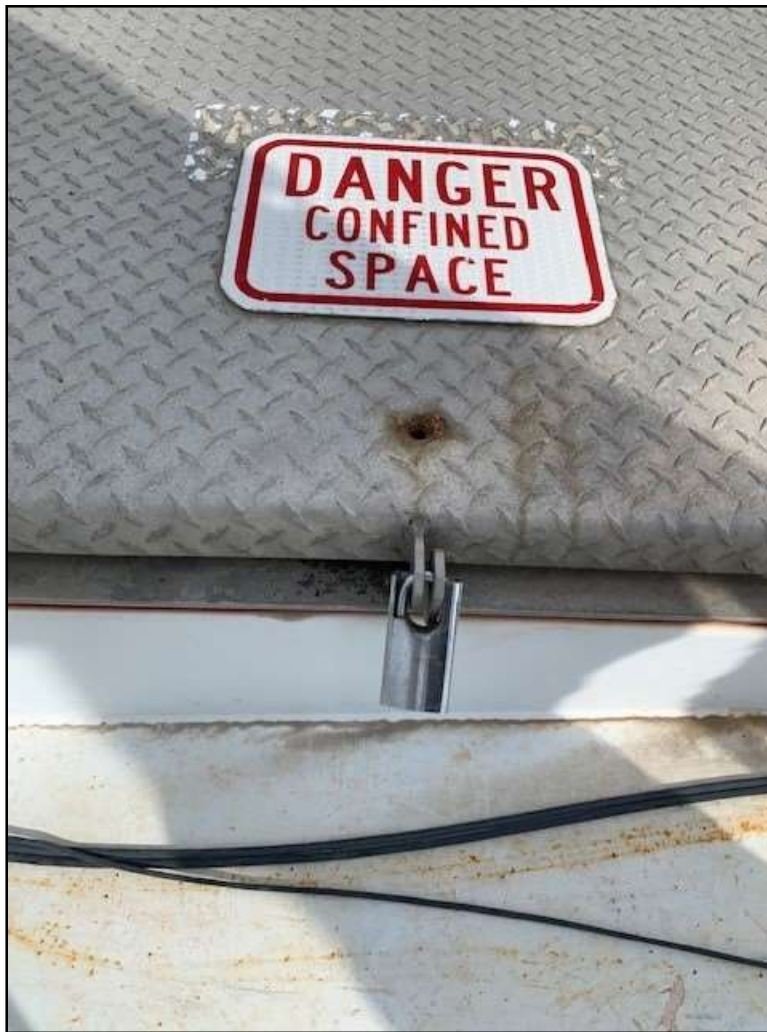
Attributes	
Title	Wagon Wheel CET
Inspection Item	Roof Hatch Manway
Condition	Fair-Element performs intended function with small reduction of reliability
Notes/Dimensions	Localized corrosion present where galvanized coating has failed.
Inspector	JAS, TWB, PJG

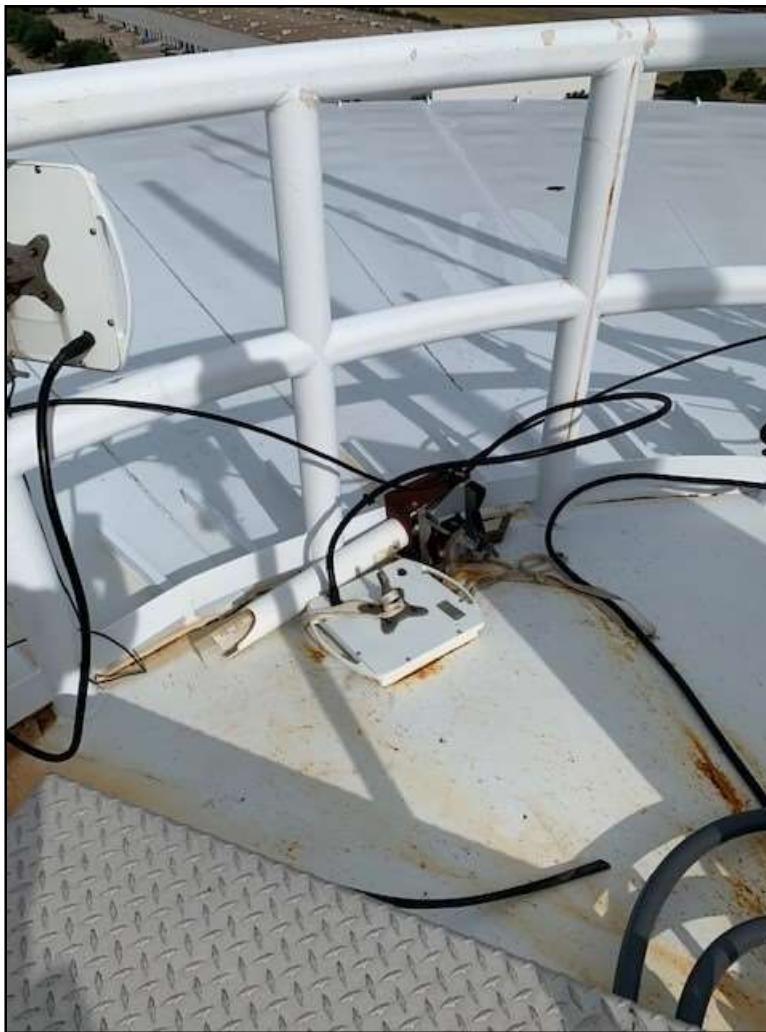
Attributes	
Title	Wagon Wheel CET
Inspection Item	Roof Communication Equipment
Condition	Poor-Element performs intended function with a significant reduction of reliability
Notes/Dimensions	Site equipment in need of repair.
Inspector	JAS, TWB, PJG
