Re: Pre-rehabilitation inspection and evaluation for the 2-million-gallon Wagon Wheel elevated storage tank located in Coppell, TX.

**Field Inspection Report**  
**Dunham Engineering, Inc. TX F-22537**  
**(979) 690-6555**

Tank ID: Wagon Wheel CET  
Owner: City of Coppell  
Inspector: Joe Seiter, Trey Biddy  
and Peyton Gorman  
Date of Inspection: (08/13/2021)  
Tank Description: 2 Million Gallon CET

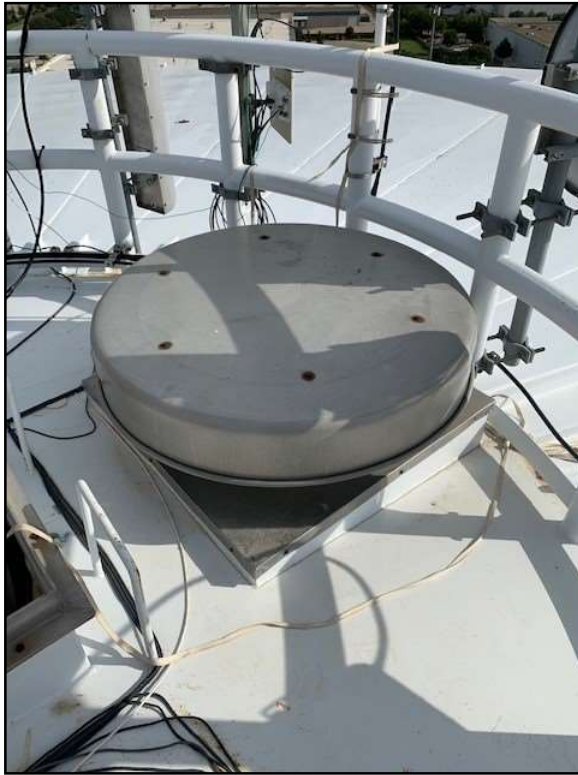
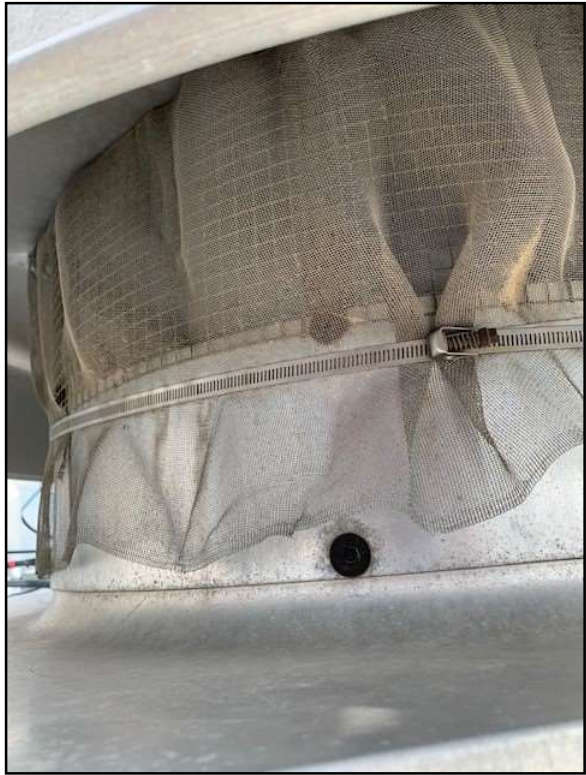
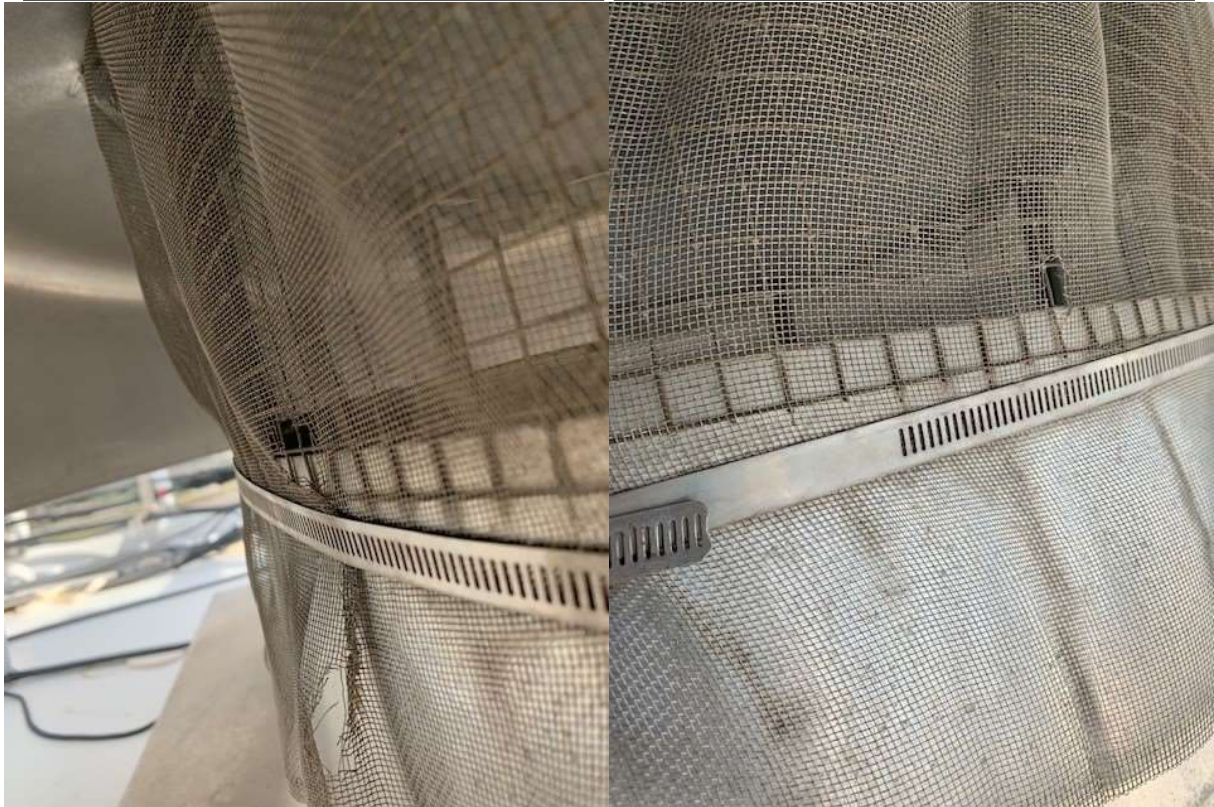
- Cathodic control box is present, and it is unknown if it is operational.
- Roof vent is in poor condition with screen in place. Screen exhibits tears. Localized corrosion present at fasteners.

Attributes	
Title	Wagon Wheel CET
Inspection Item	Air Vent
Condition	Poor-Element performs intended function with a significant reduction of reliability
Notes/Dimensions	Screen exhibits tears. Localized corrosion present at fasteners.
Inspector	JAS, TWB, PJG

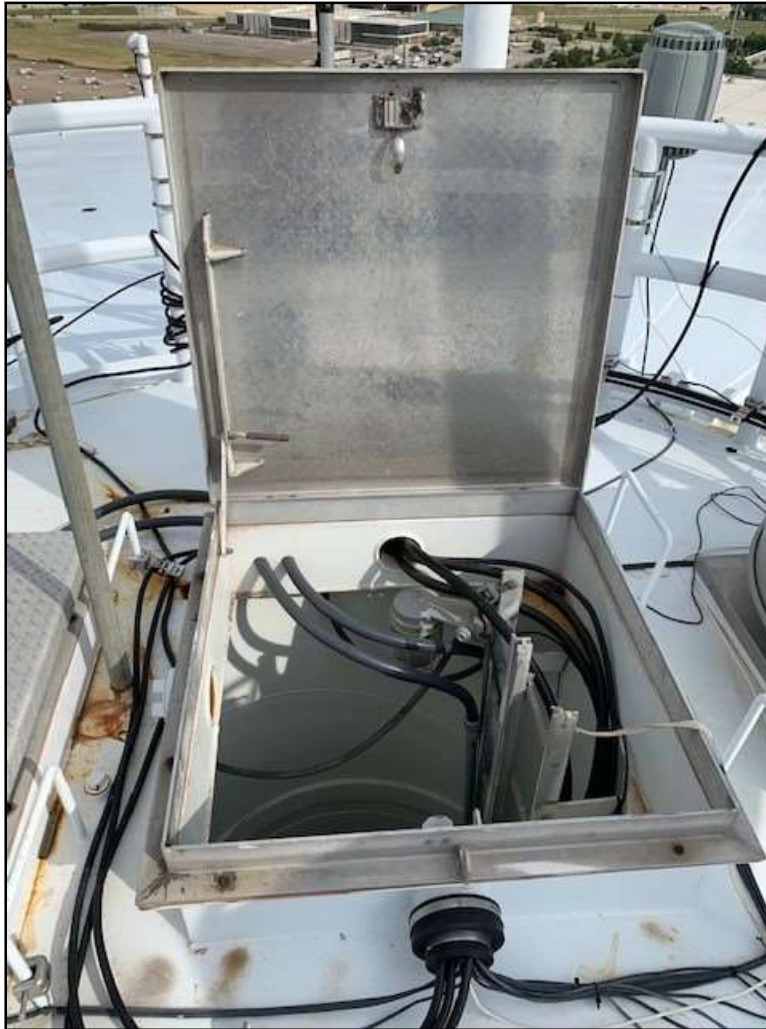
Attributes	
Title	Wagon Wheel CET
Inspection Item	Dry Riser Roof Hatch
Condition	Fair-Element performs intended function with small reduction of reliability
Notes/Dimensions	Hatch has localized corrosion at fasters. Hatch can be secured with lock.
Inspector	JAS, TWB, PJG

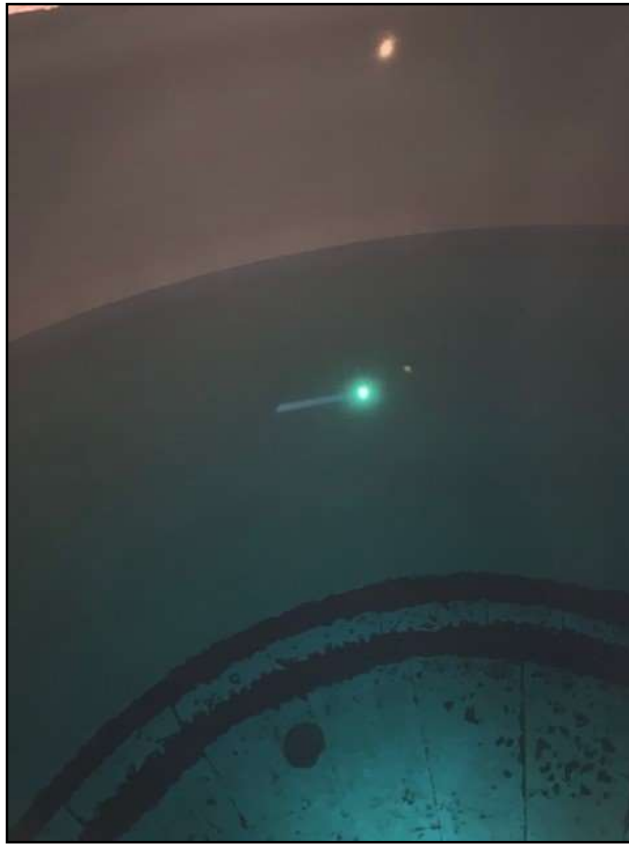
- Interior coating has localized corrosion present. DFT average reading of 12.304.
- Overall rating of the tank is fair to poor condition. Rating is result of conditions noted in report.

Attributes	
Title	Wagon Wheel CET
Inspection Item	Interior Coating
Condition	Fair-Element performs intended function with small reduction of reliability
Notes/Dimensions	Corrosion is present. Sediment is present.
Inspector	JAS, TWB, PJG

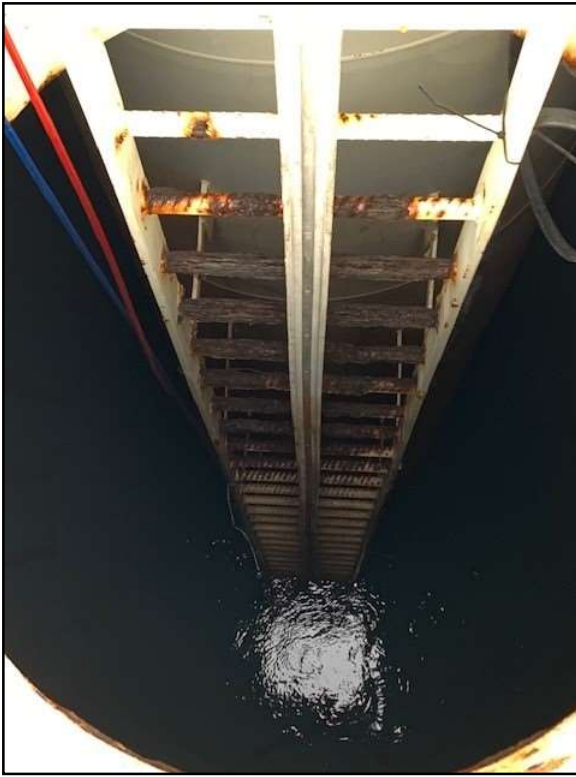
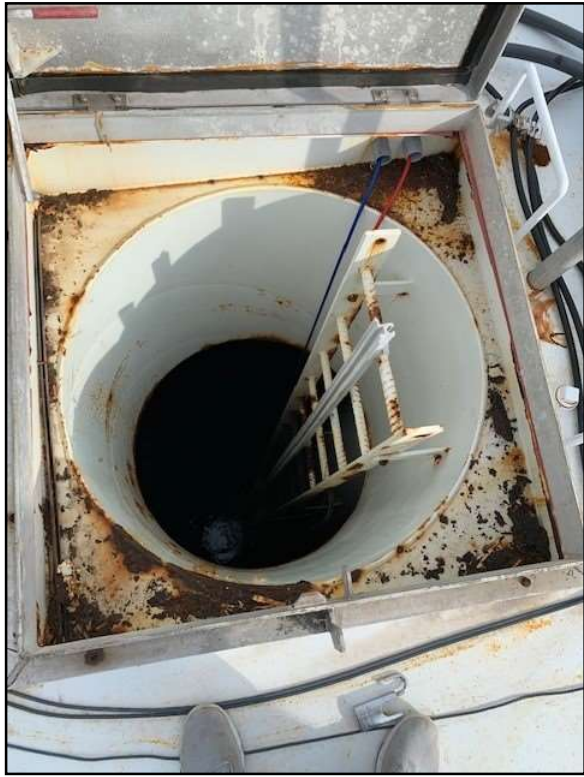
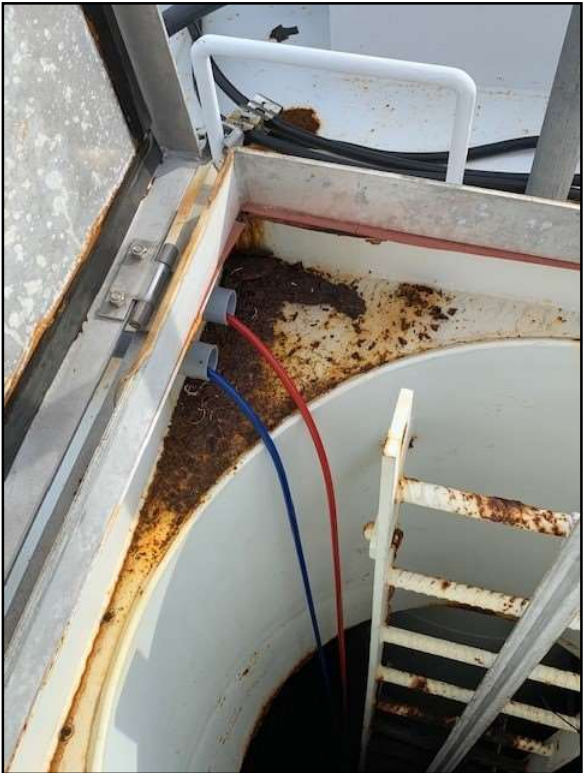
- Inlet/outlet piping is in good condition. Sample port and pressure gauge are present and appear functional.
- Dry access ladders are in good condition and equipped with safety climb devices. Wet access ladder is in poor condition with localized corrosion present. Several rungs are unsafe.

Attributes	
Title	Wagon Wheel CET
Inspection Item	Interior Coating- Ladder
Condition	Poor-Element performs intended function with a significant reduction of reliability
Notes/Dimensions	Localized corrosion on interior ladder. Ladder is equipped with safety climb device.
Inspector	JAS, TWB, PJG

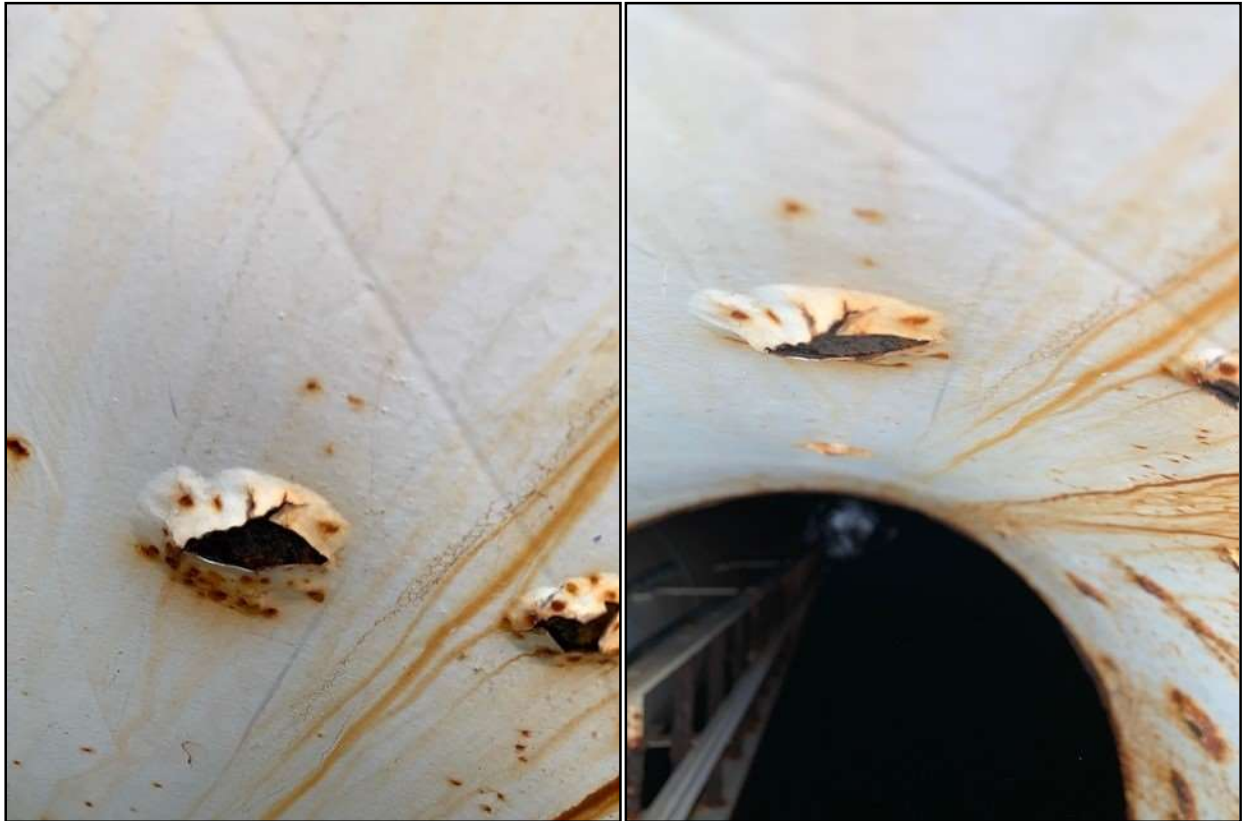
Attributes	
Title	Wagon Wheel CET
Inspection Item	Wet Riser Pipe
Condition	Poor-Element performs intended function with a significant reduction of reliability
Notes/Dimensions	Localized corrosion is present.
Inspector	JAS, TWB, PJG
