Lakeside at Coppell Clubhouse Renovation Exterior Views - Existing Conditions

Coppell, Texas

LAKESIDE AT COPELL CLUBHOUSE RENOVATION

SITE PLAN

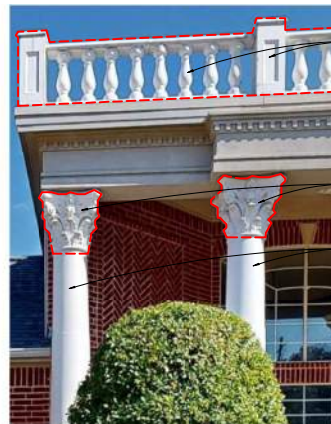
DEMOLITION REFERENCE IMAGE

REMOVE EXISTING BALUSTERS AND POSTS. REPAIR ROOF AS NEEDED FOR NEW CONDITION.

REMOVE EXISTING CAPITALS FROM COLUMNS TO MATCH COLUMN WITH.

EXISTING COLUMN SHAFT TO REMAIN AS IS

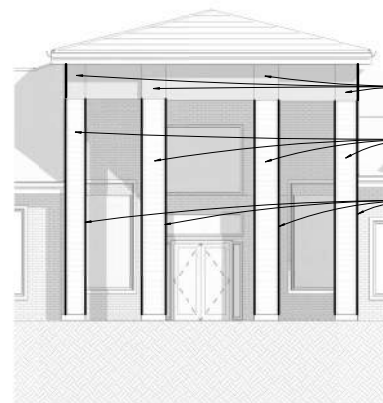
② EXTERIOR ELEVATION - WEST (PARTIAL AT ENTRY)
1/4" = 1'-0"

EXISTING CORNICE TO REMAIN

EXISTING ROUND COLUMNS TO REMAIN WITH CAPITALS. REMOVED NEW CLADDING AS DESCRIBED BELOW.

NEW SQUARED DECORATIVE CLADDING OVER EXISTING STRUCTURAL COLUMNS. GC TO PROVIDE WRAP ENVELOPE WITH 3/4" WOOD CEMENT FIBER AND GROOVE TECHNIQUE. SMOOTH FINISH. CLEAR STAIN AND SEAL. STAINED WOOD SAMPLE TO BE SENT TO IRT DESIGN GROUP FOR APPROVAL PRIOR TO INSTALLING.
