# **Traffic Signal Warrant Analysis**

# For the Intersection of Sandy Lake Road and Winding Hollow Lane Coppell, Texas

Prepared for:
The City of Coppell
Engineering & Public Works
265 E. Parkway Boulevard
Coppell, Texas 75019

September 2018

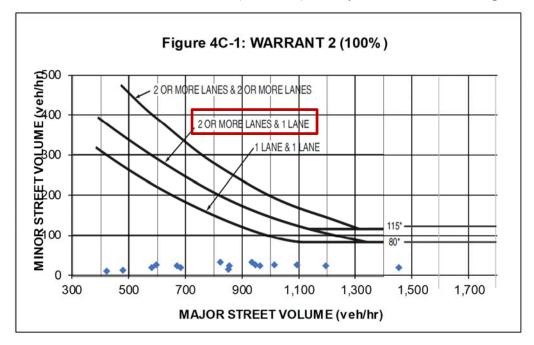
Figure 2: Four-Hour Vehicular Volume Warrant (Warrant 2) – Sandy Lake Road and Winding Hollow Lane

Warrant 2 is satisfied when the volumes for any four (4) hours of an average day, when plotted on Figure 4C-1 (or 4C-2 when applicable) of the *Texas MUTCD*, fall above the curve for the appropriate number of lanes. Based on the posted speed limit on Sandy Lake Road (40 mph) and the population of the City of Coppell (41,100), the reduced warrant threshold was not used for this warrant and Figure 4C-1 was used for this analysis. **Figure 2** shows the results of this analysis.

Based on the traffic volumes presented in Table 2 and plotted in Figure 2, no hours of the day fall above the curve for the appropriate number of lanes when plotted on Figure 4C-1 of the *Texas MUTCD* for this intersection. Four (4) hours are required for this warrant condition. Under these circumstances, **Warrant 2 is NOT MET for this intersection**.

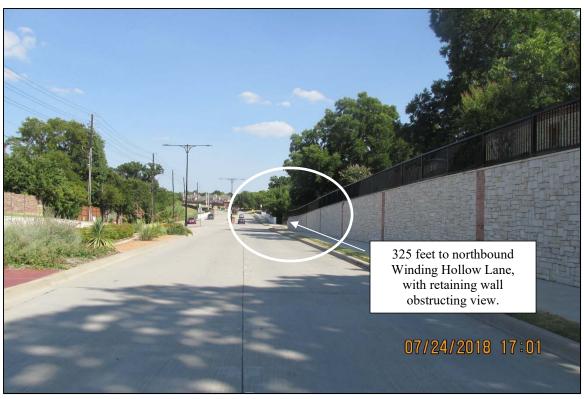
Figure 3: Sight Distance to the Left on Northbound Winding Hollow Lane at Sandy Lake Road

Sight distance obstructed by retaining wall.

As shown in Table 4 and based on a comparison of the field investigation results of the available sight distance to the required sight distance, intersection sight distance for the minor street is less than required. On the northbound approach of Winding Hollow Lane sight distance to the left is obstructed by the retaining wall on the southwest corner of the intersection, as shown in **Figure 3** and **Figure 4**. Sight distance to the right is less than required due to vegetation in the median on Sandy Lake Road, as shown in **Figure 5** and **Figure 6**. On the southbound approach of Winding Hollow Lane sight distance to the left is obstructed by the bridge and horizontal curvature to the east on Sandy Lake Road, as shown in **Figure 7** and **Figure 8**. For reference, the sight distance to the right on the southbound approach of Winding Hollow Lane is shown in **Figure 9**.

In order to improve intersection sight distance, it is recommended to remove or trim the trees and bushes in the median along Sandy Lake Road. The City could consider installing 'Intersection Ahead' signs on the eastbound and westbound approaches of Sandy Lake Road. Flashing beacons could be added for additional emphasis.

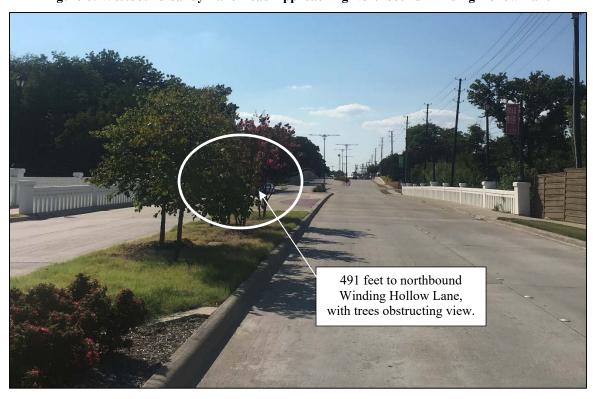
Figure 5: Sight Distance to the Right on Northbound Winding Hollow Lane at Sandy Lake Road

Sight distance obstructed by trees in median.

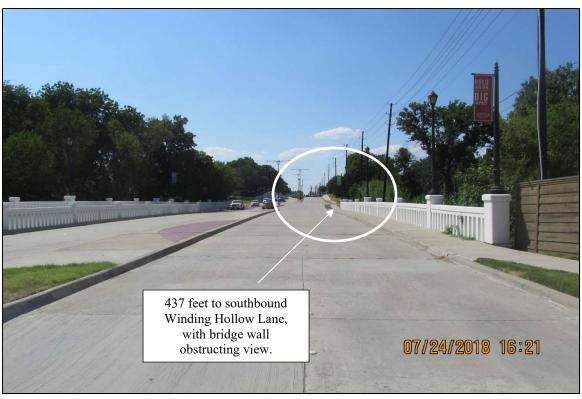
Figure 9: Sight Distance to the Right on Southbound Winding Hollow Lane at Sandy Lake Road

Sight distance requirement just met due to vertical curve on Sandy Lake Road. Vehicles briefly obstructed by bushes at 337 feet and 454 feet.

<sup>&</sup>lt;sup>1</sup> Sight distance temporarily obstructed by plants in median when vehicle is 337 feet away and 454 feet away. Sight distance does not appear to exceed 525 feet due to the vertical curve on Sandy Lake Road.
