## North Lake Raw Water System Evaluation

February 2018

### PRELIMINARY SUBMITTAL

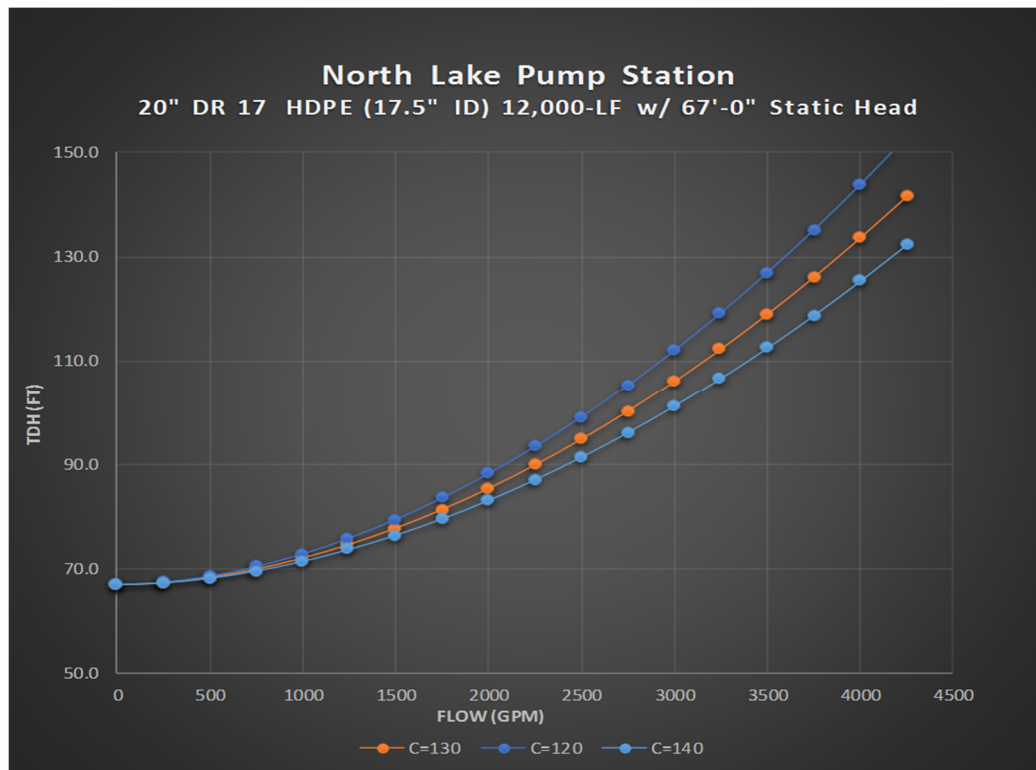
Figure 6.1: Flow vs Total Dynamic Head

These factors combine to arrive at a design duty point of 119.0-ft TDH at 3,475-gpm for the mid-range of expected pipe roughness coefficients:  $C=130$ . The head could range between 112-ft and 127-ft depending on pipe roughness. See Figure 6.1.

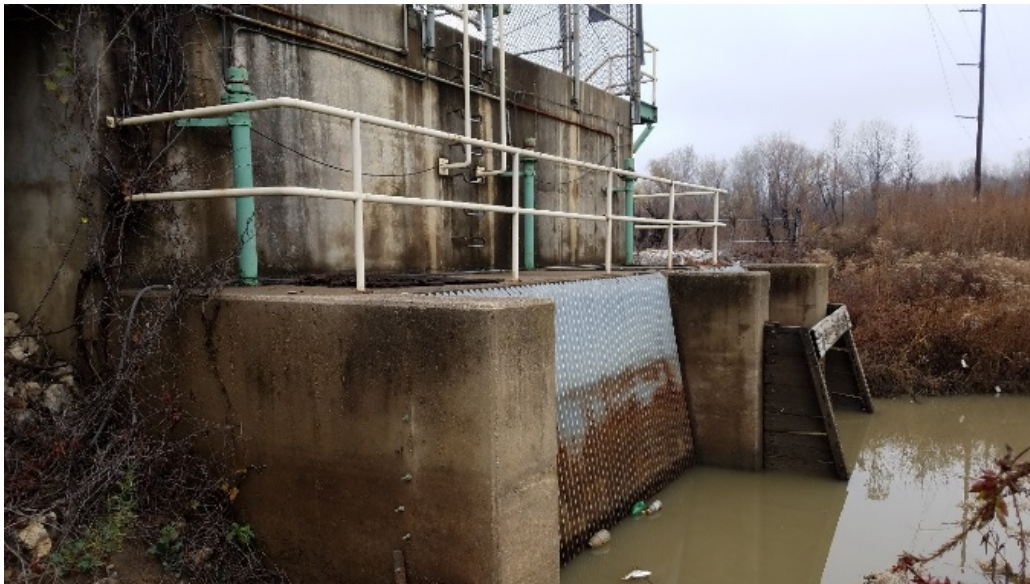
**Figure 7.1: Pump Station Intake Looking North**

It appears that the pumps in the two southernmost bays were installed as part of the original construction with a single 14’-0” wide bar screen protecting both bays. See Figure 7.1. The only construction plans available (DP&L Plan Sheet G-147465. See Appendix 3) seem to show the northern pump bay as an “open cell”. Structural telltale signs observed during our site visit and the odd wooden “fore-structure” on the river side of the northern bar screen seem to indicate that the third (northern) pump was installed at some point later in the life of this pump station. The water level in the intake is controlled by the uncontrolled spillway at the Carrollton Dam some 300-LF downstream of the intake.

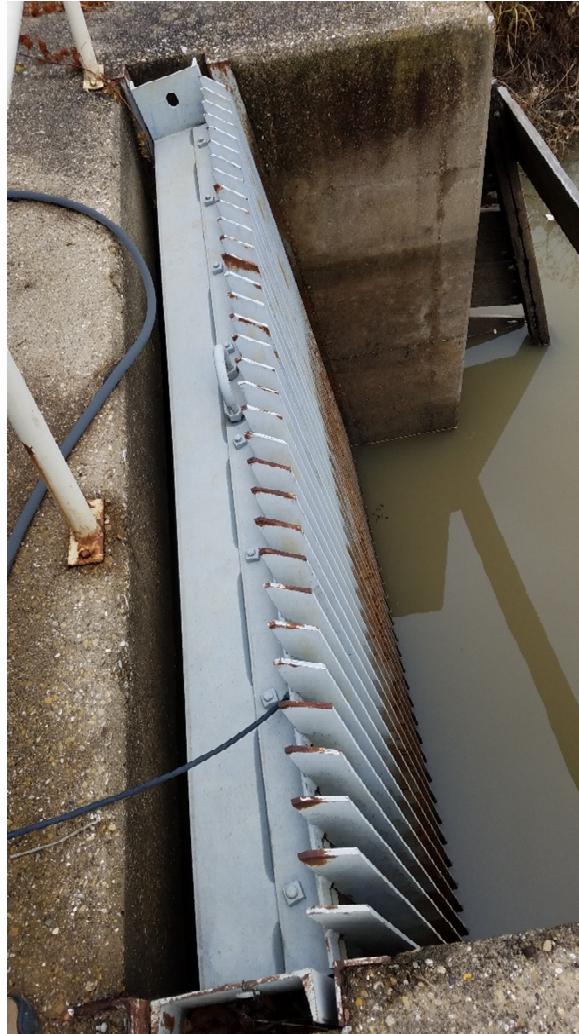
**Figure 7.2: No. 3 Pump Bar Screen**

The bar screens appear to be fabricated from 3/8-inch by 2-inch bar stock on 2-inch spacings. See Figure 7.2. The portion of the screens that are visible from the adjoining bank appear to be showing a fair amount of rust as would be expected for a structure of this age. The steel appears to be in generally good condition above the waterline. Removing and repairing or re-fabricating the rust-damaged sections of the screens should be considered while other heavy restoration work is ongoing at the pump station and heavy lift equipment is mobilized.

KHA staff performed sounding of the sediment accumulation immediately behind (pump station side) the bar screens. We used a 1/2-inch stainless steel rod to sound the level of mud and silt relative to the top of the

working platform (assumed elevation of 442). Moving from north to south (north edge of the northern pump bay to the southern edge of the north pump bay to the middle of the southern pump bay), the sediment sounded 8'-4", 9'-2," and 12'-3" below the working platform. If the bottom of the pump bays is at elevation 426.0 as shown on the DP&L drawing, this translates to between 7'-8" and 3'-9" of sediment (at least at the points sounded). This may translate to roughly 100-200-CY of accumulated sediment. The bays and channel leading up to the intake structure should be dredged to return the pump station to its former intake capacity and avoid damage to the pump impellers and other equipment.

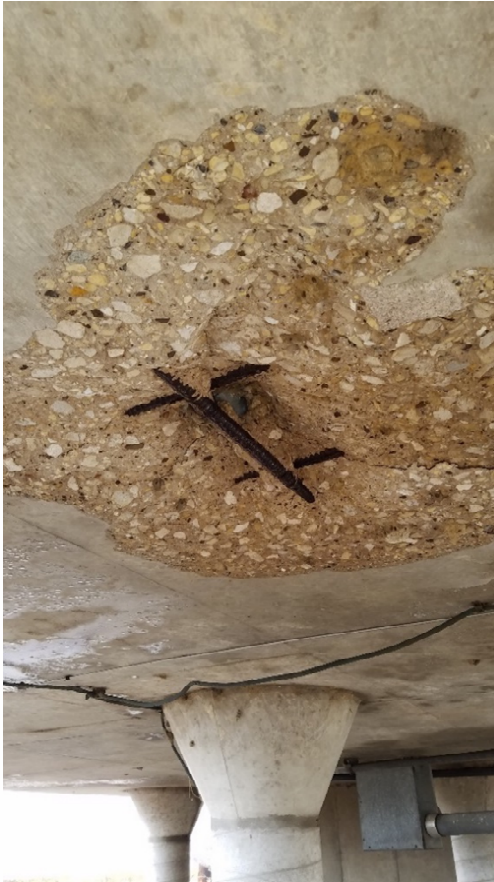
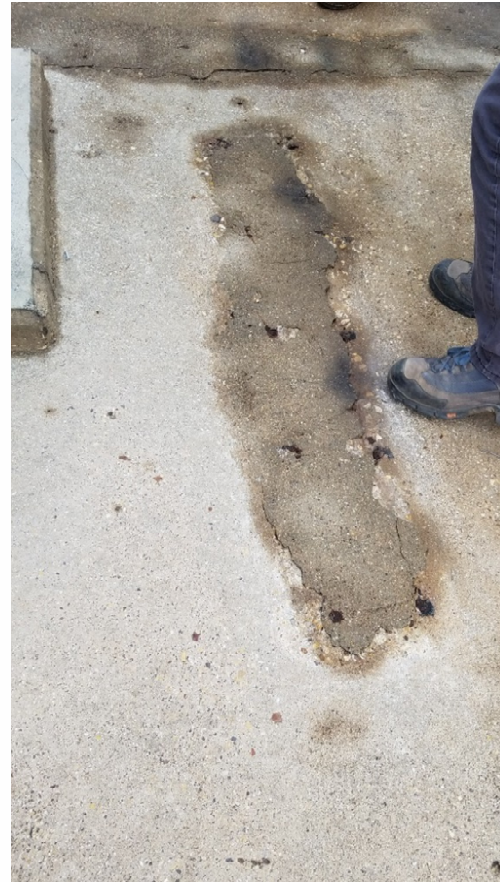
**Figure 7.3: (a) Major spall below transformer and (b) Typical concrete repair on pump deck**

As noted on the previous page, it appears that the pump station has been substantially expanded or rehabilitated in the past. A number of old floor penetrations have been removed and patched. The pad under the existing electrical transformer does not appear to be original to the pump station. There is a major spall

on the bottom of the structural platform supporting the transformer near the mid-span of the concrete deck between the four adjoining columns. See Figures 7.3a and 7.3b. It is unknown if the new transformer pad was added as a corrective structural feature to redistribute the mass of the transformer between the piers and reduce the moment load between them.

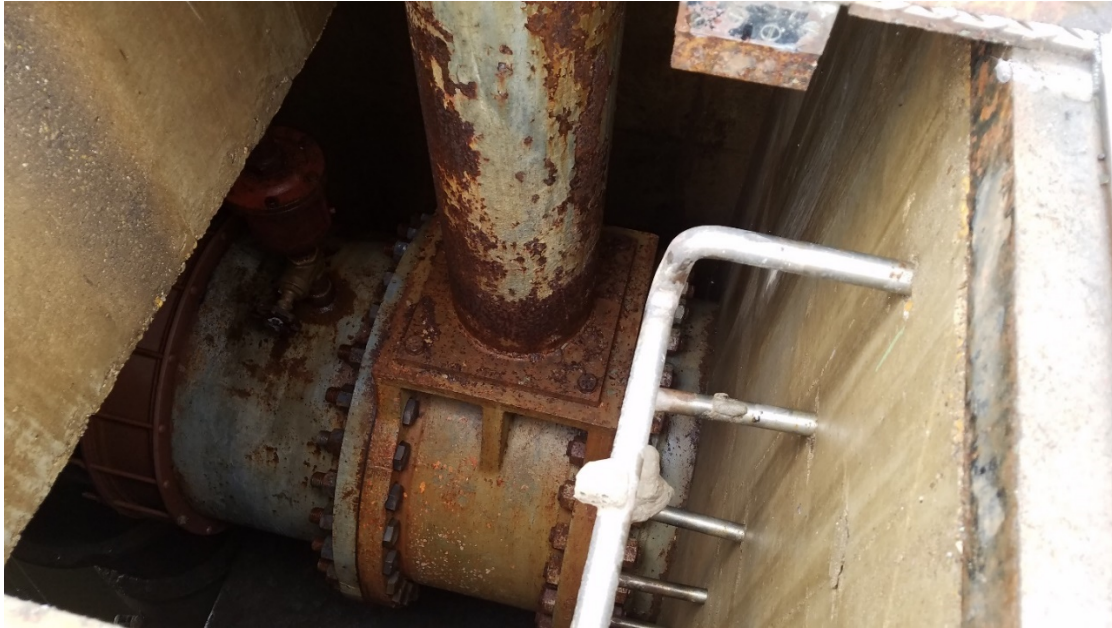
Figure 7.4: Discharge Arrangement Pump No. 2 (Facing South)

The pump discharge heads and isolation butterfly valves are located in the pump bays below the pump operating deck. The pumps discharge through the back (west) wall of each pump bay. Pump motors and valve operators are attached to the pump operating deck. The age of the equipment and appurtenances appears to vary from unit to unit. For instance, the body of the valve operator and the spool piece on the No. 2 pump discharge shows considerable amounts of corrosion, whereas the flexible coupling adapter joining the spool to the discharge head appears to be relatively new. See Figure 7.4. Likewise, pump No. 3 appears to be of a newer make than the other two. See Figure 7.5.

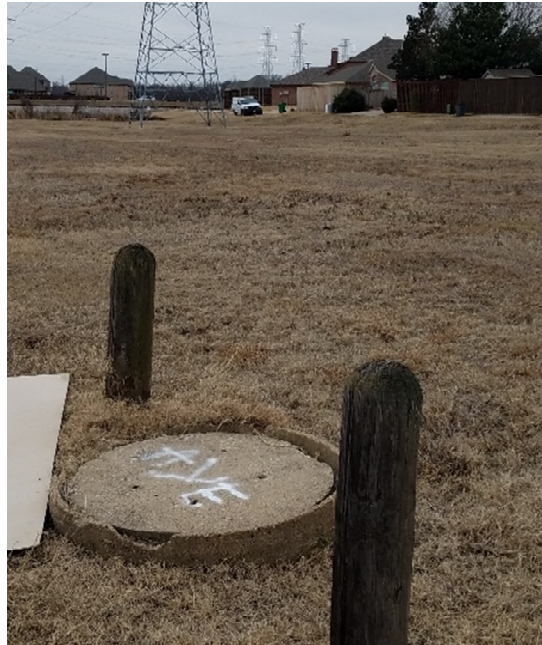
Figure 7.7: Typical ARV Pit Facing Southwest at 500-LF North of Railroad

Limited field investigations (walks) revealed what appear to be air release valve pits generally in the vicinity of where they are indicated on DP&L Plan Sheet G-147465. See Exhibit 5 in Appendix 1. The apparent construction of these facilities appears to conform in general with the details appearing on the DP&L Plan sheet. They appear to be approximately 36-inch round cast concrete covers set in what appears to be the bell of a 36-inch concrete pipe segment. Most are “marked” with a wooden fence post or bollard. See Figure 7.7. The manhole closest to and north of the railroad crossing is a larger structure, but of similar design, as shown in Figure 7.8.

The existing air release valves should be located, inspected and replaced, if necessary. This would also afford the opportunity to remove the 10-inch flanges at those locations and possibly allow for limited internal inspection by CCTV. This would require draining the pipe.

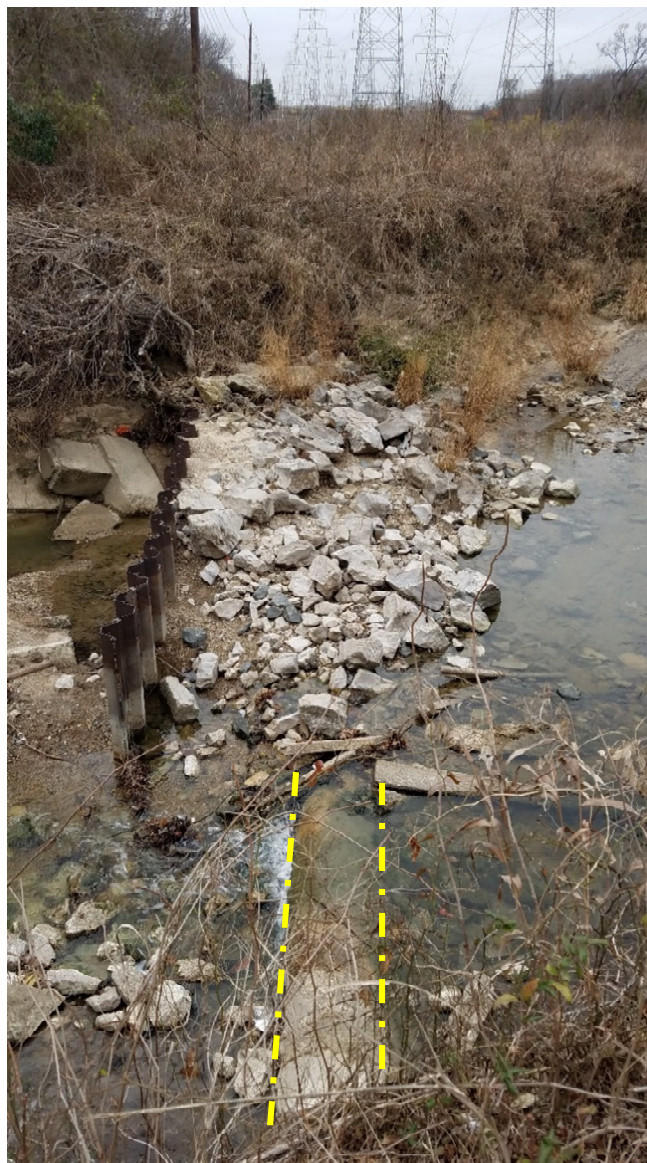
Figure 7.9: Exposed Pipe at Grapevine Creek Crossing Facing West

The pipe is exposed at the Grapevine Creek crossing/grade control structure as seen in Figure 7.9 below. The crossing is located at the southern (downstream) edge of the power corridor where the creek exists the corridor. The driven pile grade control structure installed as part of the pipeline appears to have been flanked on the east side by the creek. Some 12-ft to 15-ft of pipe are exposed where the creek has washed away its backfill, but appears to be intact.

**Grapevine Creek Crossing:** As noted elsewhere, the crossing of Grapevine Creek has been compromised and some form of channel stabilization will be required. Grapevine Creek forms the boundary between Coppell and the City of Irving. The west side of the crossing would be completed in the City of Irving. Because this section is within the power transmission corridor, land ownership is not believed to be a significant issue. However, design, construction, and maintenance of channel stabilization structures would need to be coordinated if not approved by the City of Irving.

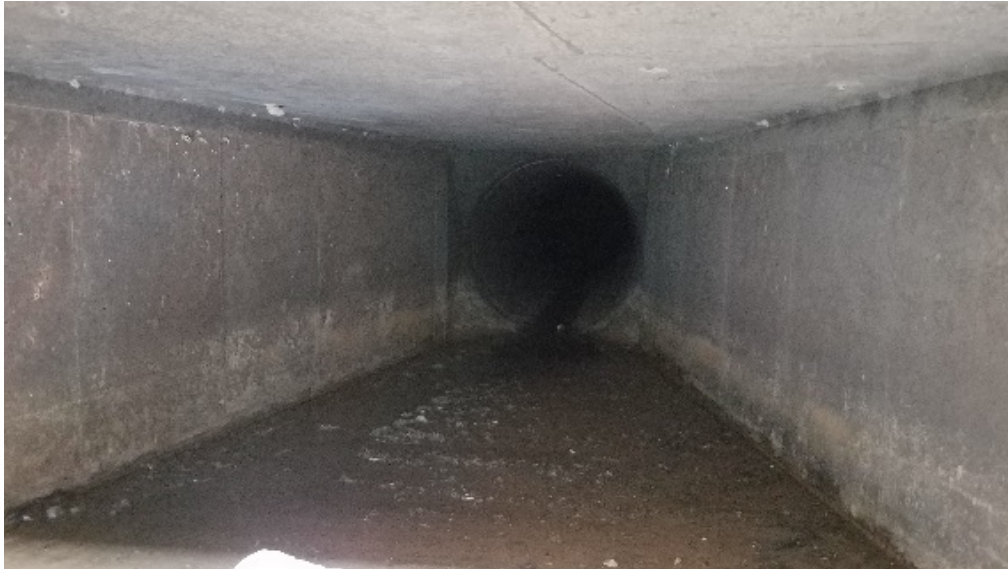
Figure 7.10: Trapezoidal Flume-Like Structure at Outfall Structure

The existing outfall structure is located near the left abutment of the dam. See Exhibit 6 in Appendix 1. The structure was designed to provide a flooded pipe discharge in a stilling basin that overflowed a weir wall that appears to have been set near the original lake's operating surface, approximate elevation 510-ft-msl. We infer that the outfall was designed this way to prevent draining the lake in the event of a pump station or control valve failure. The 42-inch raw water pipeline enters the structure via a normally submerged, trapezoidal flume-like structure. See Figure 7.10.

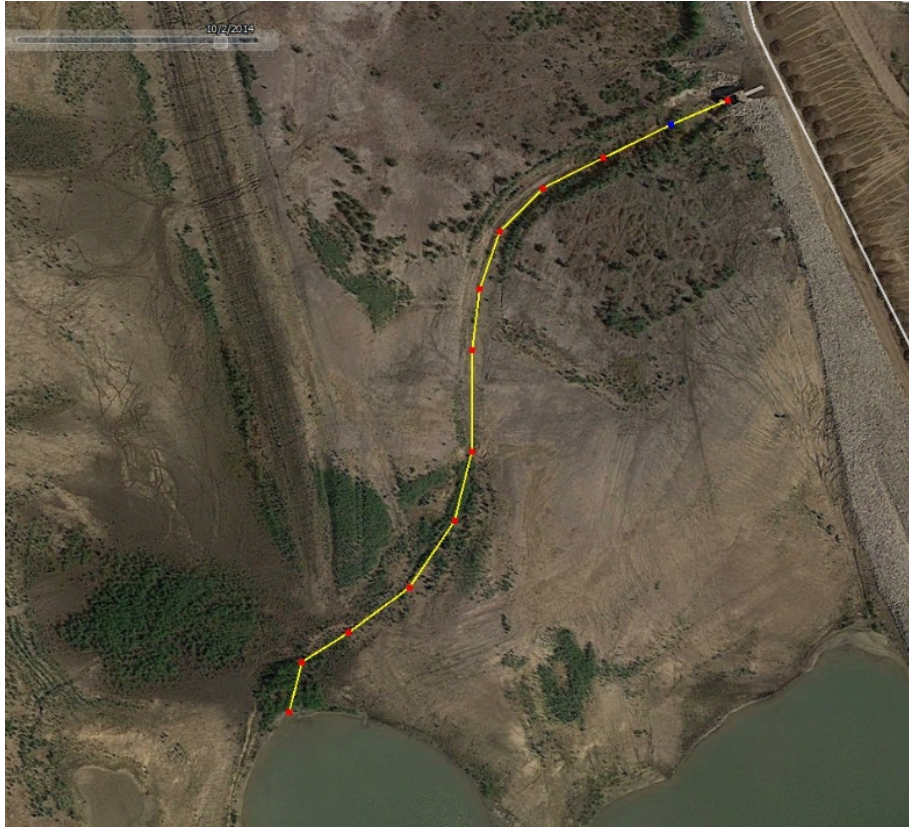
**Figure 7.12: Original Outfall Channel Location**

The existing outlet structure was effectively "stranded" by the lowering of the lake and consequential lateral movement of the "shoreline". Review of aerial photography during construction of the spillway improvements in 2014 shows that the "outfall" channel is now nearly 850-LF long from the original outfall structure to the apparent lake edge. See Figure 7.12.

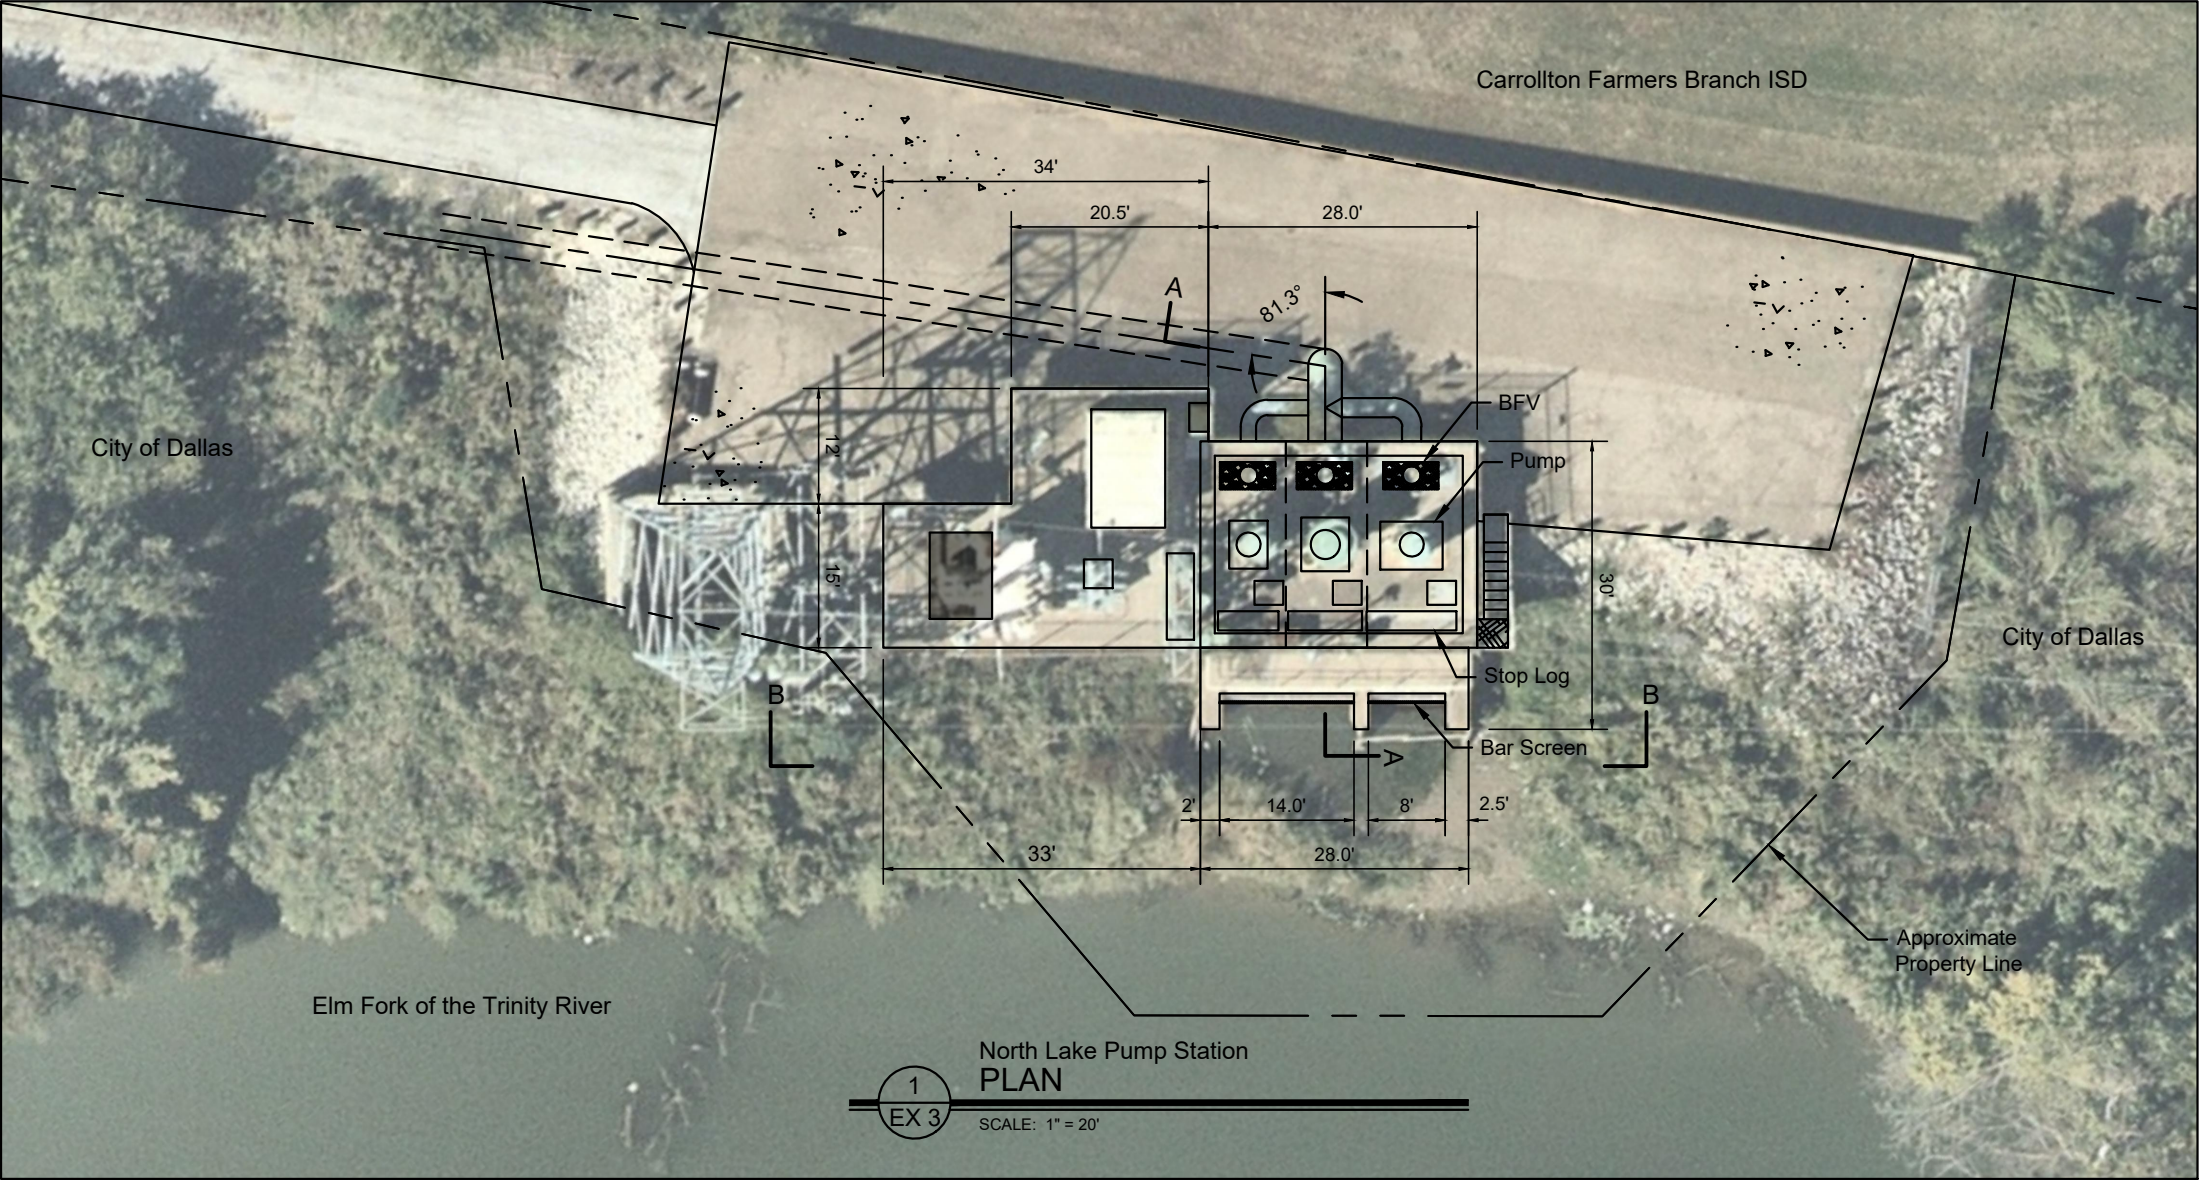
The information shown on this drawing is replicated from available record information and recent aerial; it is intended to indicate the configuration of the pump station and is not guaranteed to be accurate nor all inclusive.

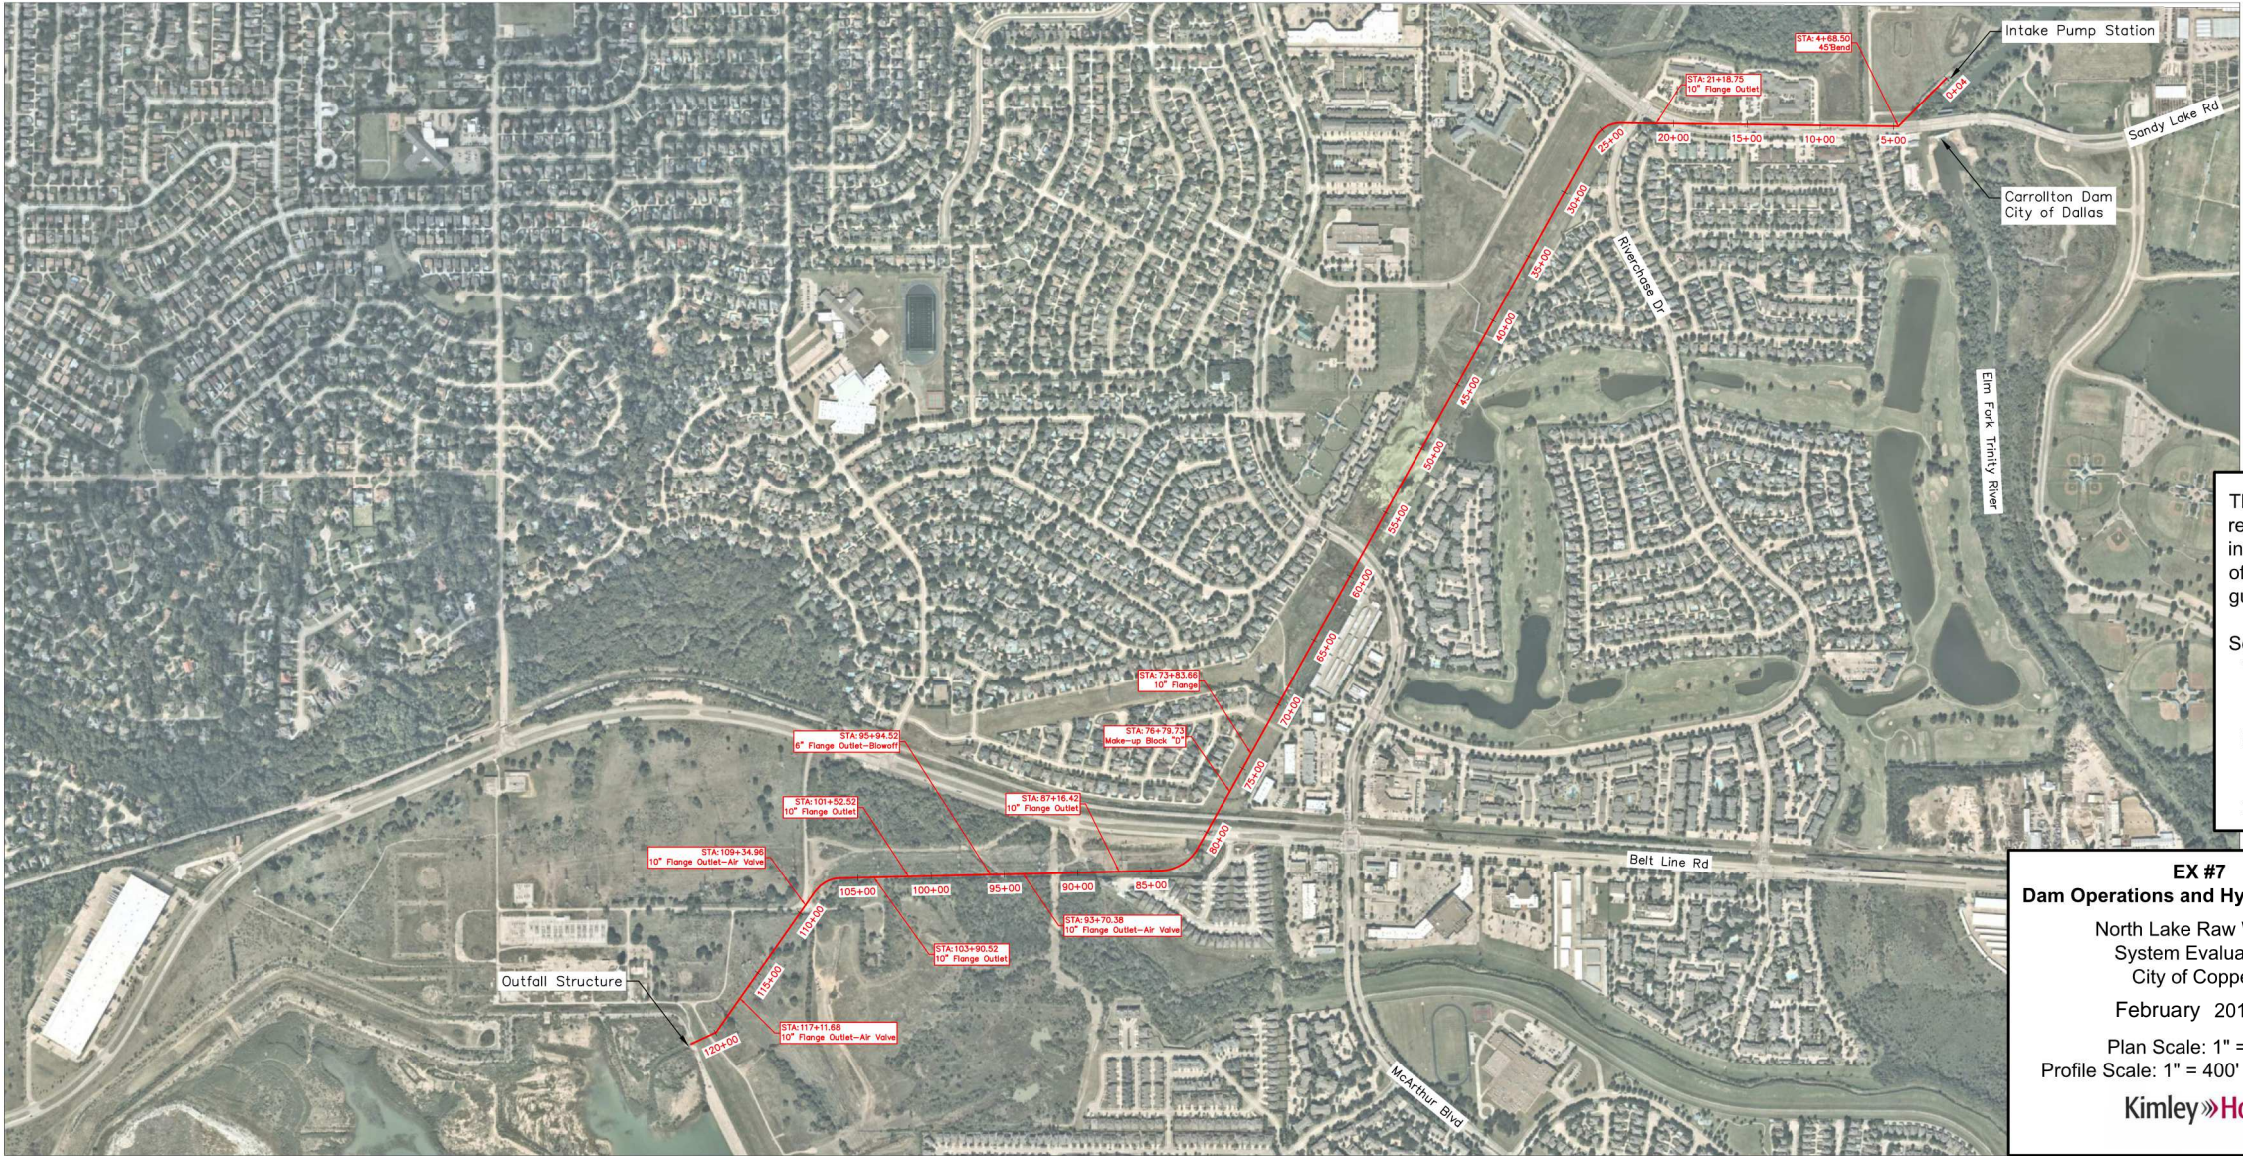
The information shown on this drawing is replicated from available record information; it is intended to indicate the approximate alignment of the existing 42" waterline and is not guaranteed to be accurate nor all inclusive.

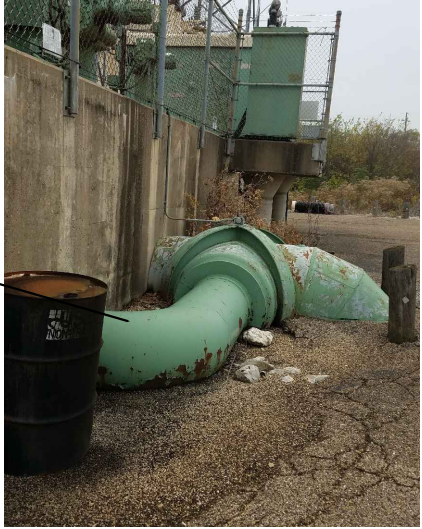
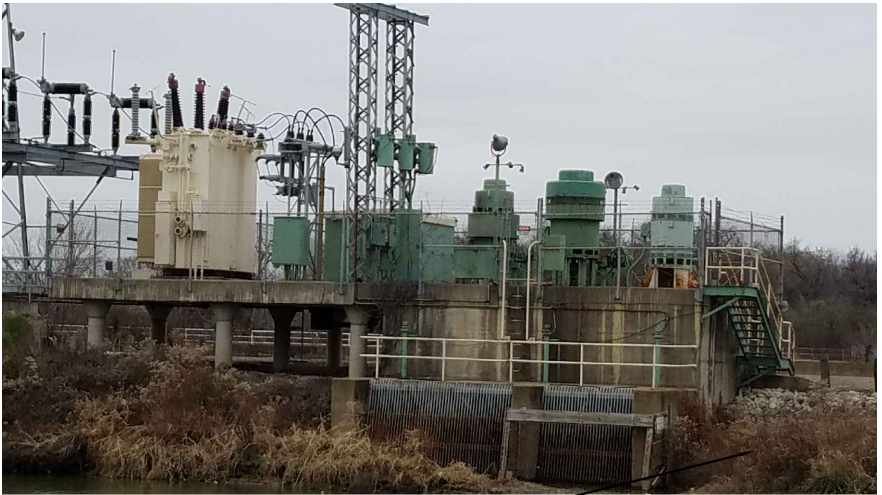
The information shown on this drawing is replicated from available record information and recent aerial; it is intended to indicate the configuration of the pump station and is not guaranteed to be accurate nor all inclusive.
