Re: Pre-rehabilitation inspection and evaluation for the 2-million-gallon Wagon Wheel elevated storage tank located in Coppell, TX.

**Field Inspection Report**  
**Dunham Engineering, Inc. TX F-22537**  
**(979) 690-6555**

Tank ID: Wagon Wheel CET  
Owner: City of Coppell  
Inspector: Joe Seiter, Trey Biddy  
and Peyton Gorman  
Date of Inspection: (08/13/2021)  
Tank Description: 2 Million Gallon CET

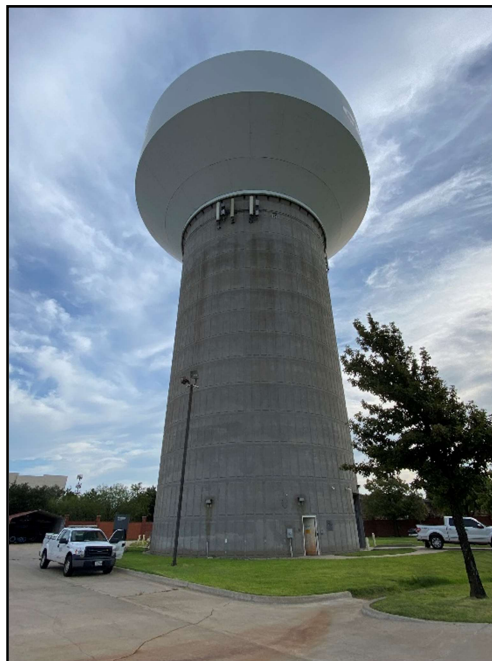
Attributes	
Title	Wagon Wheel CET
Inspection Item	Overview
Condition	Overall fair to poor condition.
Notes/Dimensions	<p>Wagon Wheel 2-million-gallon CET</p> <p>Data plate is present. Built in 1999 by Landmark Structures, Inc.</p> <p>Site fencing is secure with gate lock.</p> <p>Foundation is level. Some minor cracking is present.</p> <p>Building and cable tray to CET are in good condition.</p> <p>Man door has general corrosion over majority of the door. Overhead doors are in good condition, functional and can be secured and locked. Exterior coating of reverse cone of tank is in poor condition due to coating failures. Sidewall and roof exterior coating is in fair condition. Some chalking is present on roof. Localized corrosion is present on the roof. DFT average reading of 10.246 mils was measured.</p> <p>Flap valve is present on overflow pipe discharge. No screen is present on flap valve.</p> <p>Washout under foundation of the overflow pipe discharge is present.</p> <p>Inlet/outlet piping is in good condition. Sample port and pressure gauge are present and appear functional.</p> <p>General corrosion present on bolt heads on flanged connections of inlet/outlet piping.</p> <p>Dry access ladders are in good condition and equipped with safety climb devices.</p> <p>Wet access ladder is in poor condition with localized corrosion present. Several rungs are unsafe.</p> <p>Cathodic control box is present, and it is unknown if it is operational.</p> <p>Roof vent is in poor condition with screen in place.</p> <p>Localized corrosion present at fasteners.</p> <p>Vent screen exhibits tears.</p>

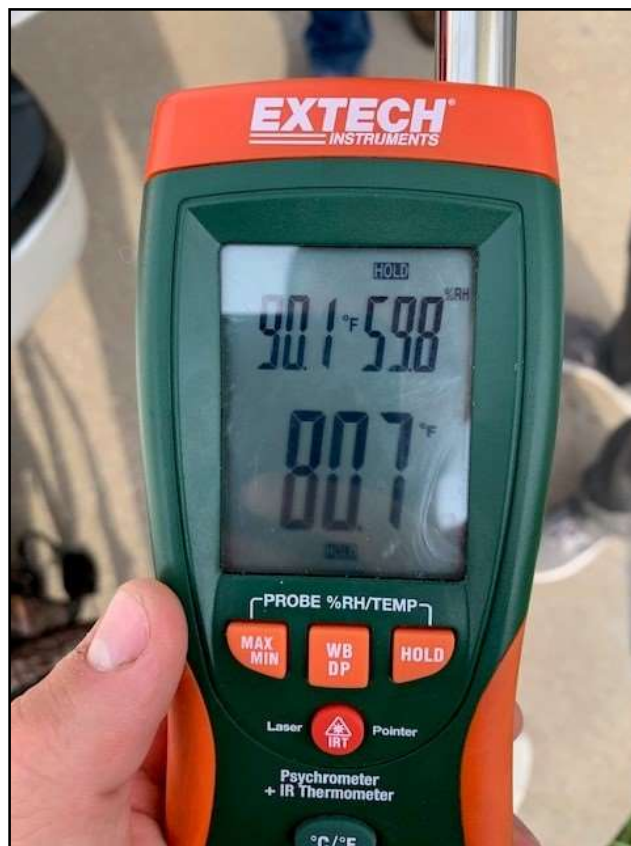
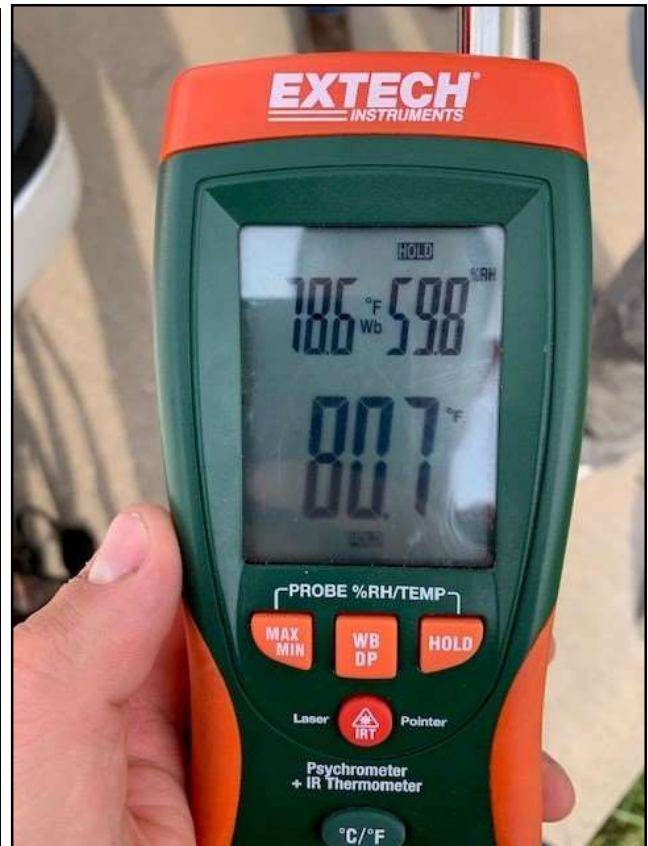
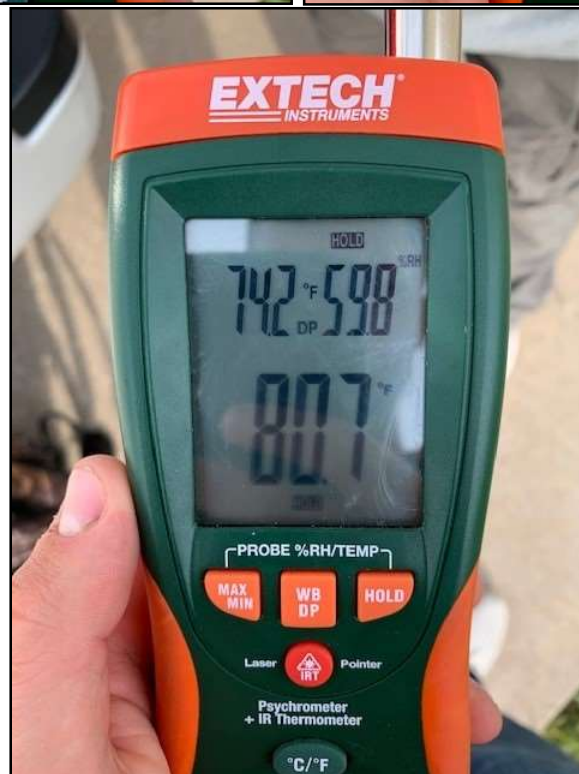
Attributes	
Title	Wagon Wheel CET
Inspection Item	Ambient Conditions
Condition	Good-Element performs intended function with high degree of reliability
Notes/Dimensions	ST= 80.7°F, AT=90.1°F, H=59.8%, DP=74.2°F, WB= 78.6°F
Inspector	JAS, TWB, PJG

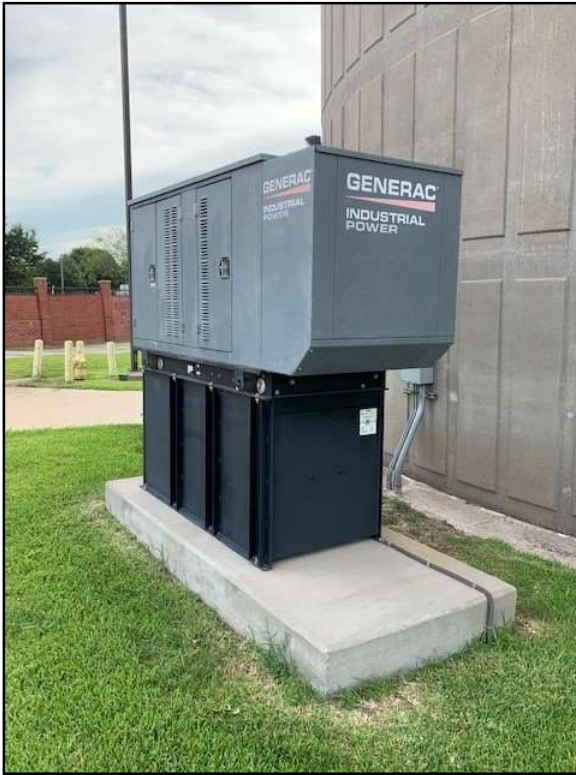
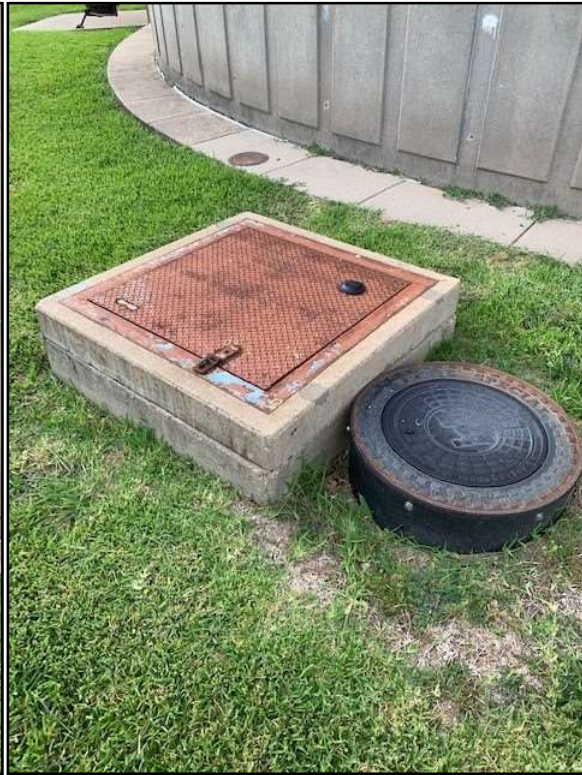
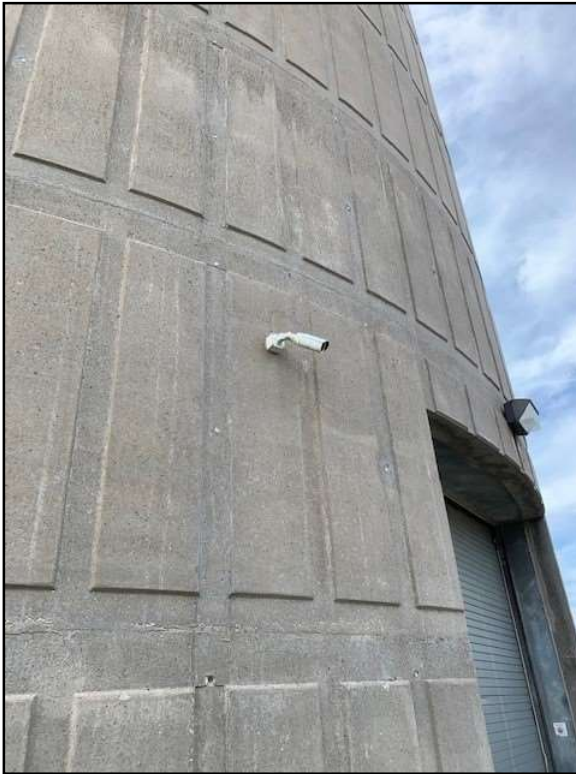
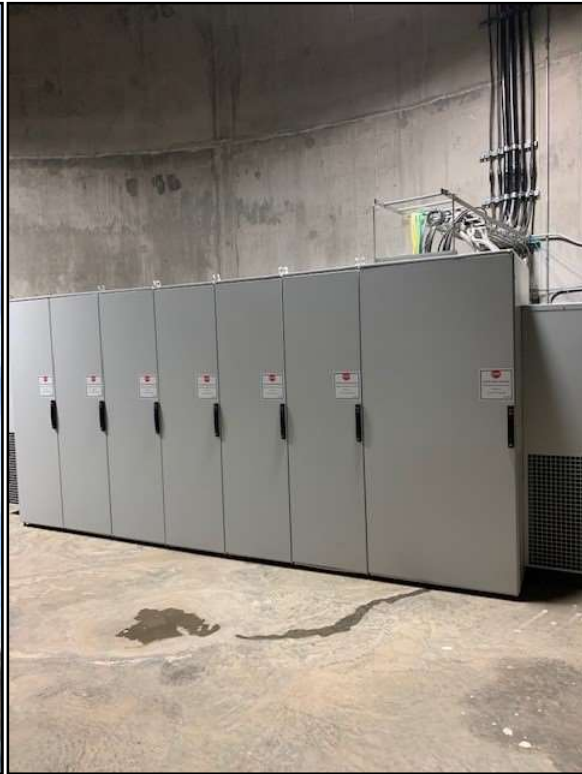
Attributes	
Title	Wagon Wheel CET
Inspection Item	Foundation
Condition	Good-Element performs intended function with high degree of reliability
Notes/Dimensions	Foundation is level and concrete pedestal is plumb. Some minor cracking is present.
Inspector	JAS, TWB, PJG

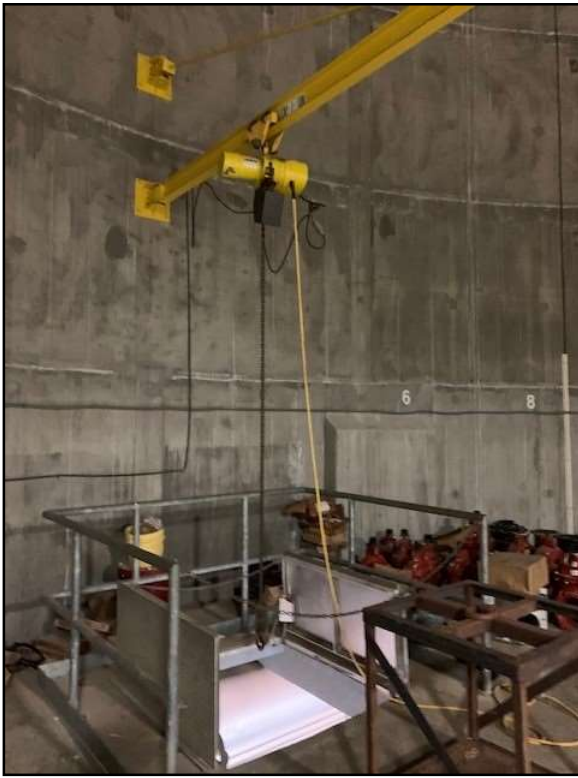
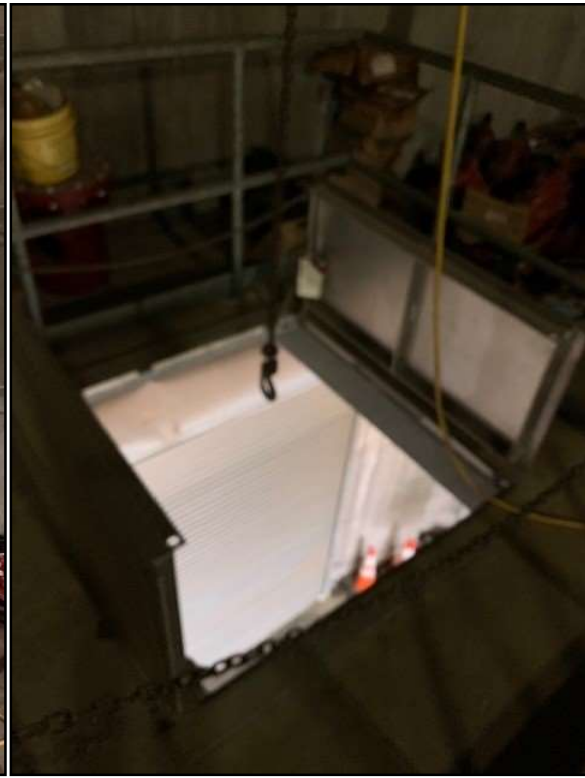
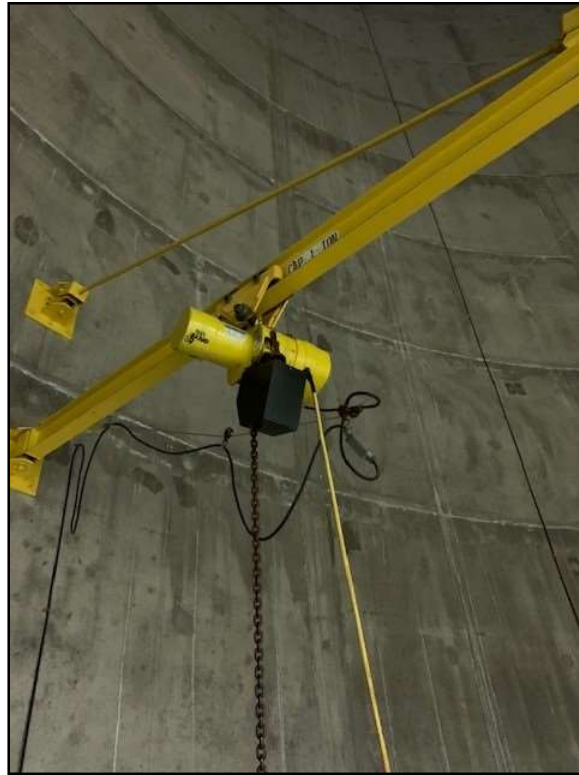
Attributes	
Title	Wagon Wheel CET
Inspection Item	On Site Equipment
Condition	Good-Element performs intended function with high degree of reliability
Notes/Dimensions	Acceptable
Inspector	JAS, TWB, PJG

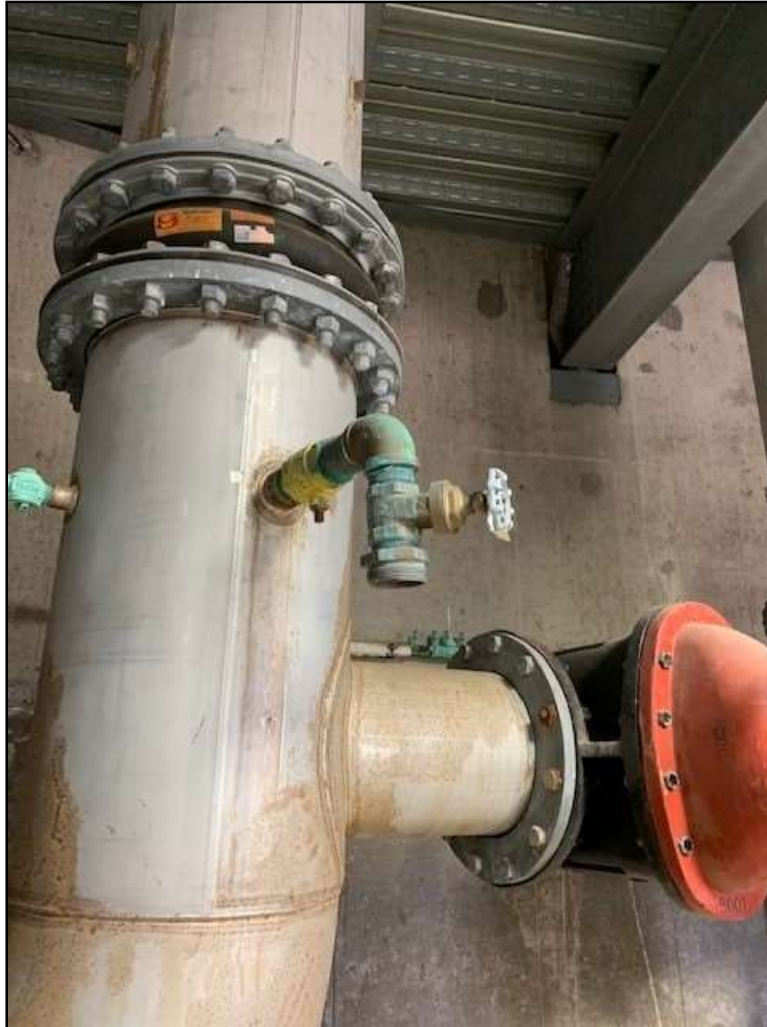
Attributes	
Title	Wagon Wheel CET
Inspection Item	Inlet Outlet Piping
Condition	Good-Element performs intended function with high degree of reliability
Notes/Dimensions	Acceptable
Inspector	JAS, TWB, PJG

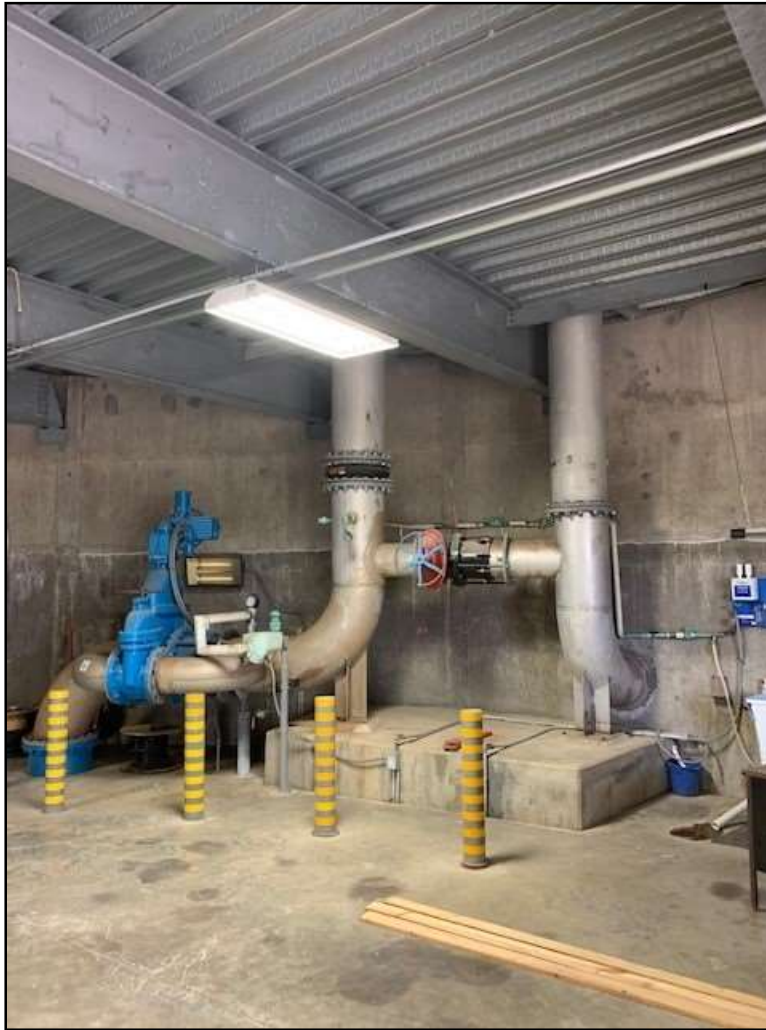
Attributes	
Title	Wagon Wheel CET
Inspection Item	Sample Port
Condition	Good-Element performs intended function with high degree of reliability
Notes/Dimensions	Sample port is present and appears functional.
Inspector	JAS, TWB, PJG

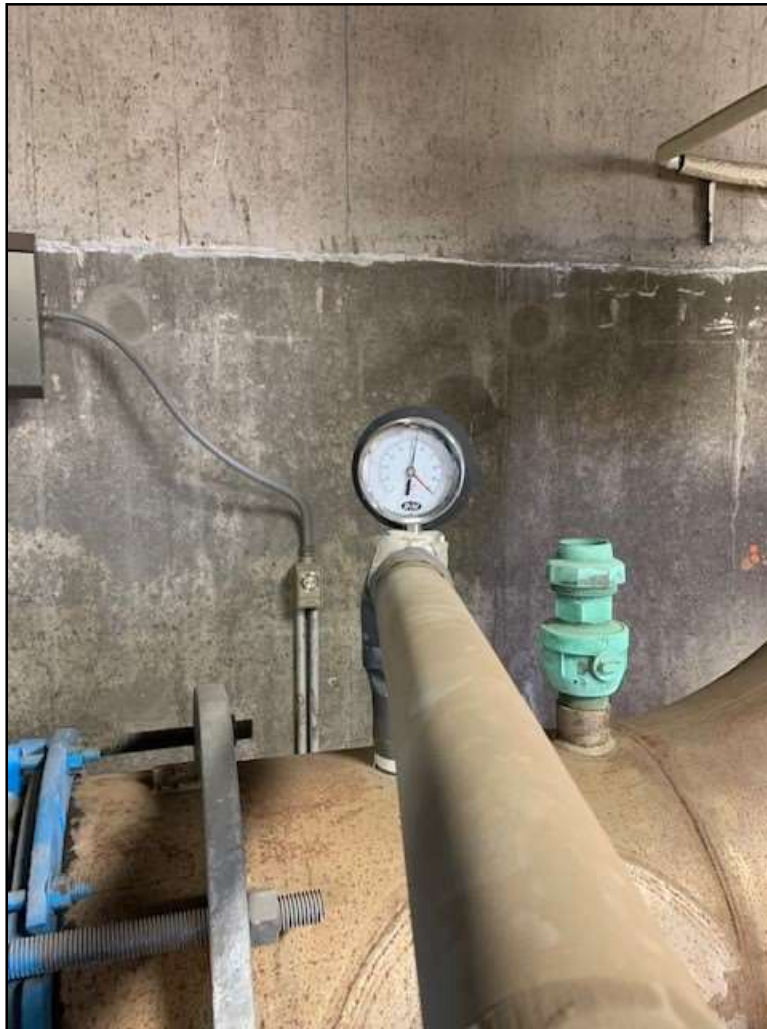
Attributes	
Title	Wagon Wheel CET
Inspection Item	Inlet Outlet Piping
Condition	Good-Element performs intended function with high degree of reliability
Notes/Dimensions	Acceptable
Inspector	JAS, TWB, PJG

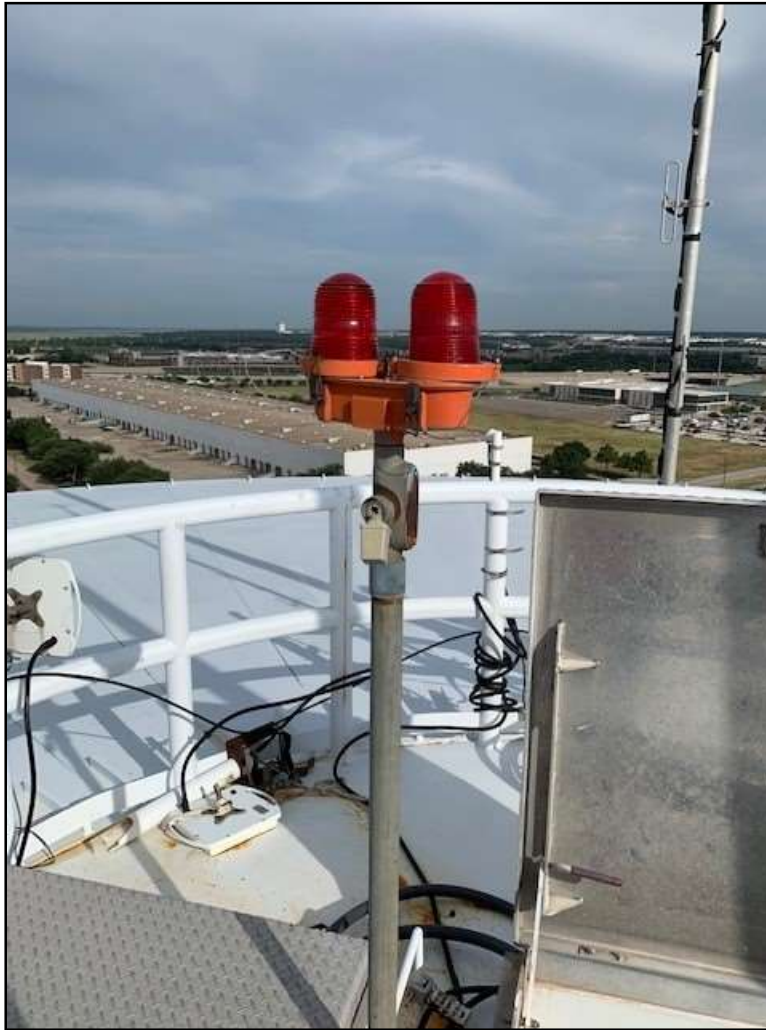
Attributes	
Title	Wagon Wheel CET
Inspection Item	Roof Communication Equipment
Condition	Poor-Element performs intended function with a significant reduction of reliability
Notes/Dimensions	Site equipment in need of repair.
Inspector	JAS, TWB, PJG

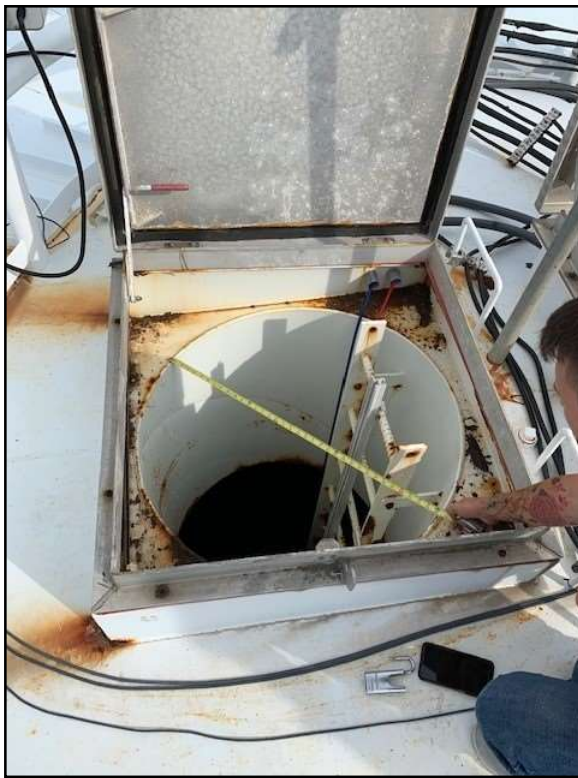
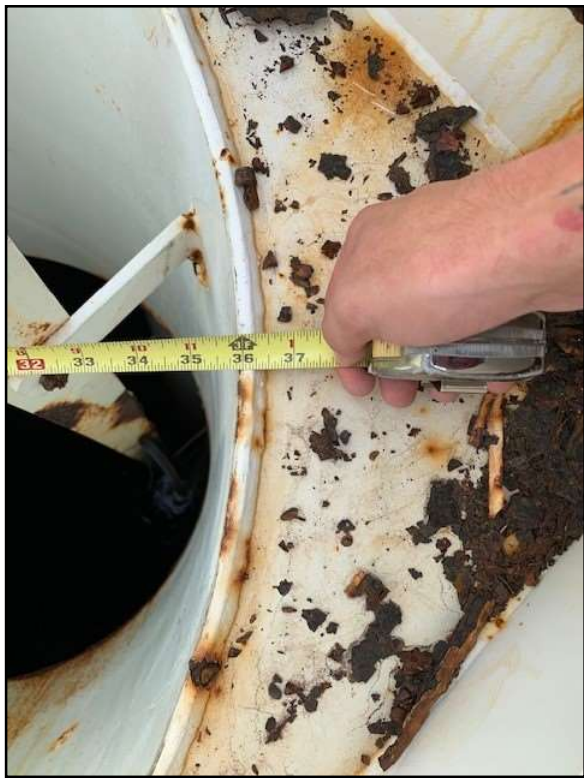
Attributes	
Title	Wagon Wheel CET
Inspection Item	Roof Hatch
Condition	Fair-Element performs intended function with small reduction of reliability
Notes/Dimensions	Dimensions of roof hatch are acceptable. 36"X36"
Inspector	JAS, TWB, PJG
