# Lakeside at Coppell Clubhouse Renovation Exterior Views - Existing Conditions

## LAKESIDE AT COPELL CLUBHOUSE RENOVATION

### SITE PLAN

# AS-01

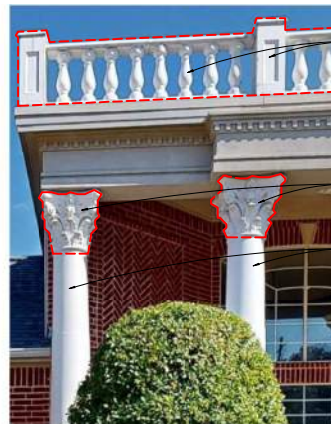
DEMOLITION REFERENCE IMAGE

REMOVE EXISTING BALUSTERS AND POSTS. REPAIR ROOF AS NEEDED FOR NEW CONDITION.

REMOVE EXISTING CAPITALS FROM COLUMNS TO MATCH COLUMN WITH.

EXISTING COLUMN SHAFT TO REMAIN AS IS

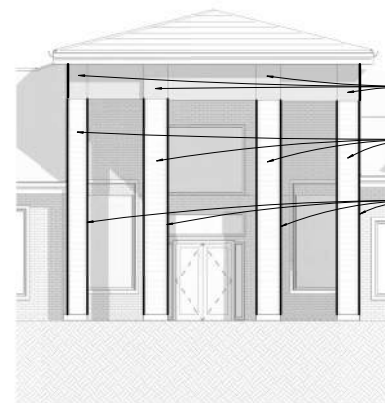
② EXTERIOR ELEVATION - WEST (PARTIAL AT ENTRY)  
1/4" = 1'-0"

EXISTING CORNICE TO REMAIN

EXISTING ROUND COLUMNS TO REMAIN WITH CAPITALS REMOVED. NEW CLADDING AS DESCRIBED BELOW.

NEW SQUARED DECORATIVE CLADDING OVER EXISTING STRUCTURAL COLUMNS. GC TO PROVIDE WRAP ENVELOPE WITH 3/4" WOOD CEMENT FIBER AND GROOVE TECHNIQUE. SMOOTH FINISH. CLEAR STAIN AND SEAL. STAINED WOOD SAMPLE TO BE SENT TO IRT DESIGN GROUP FOR APPROVAL PRIOR TO INSTALLING.
