Architecture/Urban Design, PC

DFW LAND
REAL ESTATE

LAKE BREEZE SENIOR LIVING
Coppell, Texas

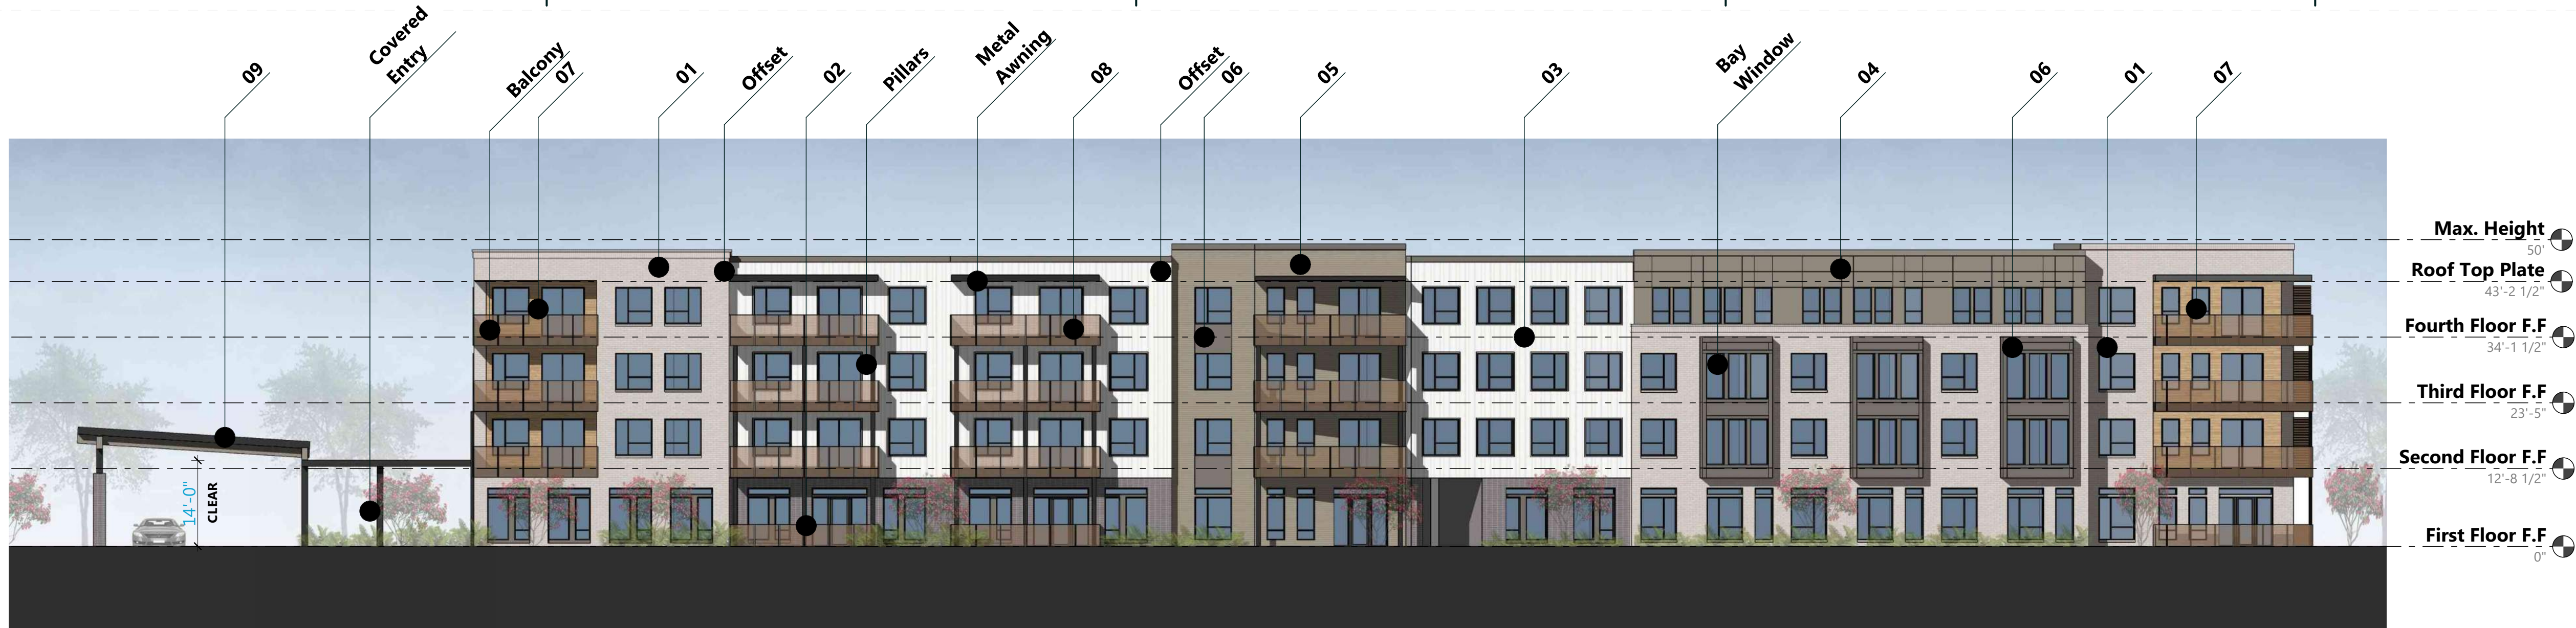
06 | South Elevation
Scale: 1/16" = 1'-0"

South Elevation Material Percentages	
Material	Percentage
Brick	38.8%
Cementitious Siding	14.3%
Cementitious Board and Batten	29.1%
Cementitious Panel	11.0%
Woodtone	6.8%
Total	100.0%

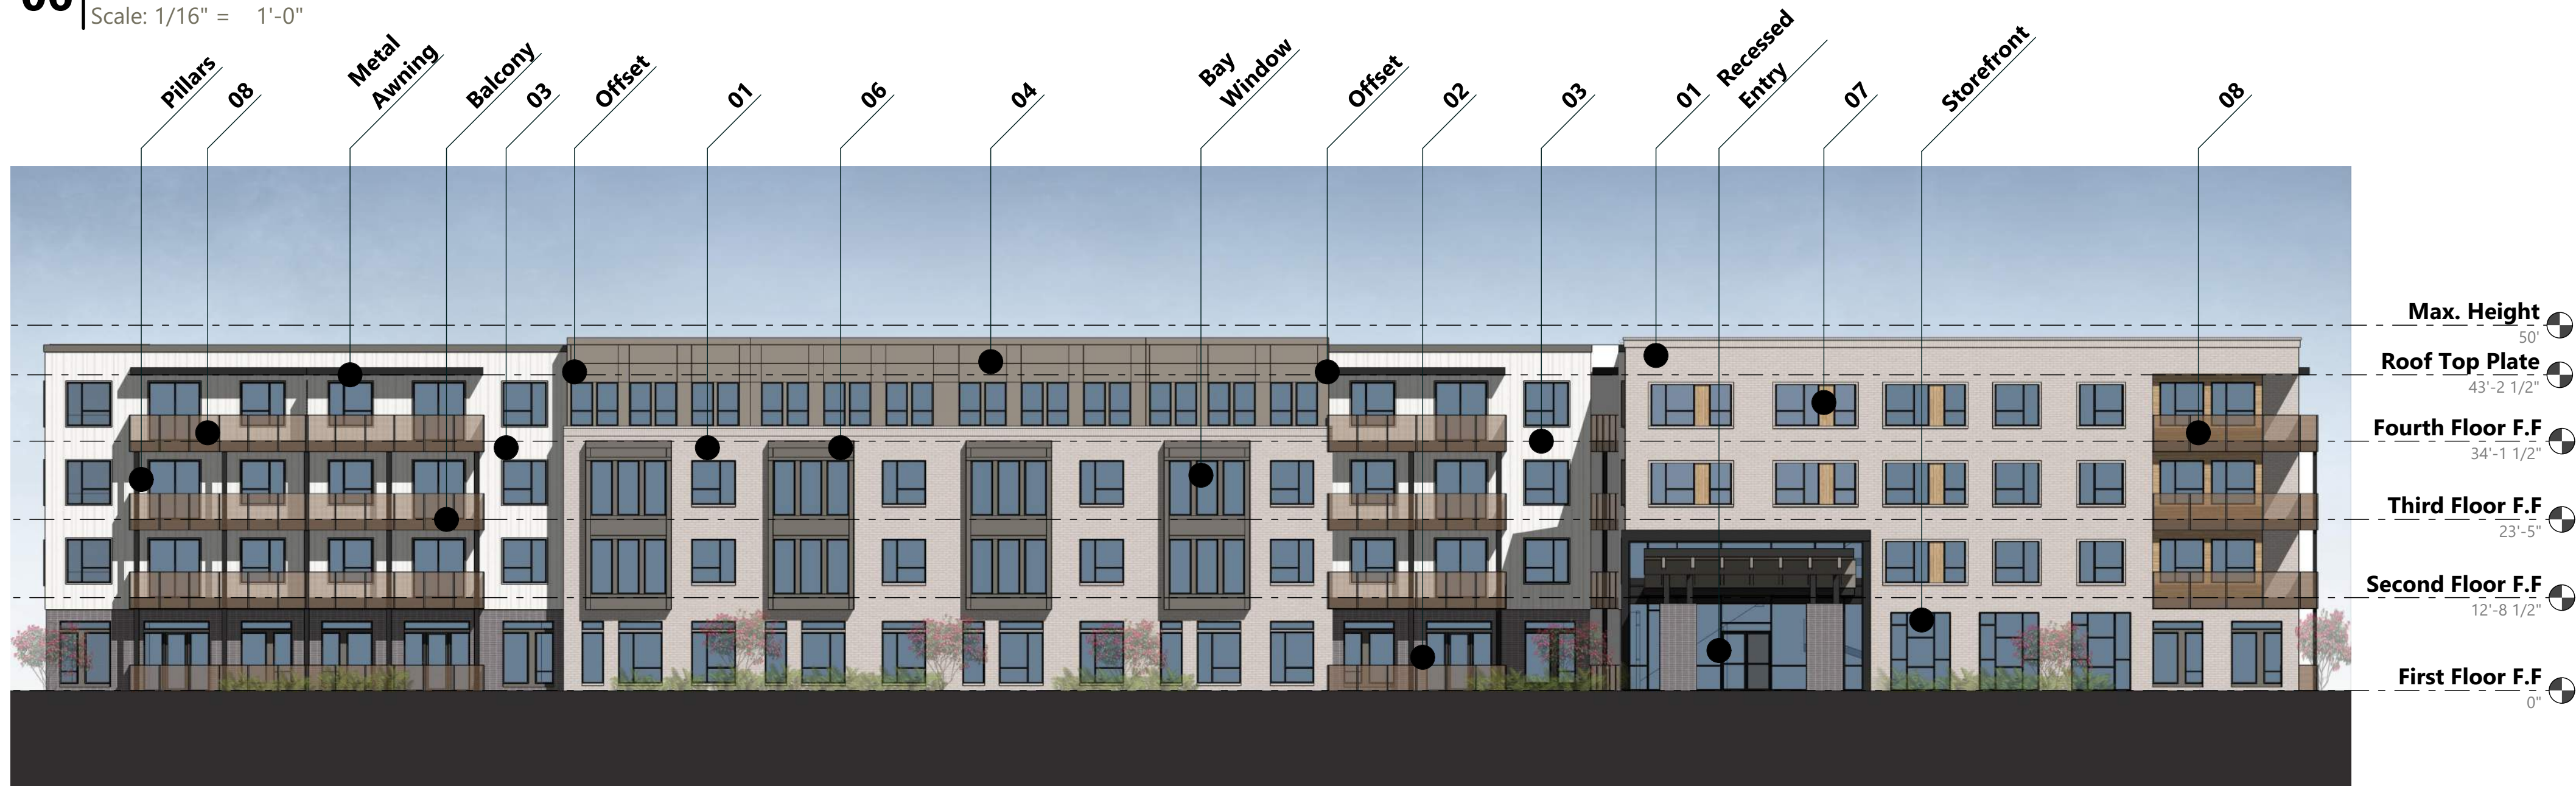
11 | West Elevation
Scale: 1/16" = 1'-0"

West Elevation Material Percentages	
Material	Percentage
Brick	51.1%
Cementitious Board and Batten	30.3%
Cementitious Panel	14.8%
Woodtone	3.8%
Total	100.0%

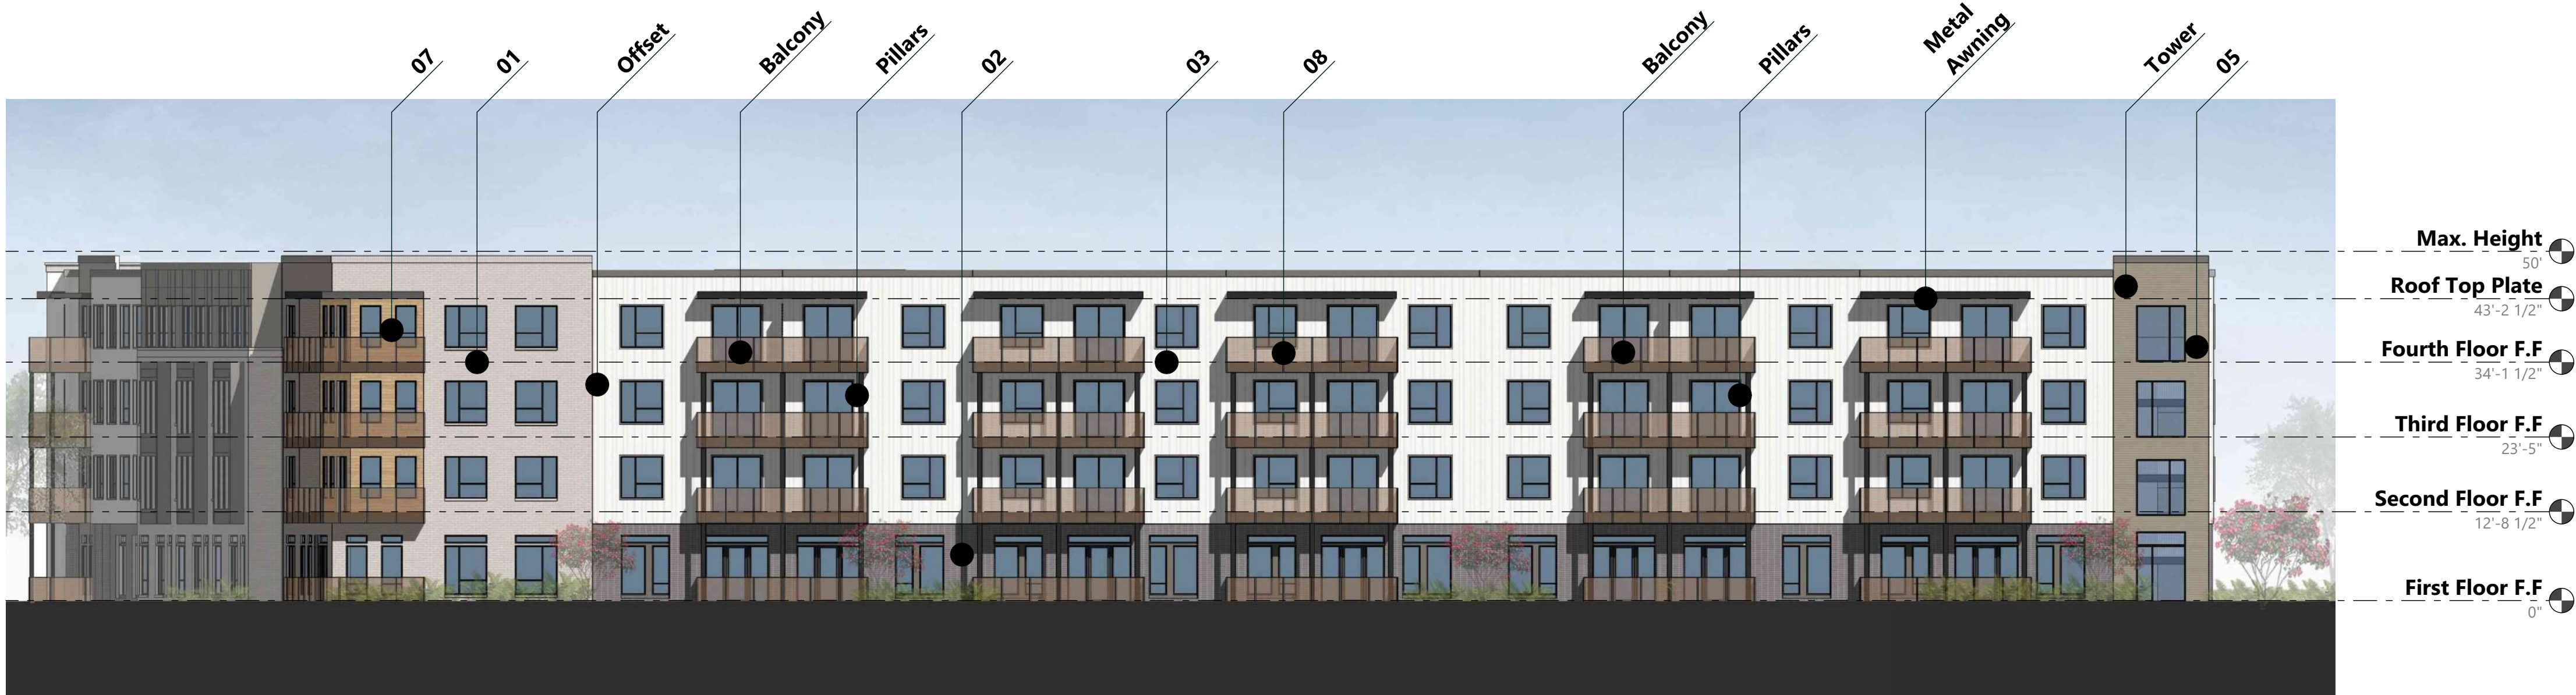
06 East Elevation
Scale: 1/16" = 1'-0"

East Elevation Material Percentages	
Material	Percentage
Brick	26.4%
Cementitious Siding	5.1%
Cementitious Board and Batten	66.1%
Woodtone	2.5%
Total	100.0%

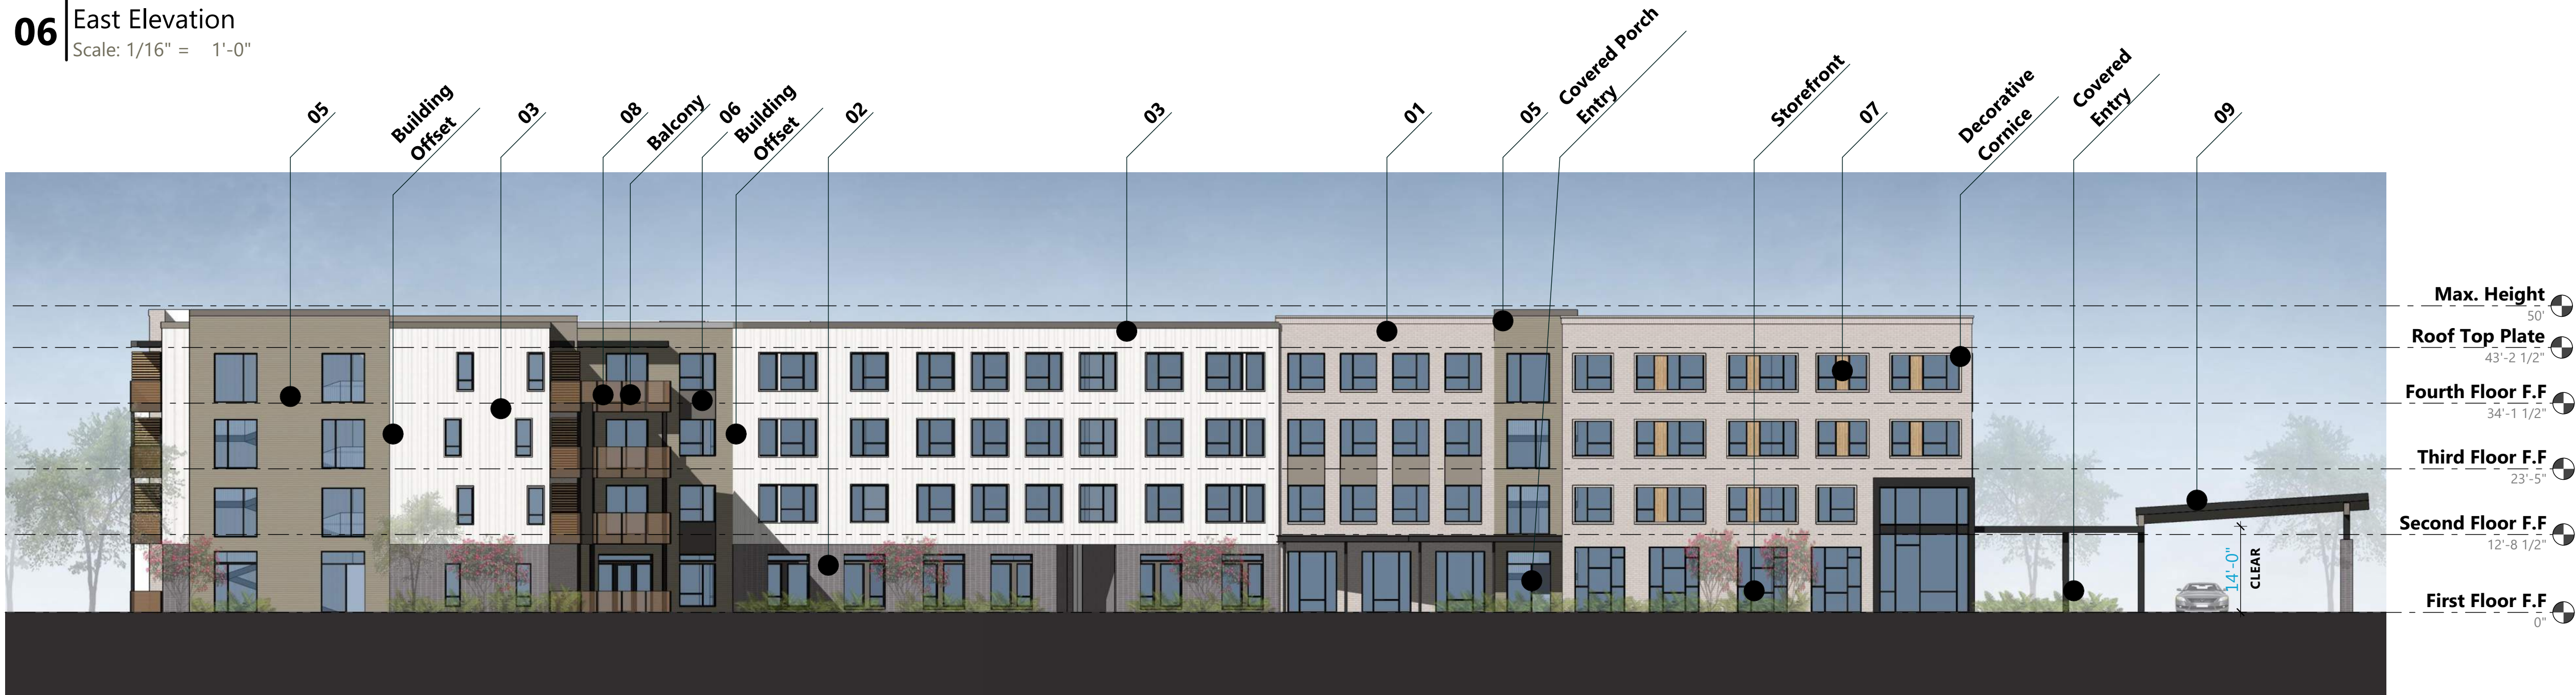
11 North Elevation
Scale: 1/16" = 1'-0"

North Elevation Material Percentages	
Material	Percentage
Brick	39.0%
Cementitious Siding	25.8%
Cementitious Board and Batten	34.1%
Woodtone	1.1%
Total	100.0%

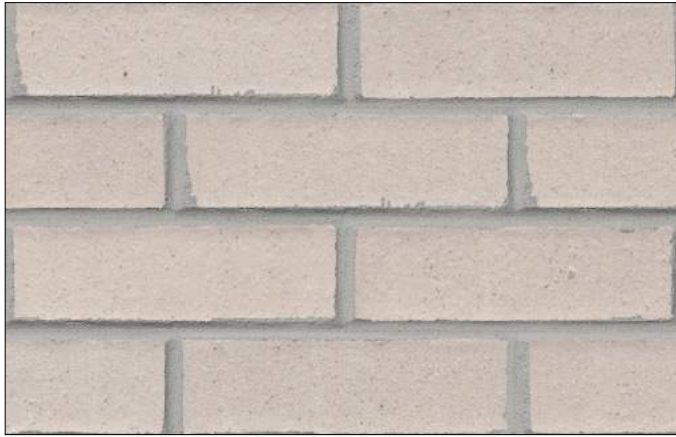
01 - Brick 1 - ACME Steel Gray

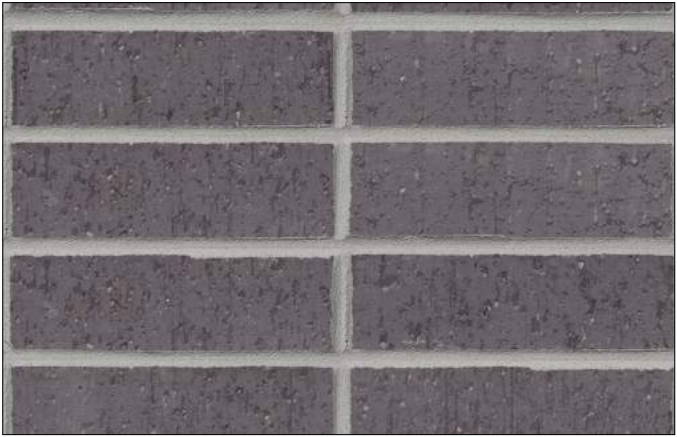
02 - Brick 2 - ACME Ebony

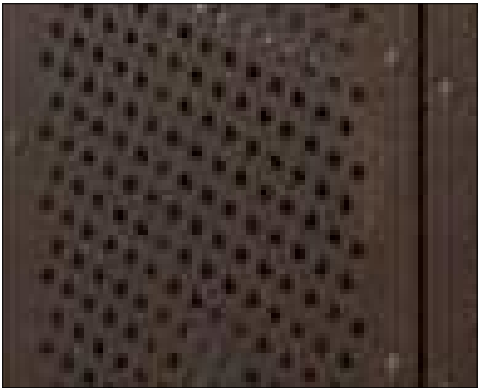
08 - Perforated Metal Panel railing-
33% Open Area- Dark Bronze
